Indian Creek Road Sediment Reduction Project

Indian Creek – Trinity County – January 2009

FINAL REPORT

California Department of Fish and Game – Fisheries Restoration Grant Program
Contract No. P0510325

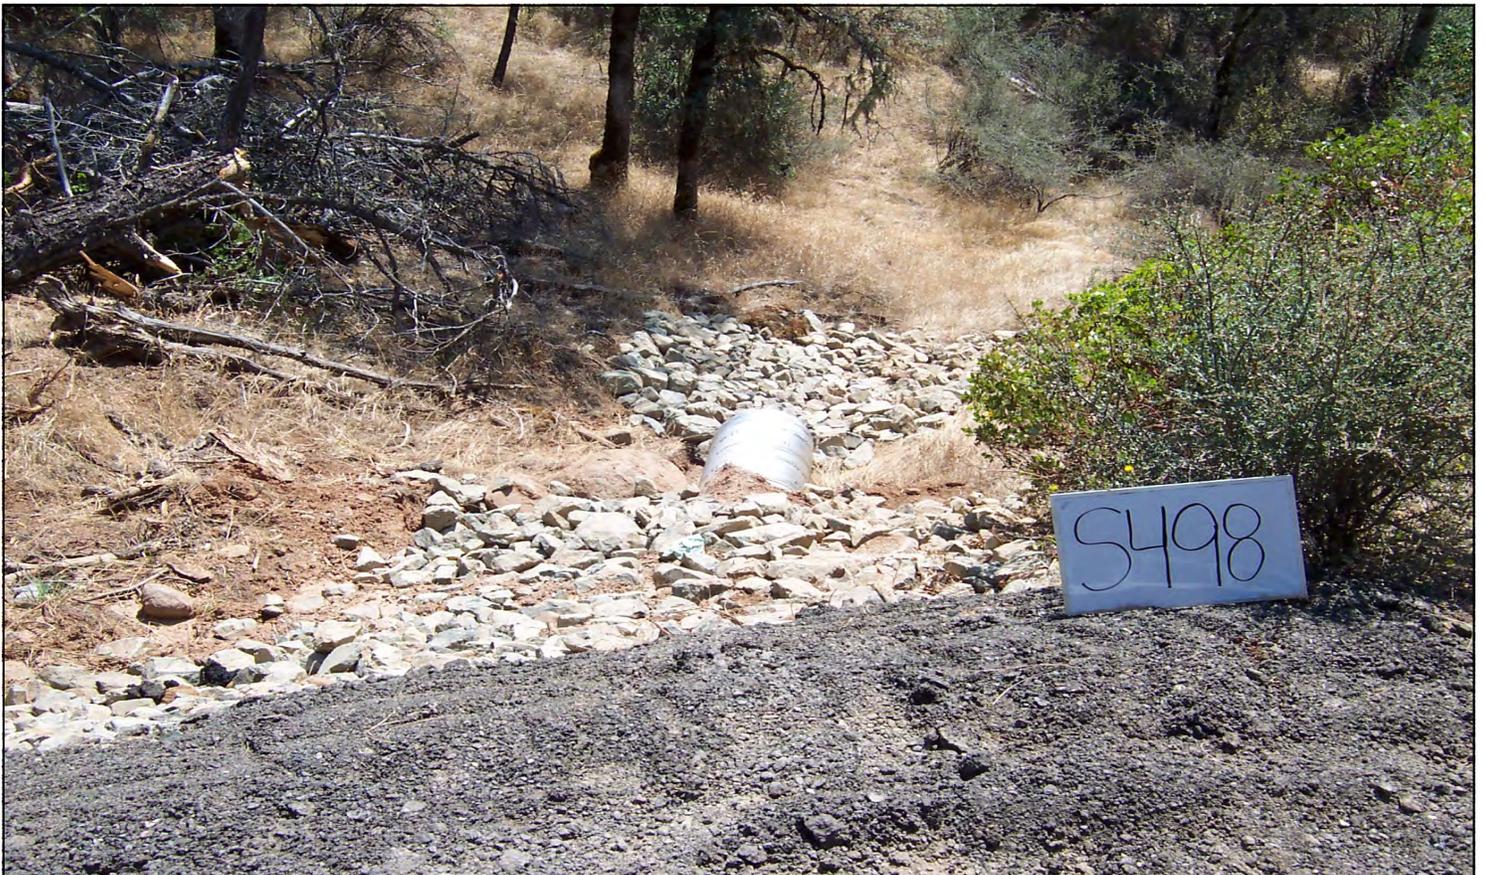
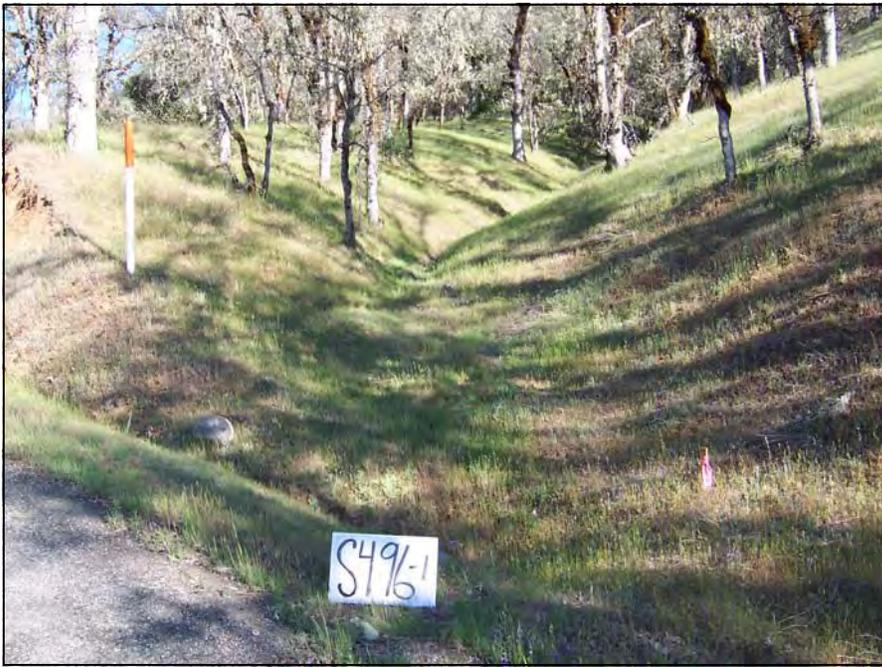
Site 498—Milepost 1.52—Treated Erosion: ~100 cyds

Stream crossing with undersized 18" x 40' CMP that was causing outboard fill face erosion due to short length

Right photos are upstream channel & old culvert

Bottom & upper right photos are of the new 24" x 60' CSP culvert installed with the upstream (top) & downstream rock armor (below)

Treatment: Replace with a 24" x 60' CMP at bottom of fill, at channel grade & rock the outlet channel

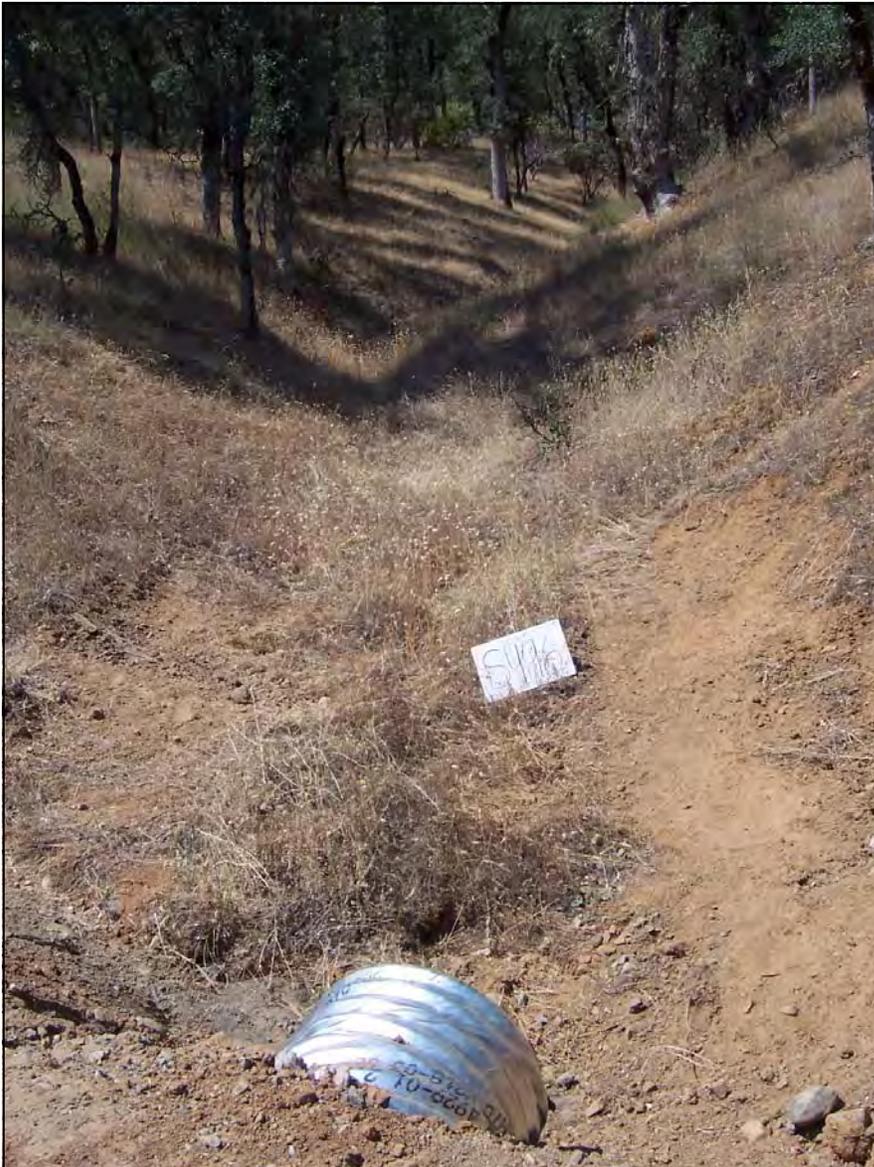
Site 496
Milepost 1.69—Treated erosion: ~100 cyds

Stream crossing with undersized 18" x 35' hydraulic mining pipe that was separated & causing road fill erosion.

Bottom right top photo is the new 24" inlet

Bottom right photo is the rocked outlet channel

Treatment: Replace with 24" x 50' CMP at bottom of fill & rock the outlet channel

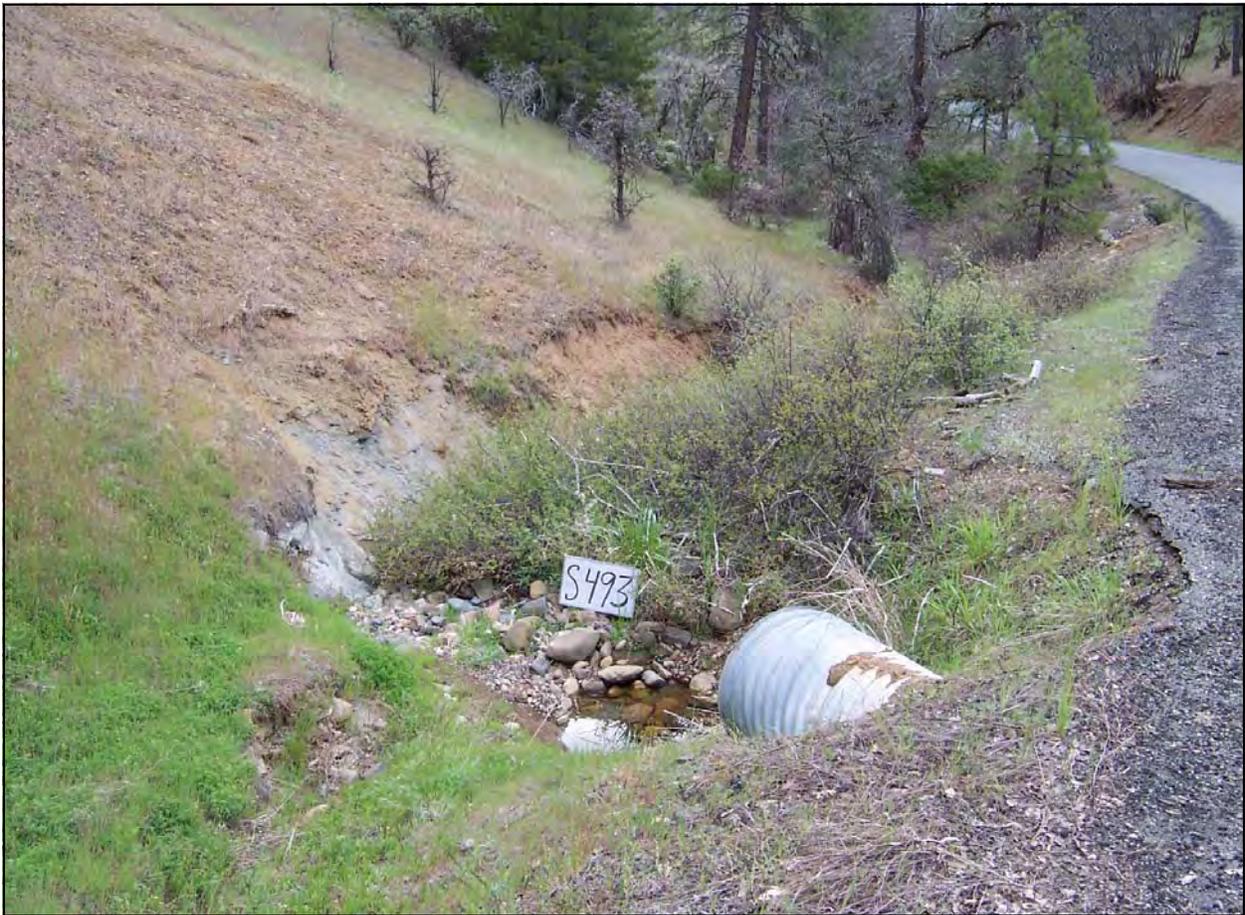
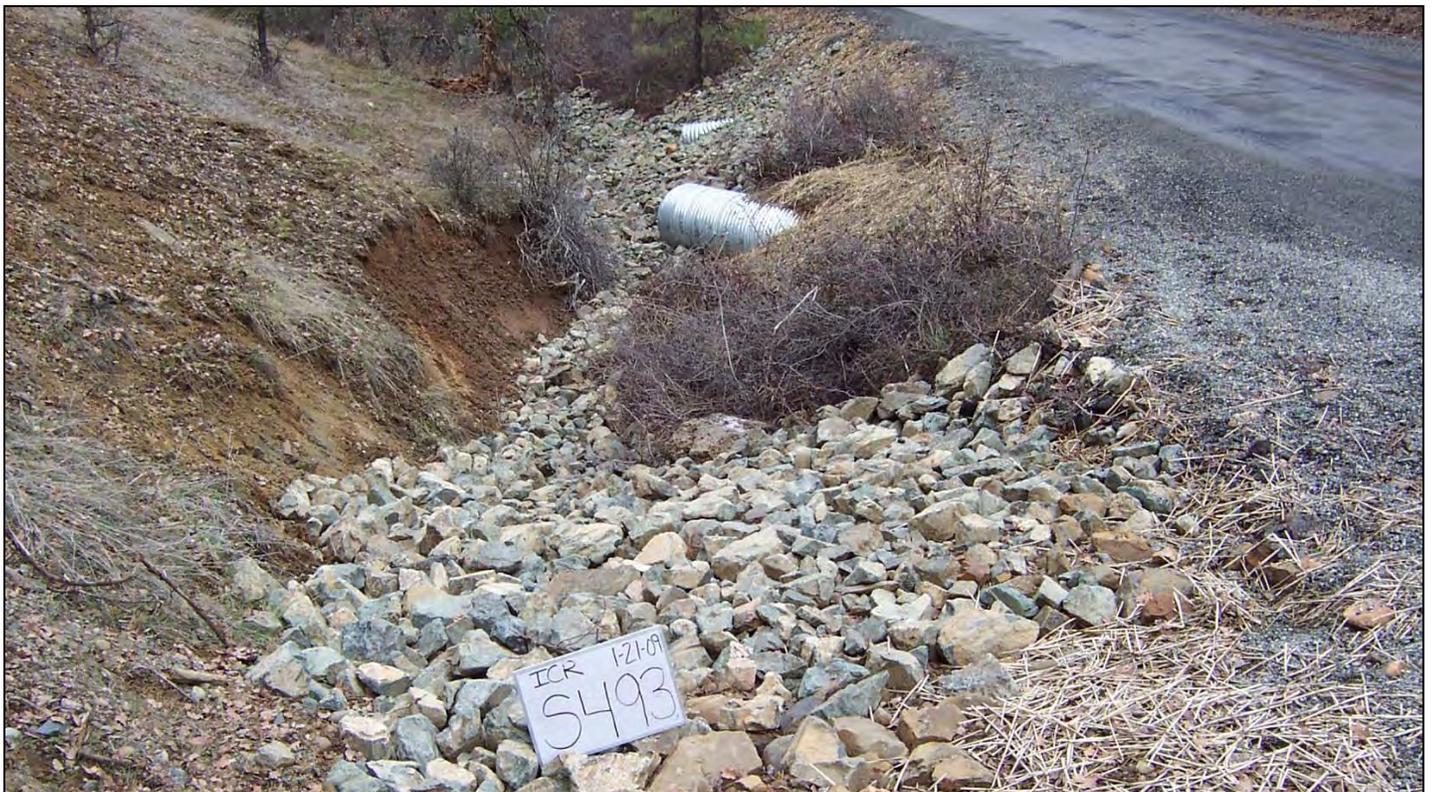
Site 493—Milepost 1.80—Treated Erosion: ~40 cyds

Stream crossing with 24" x 35' CMP with a rusted bottom & plugged inlet

Top photo is of the outlet & outboard channel prior to replacement

Bottom photo is newly aligned 30" CMP at bottom of fill with outlet of DRC replaced at Site 492 in background

Replace with 30" x 80' CMP aligned with channel, at bottom of fill & at 8% slope

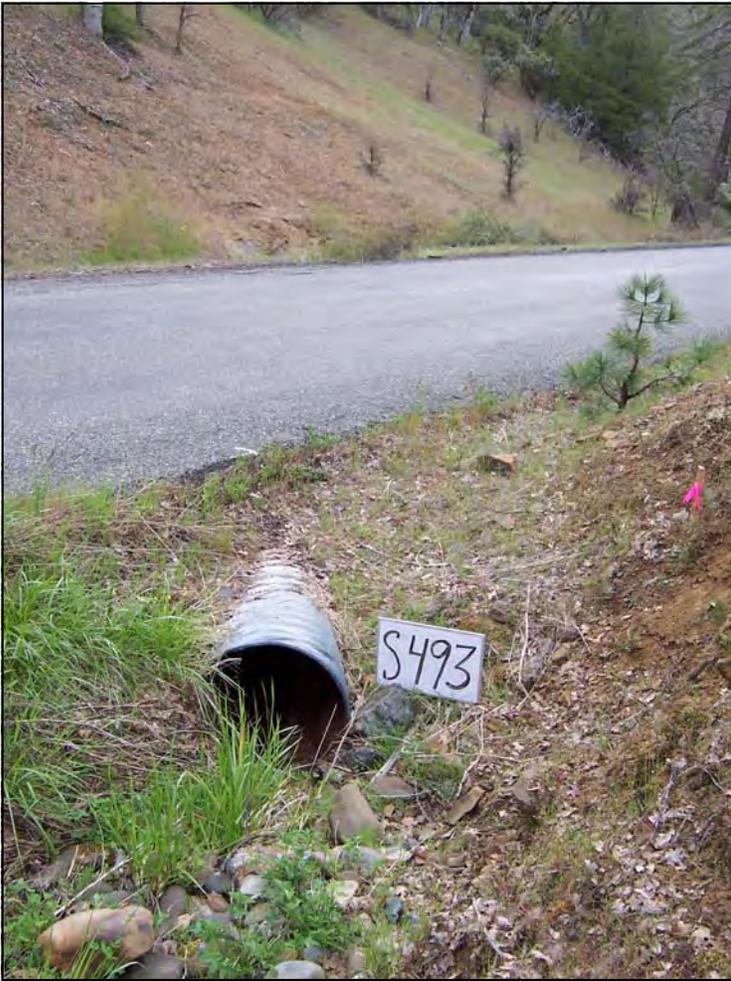
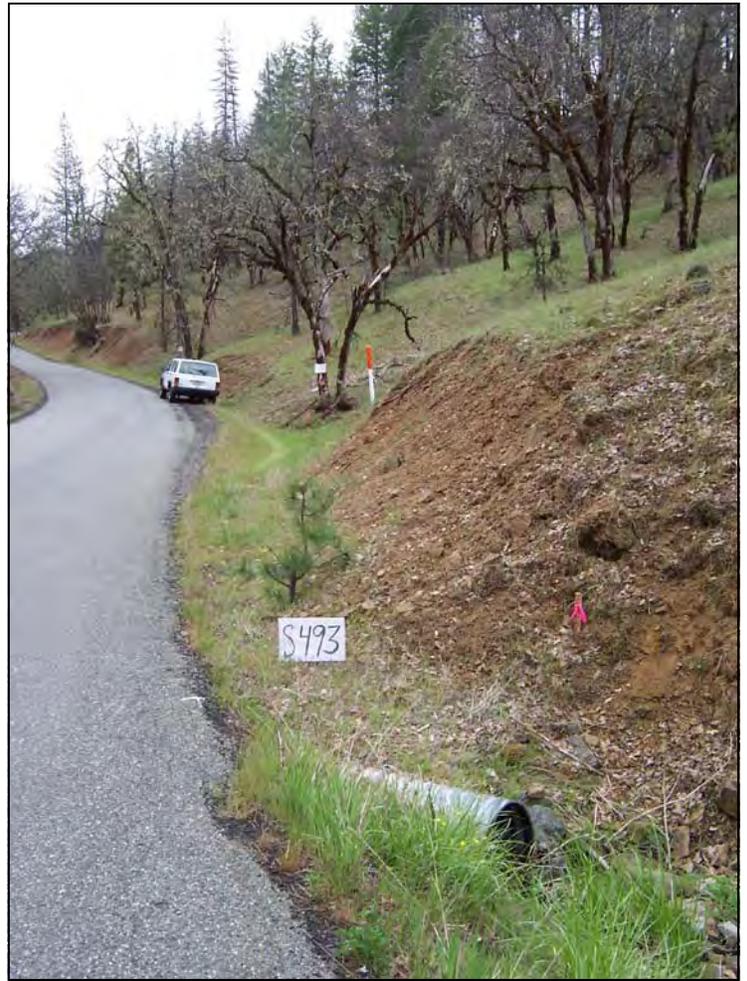
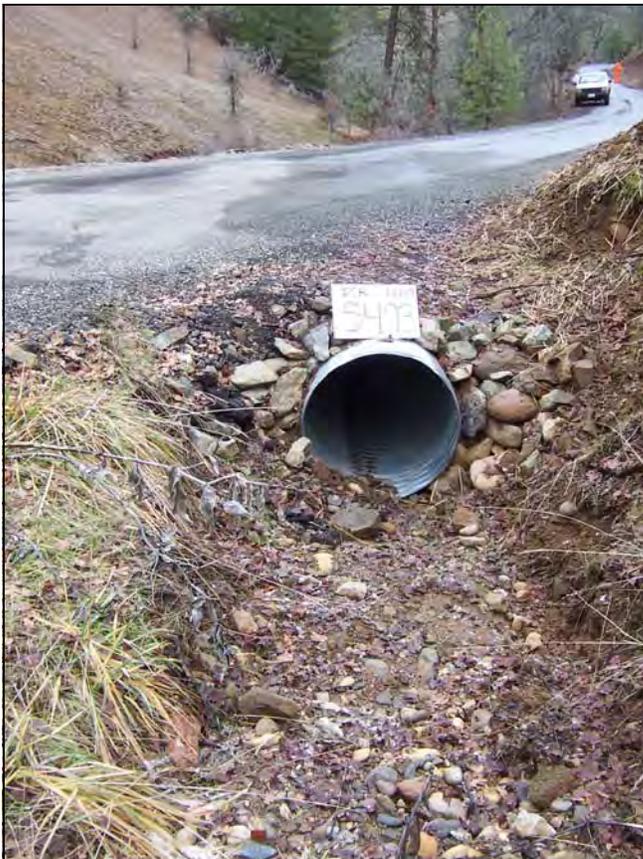
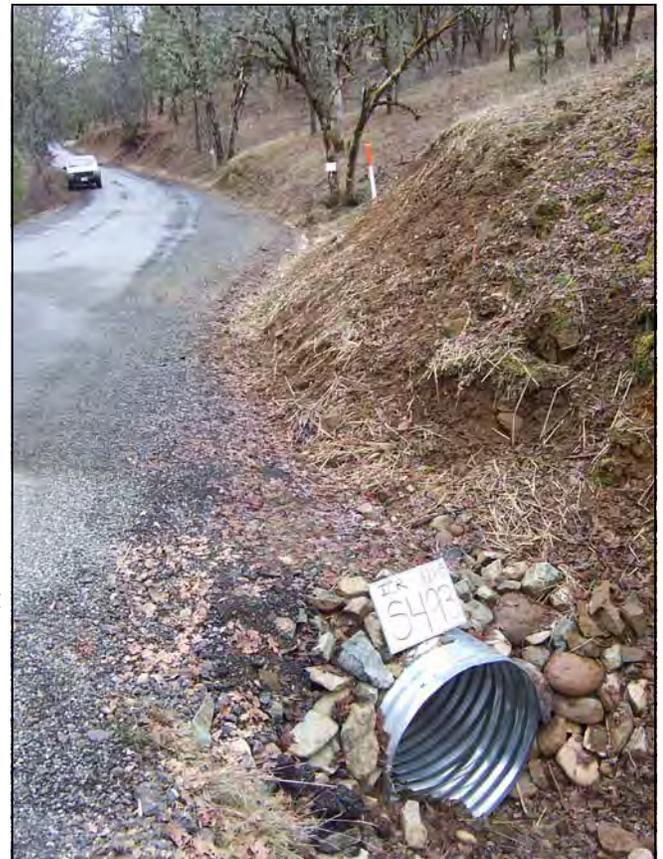
Site 493
Milepost 1.80
Stream crossing

Top Left is inlet view prior to 30" culvert being installed

Note plugging & misalignment with channel compared with newly installed inlet at bottom left

Top Right is inlet view looking down road to Site 492 prior to 30" culvert installation (bottom right)

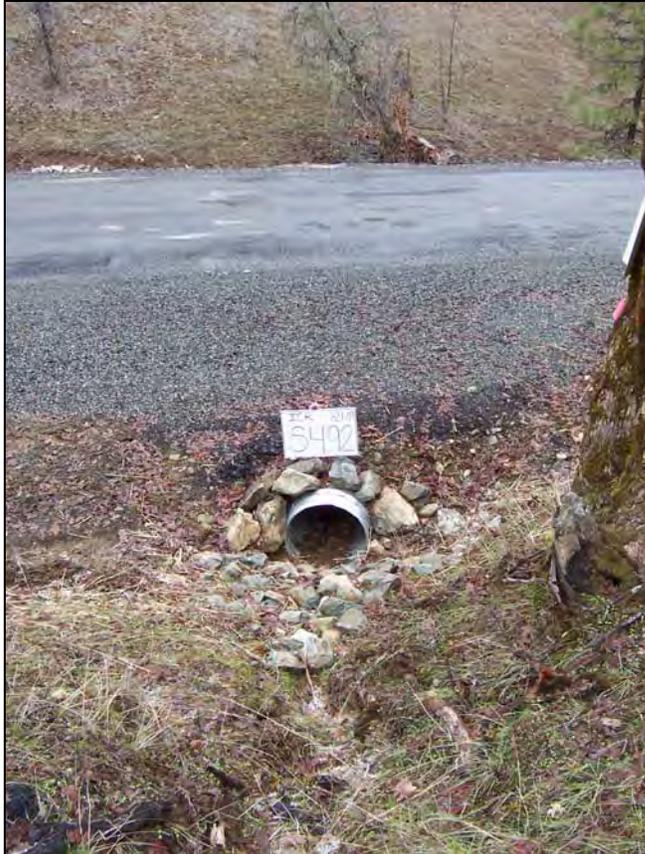
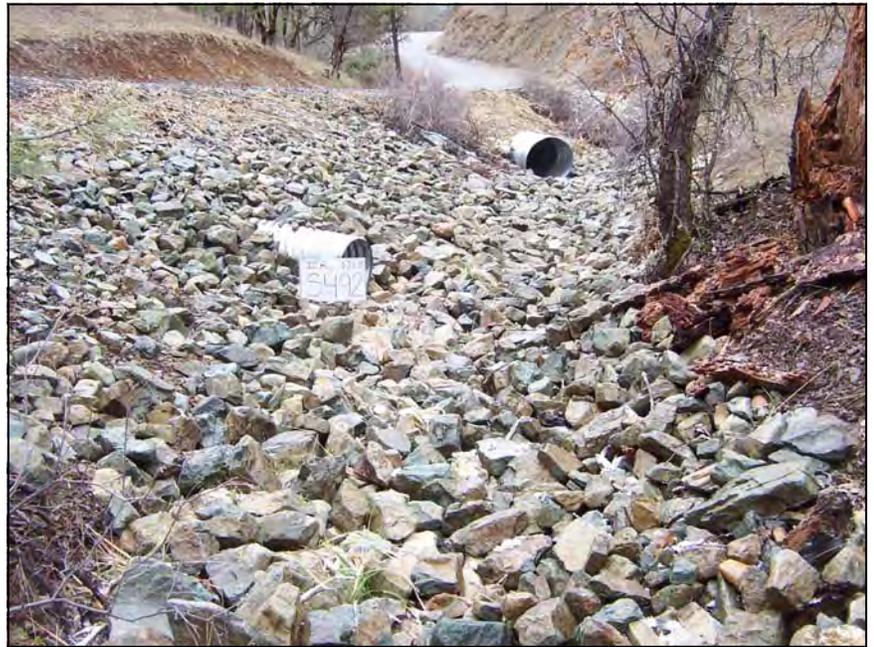
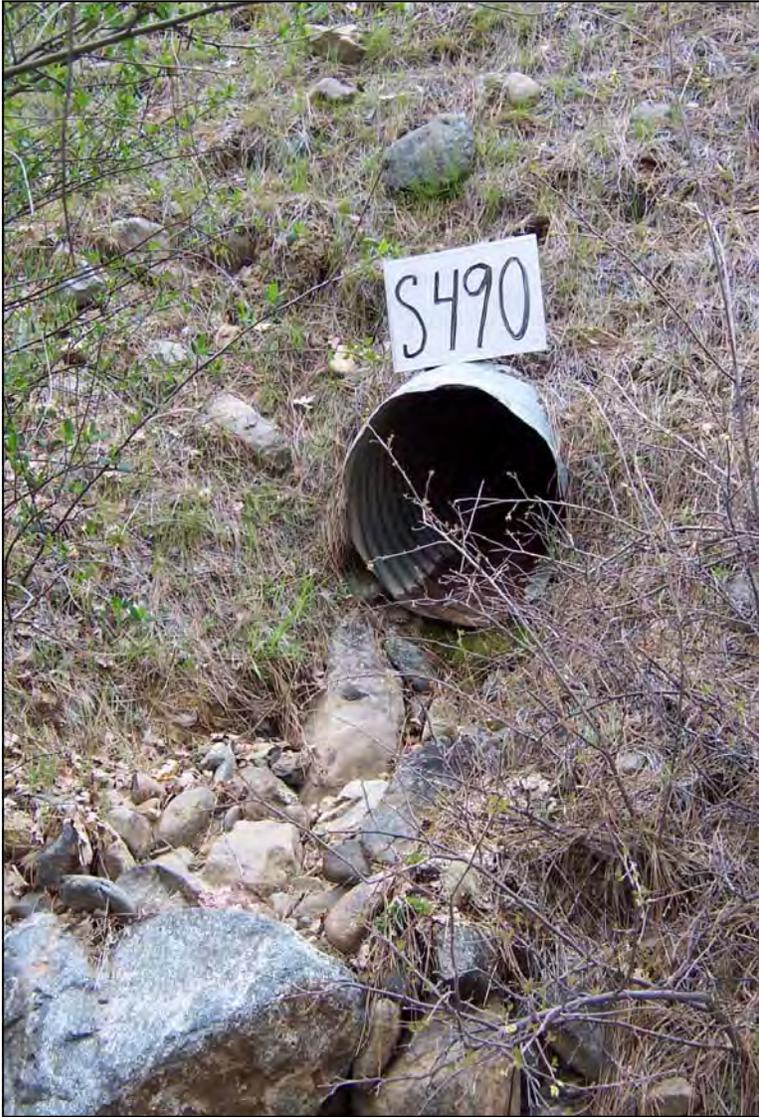
Site 492—Milepost 1.82—Treated Erosion: ~10 cyds

Top left photo is the inlet & right photo is the outlet prior to implementation

Bottom left & right photos are after the 18" DRC installation (note outlet of 30" CMP at Site 493 in bottom right photo)

Treatment: Replace with 18" x 40' CMP in same location and outlet into rocked outboard outlet channel of Site 493

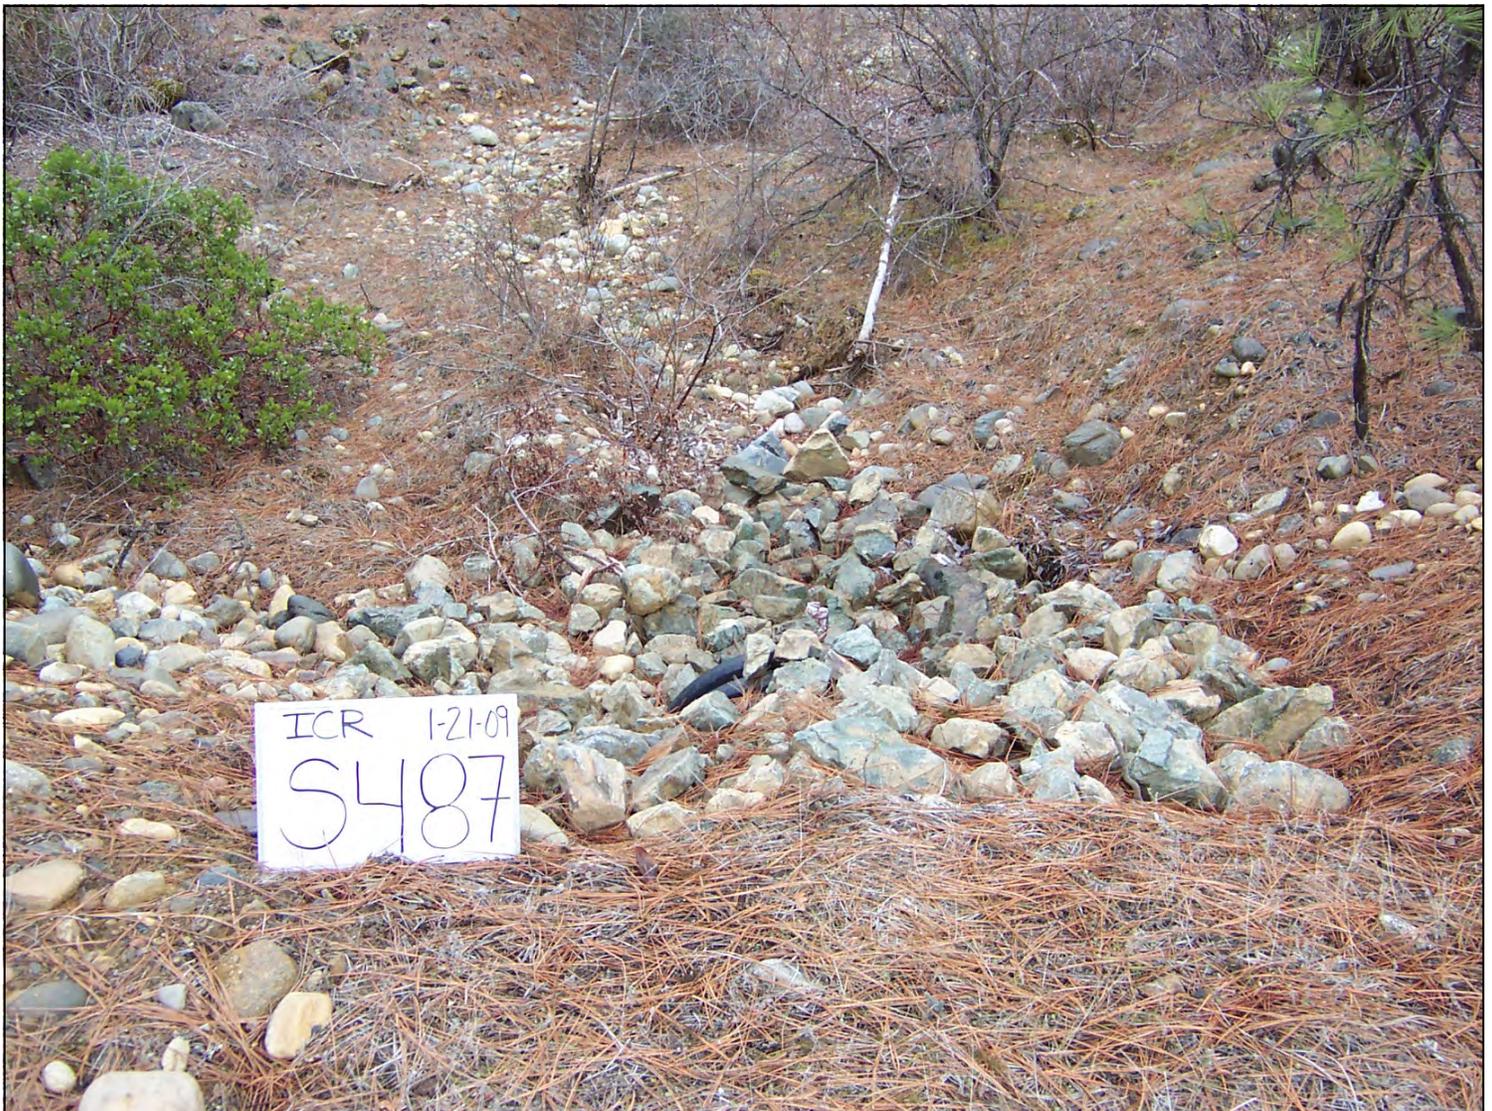
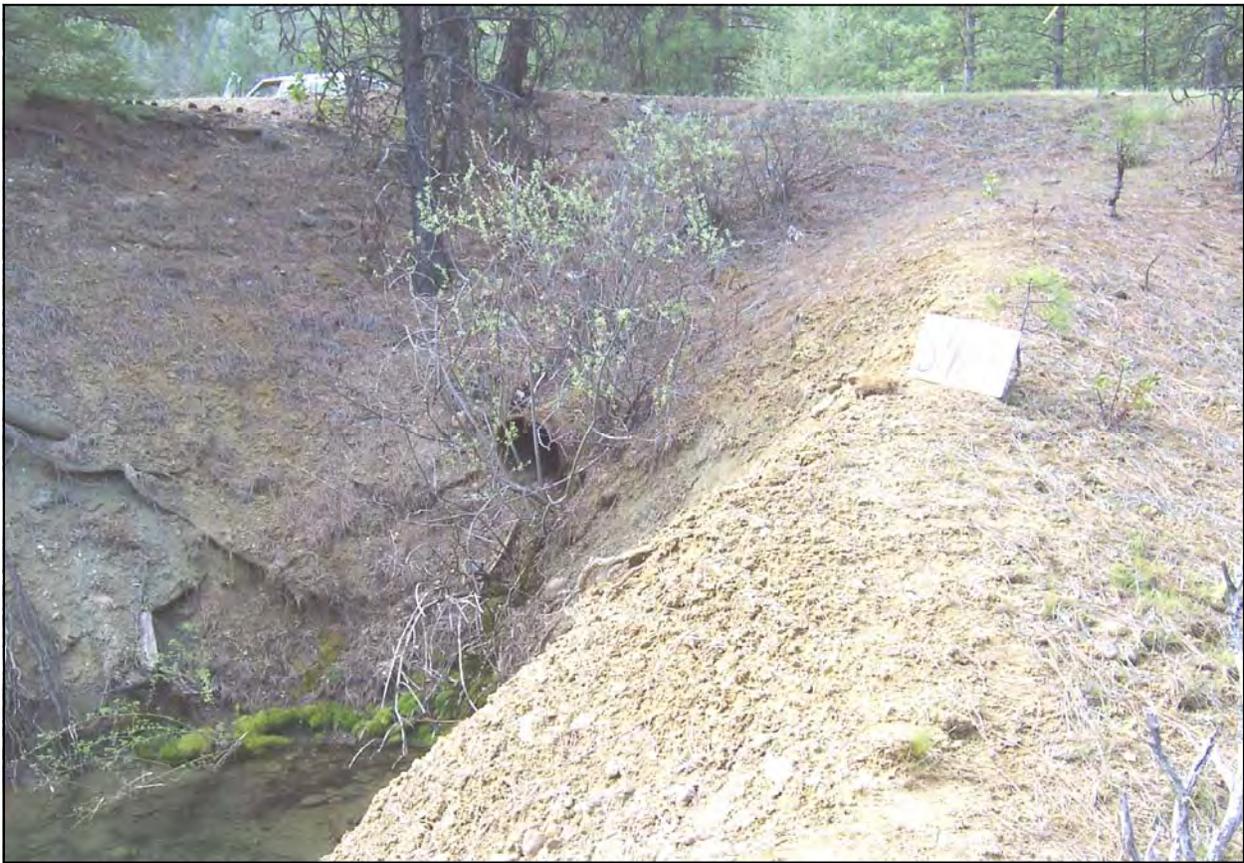
Site 487
Milepost 2.07—Treated Erosion: ~60 cyds

Stream crossing with a 30" x 40' plastic pipe installed at a flat grade that's eroding the outlet channel (shown in left photo)
Treatment: Rock Armor Outlet Channel (bottom photo)

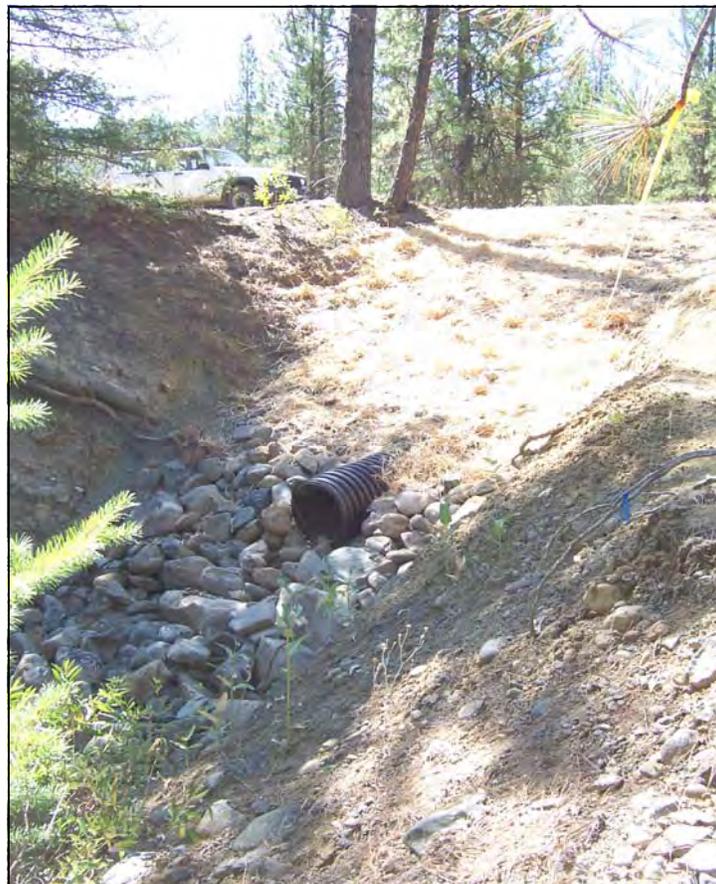
Site 485—Milepost 2.19—Treated Erosion: ~270 cyds

Stream crossing with an undersized 22" x 50' Hydraulic mining pipe that is separated mid-length
Treatment: Replace with 24" x 40' SBP at bottom of fill & at channel grade of 8%; Rock armor the outlet channel
Top photo is of outlet & erosion prior to implementation—Bottom photo is new 24" SBP with rock armored outlet

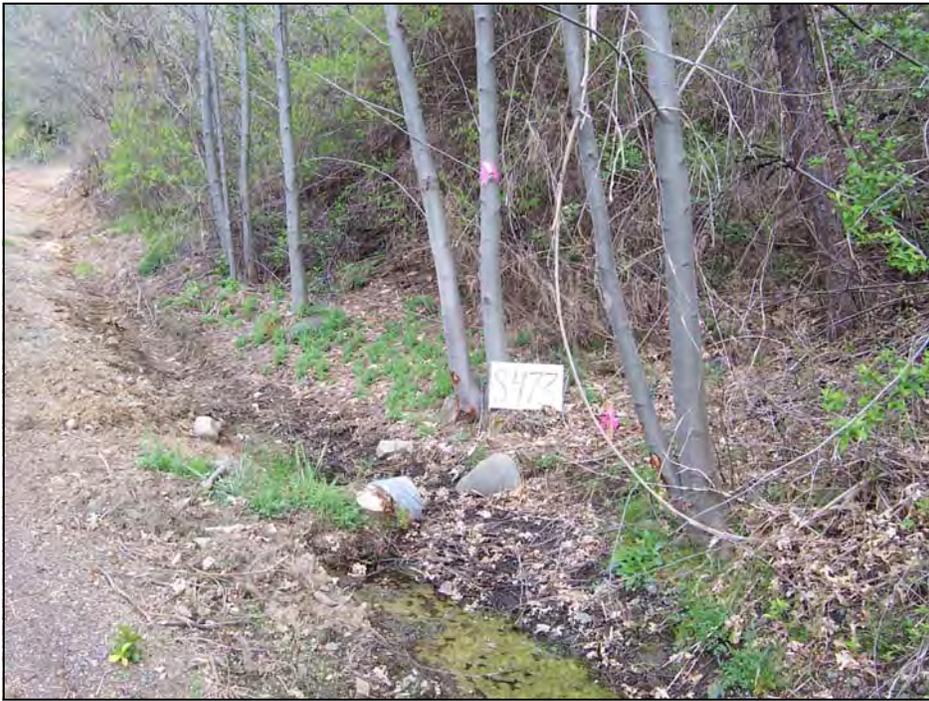
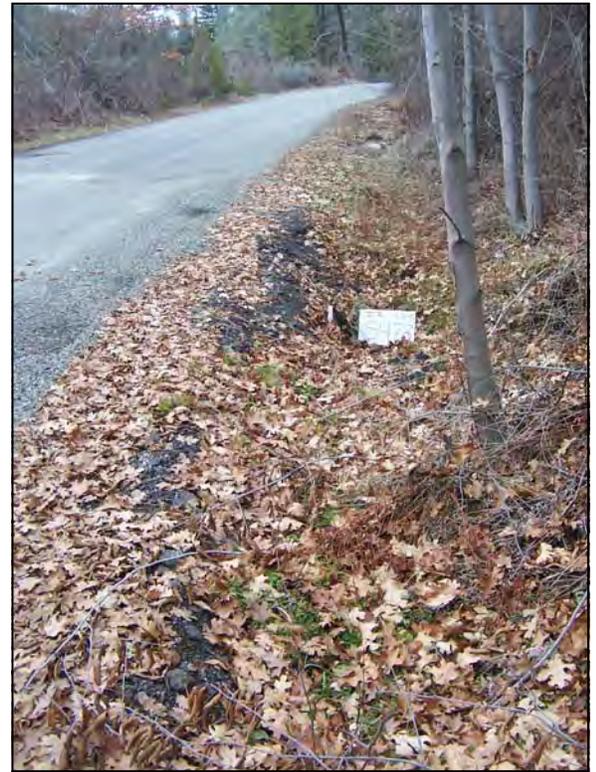
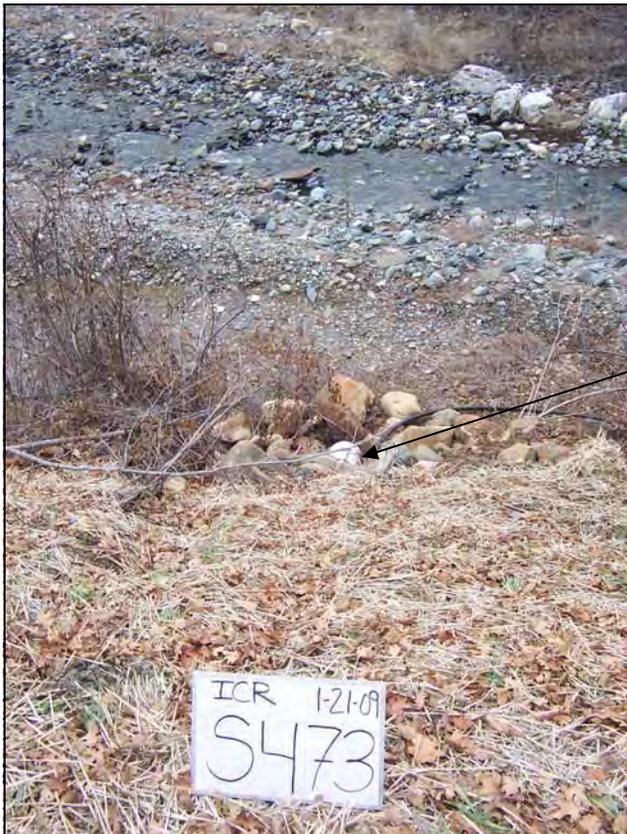
Site 473—Milepost 3.56—Treated Erosion: ~70 cyds

Diverted stream crossing with undersized 12" x 40' CMP

Treatment: Replace with 18" x 60' CMP in the same place, at the bottom of fill & at channel grade of 15% slope
 Top left photo is of the inlet area and 12" pipe prior to implementation & right is of new 18" culvert. Bottom left photos are post-implementation: left is of the outlet & right is the inlet—note proximity to Indian Creek

Culvert was left in the same location as moving to natural channel would result in increased erosion

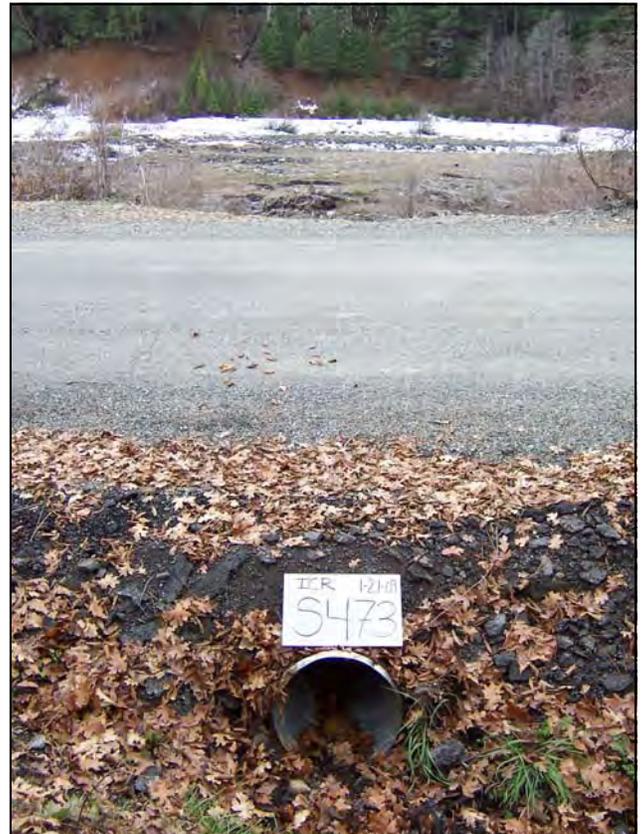
Outlet at bottom of fill

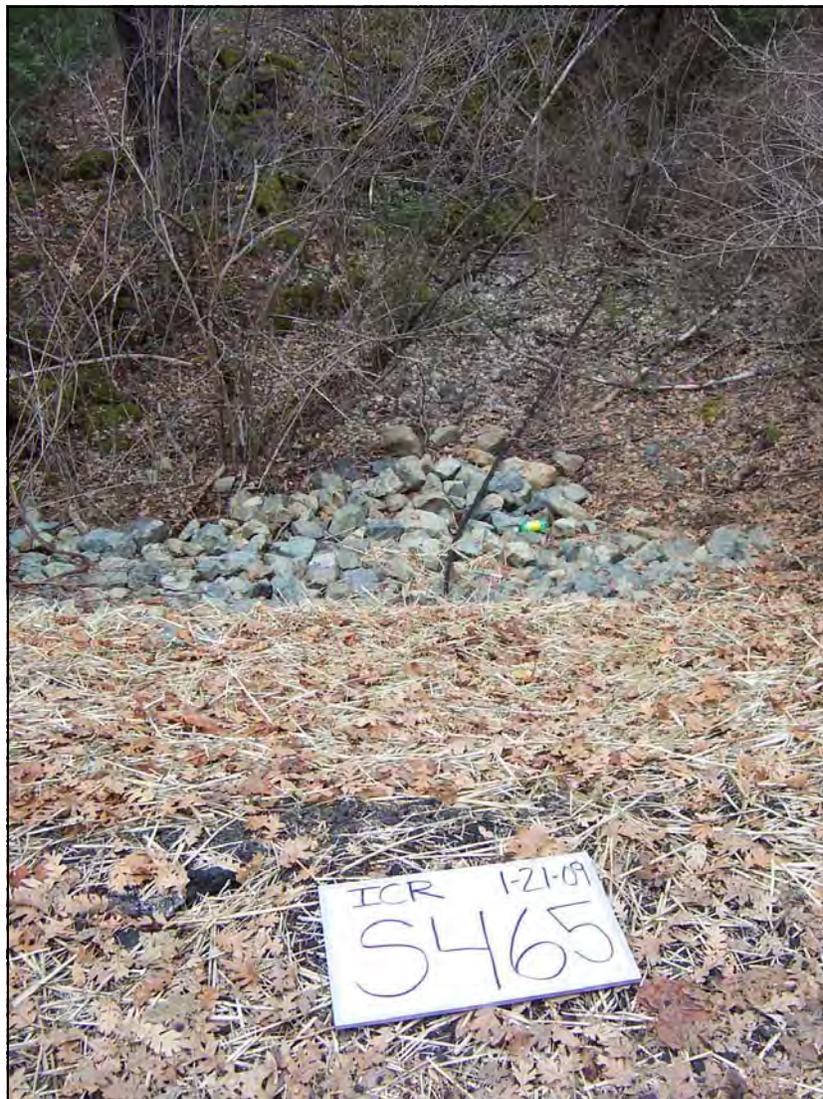
Site 465—Milepost 4.76—Treated Erosion: ~30 cyds

**All photos are post-implementation as the pre-photos of this Site was taken at the wrong location on the road due to a mileage inconsistency

Top photos are of upstream watershed area & inlet with rock armor; Bottom photo is outlet

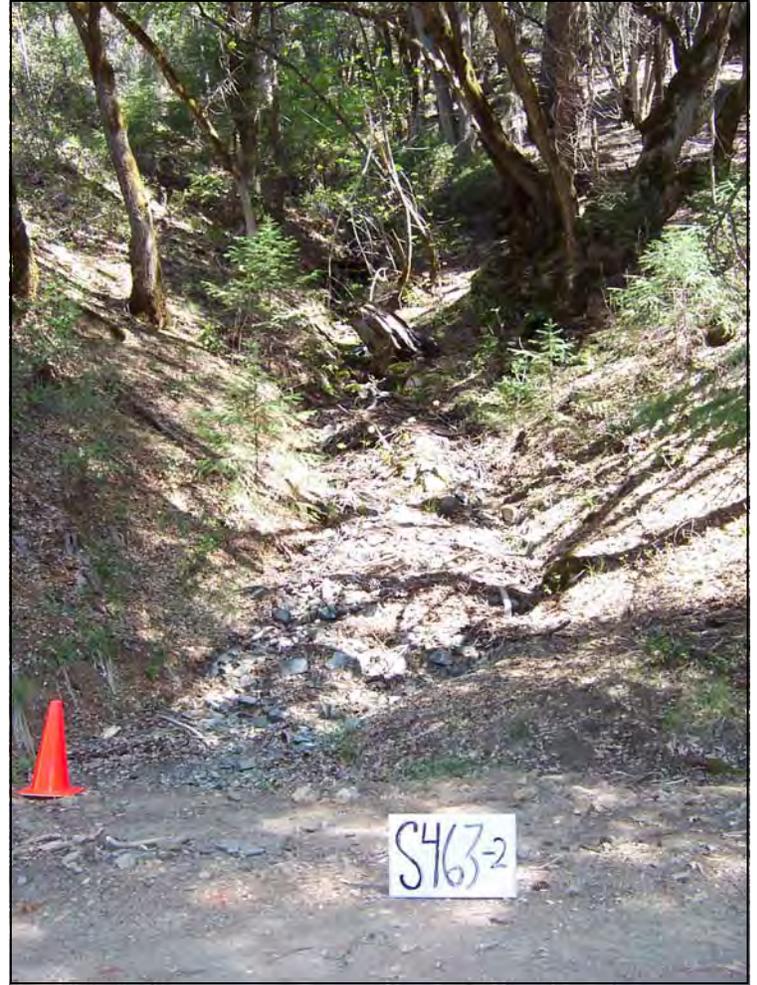
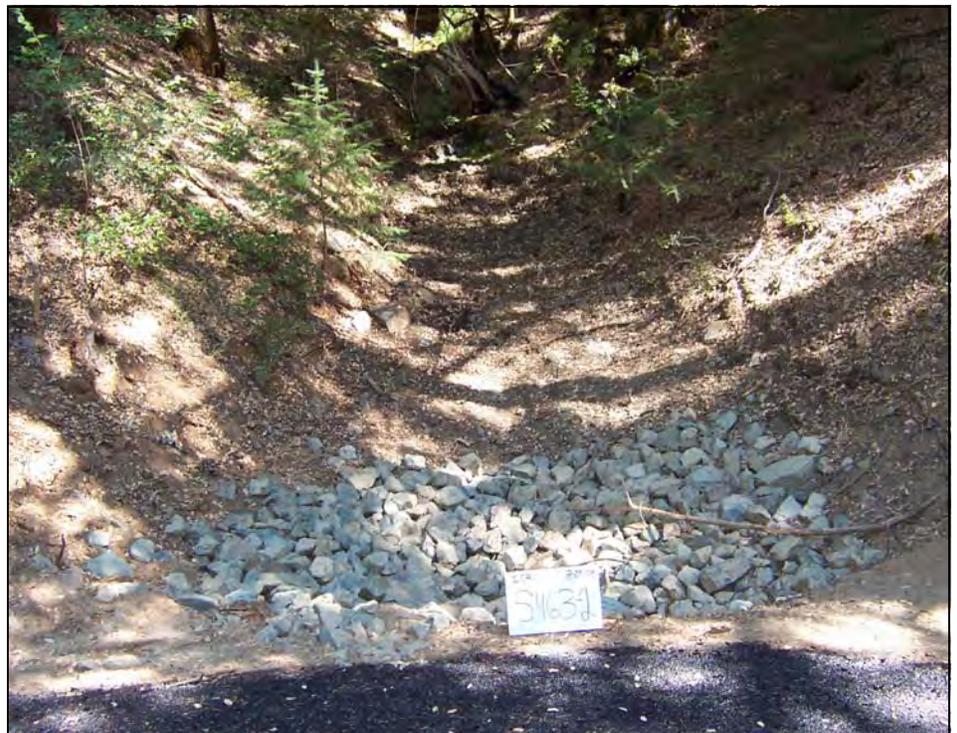
**Site 463
Milepost 5.07**

Treated Erosion: ~100 cyds

Top left photo is the plugged inlet prior to implementation & the new 30" inlet below.

Top right photo is the upstream channel prior to implementation & bottom right photo is same view after new culvert

Treatment: Replace with 30" x 60' CMP aligned with channel, at bottom of fill & at channel grade of 40%. Install new CMP with outlet 12' down left of existing outlet location; Rock armor outboard fillface.

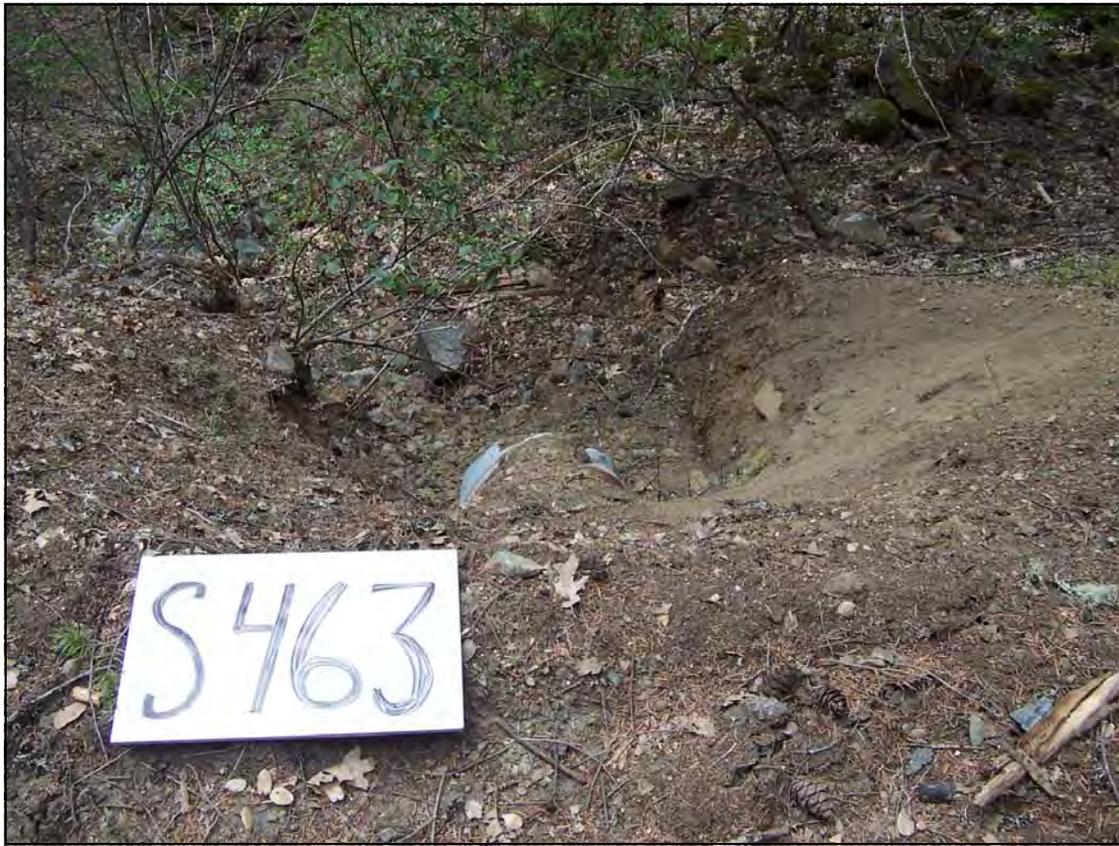
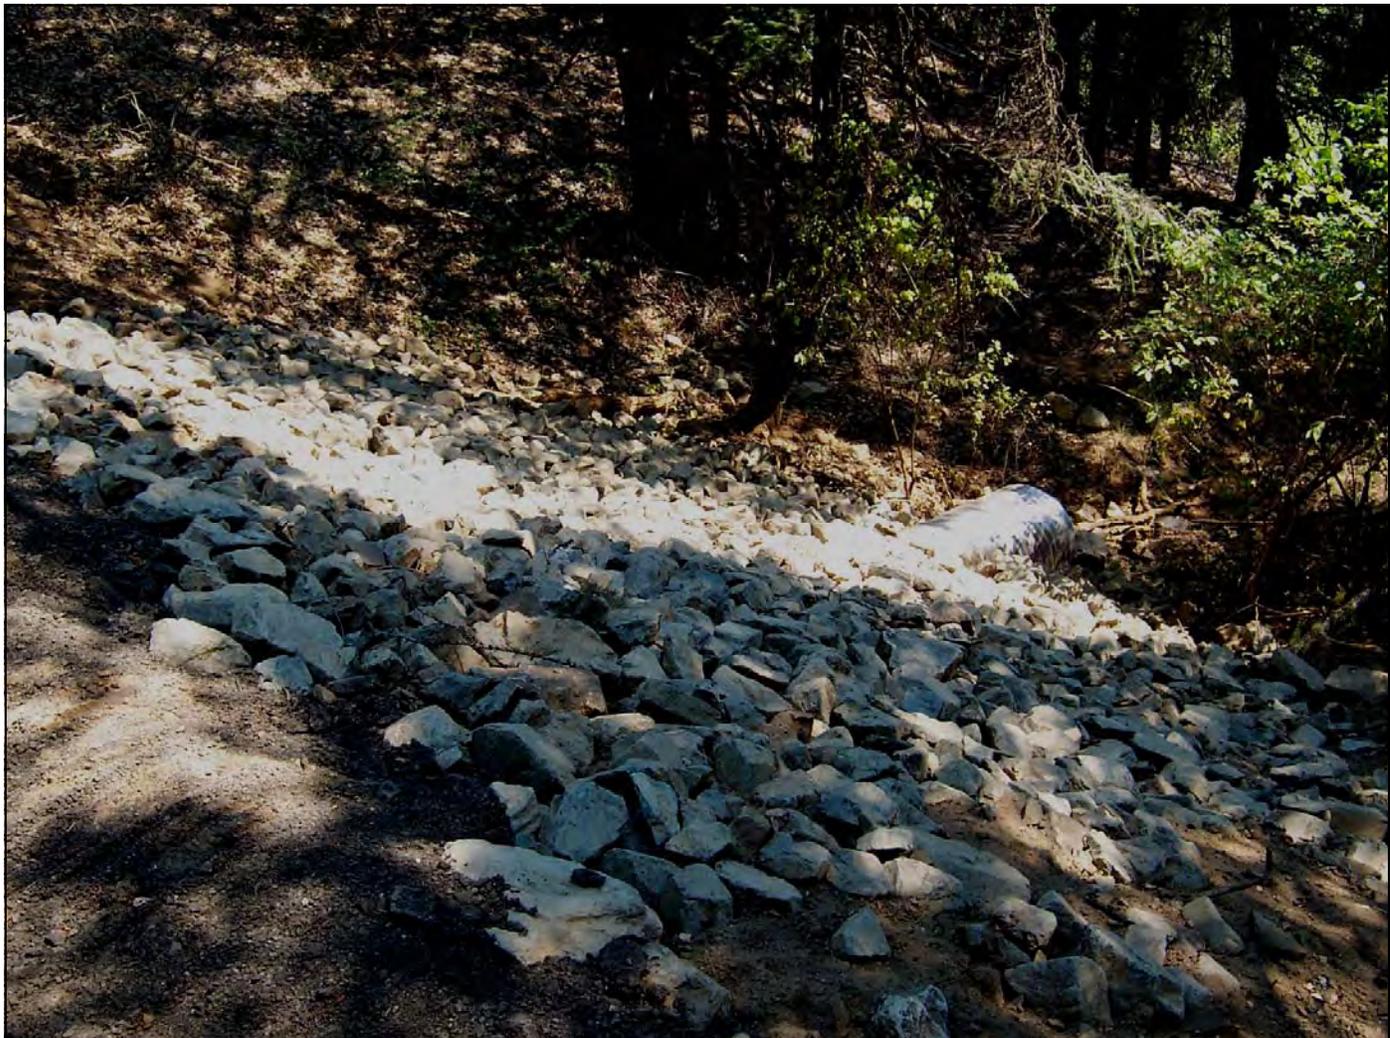
Site 463—Milepost 5.07

Top photo is the outlet area prior to Implementation. Note erosion/outlet gully formation, short pipe length for road prism & pipe position in outboard fillface (not at bottom)

Bottom photo is the outlet at the bottom of the fill after replacement & rock armoring on the outboard fillface

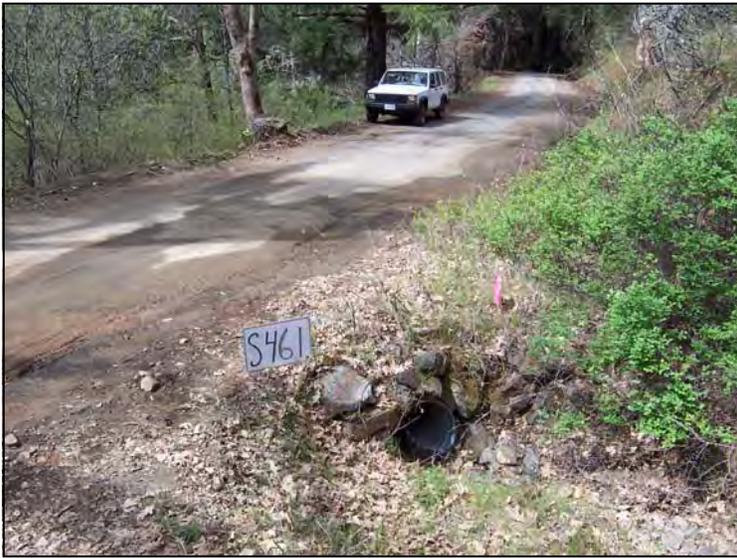
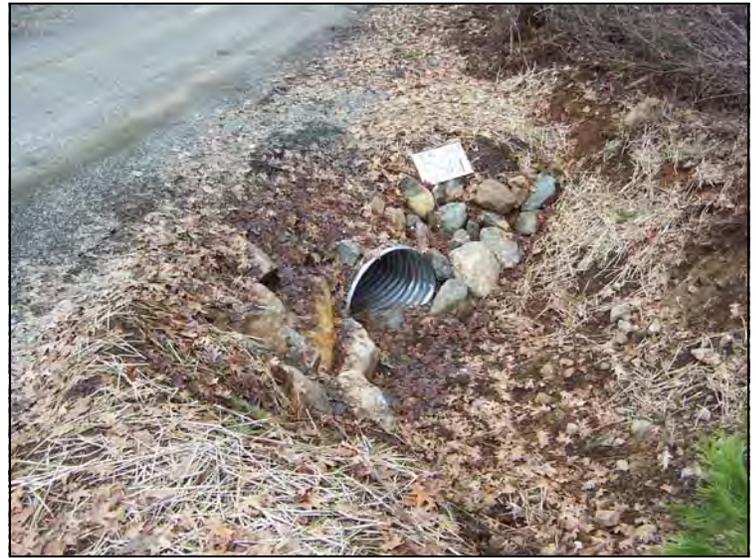
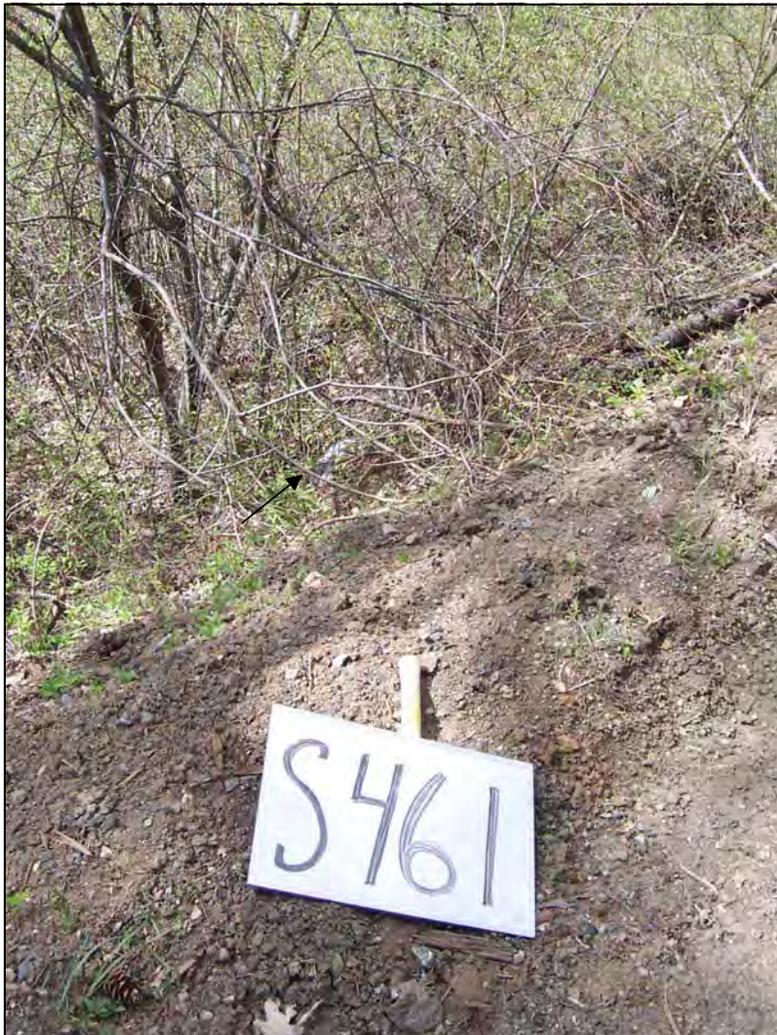
Site 461—Milepost 5.21—Treated Erosion: ~110 cyds

Stream crossing with undersized 18" x 40' CMP not at bottom of fill & substantial runoff from private road up left
 Treatment: Replace with arched 30" x 40' CMP at bottom of fill & at channel grade of 12%; Rock armor outlet channel;
 Surface the County Road for ~470 feet up left with asphalt grindings
 This is where the County Road surface changes from chip seal to native surface.
 Top & bottom left photos are of inlet & outlet prior to implementation, respectively
 Top & bottom right photos are of the inlet & outlet after implementation - note new outlet at bottom of fill, rock armored
 channel & outboard fillface
