Indian Creek Road Sediment Reduction Project

Indian Creek – Trinity County – January 2009

FINAL REPORT

California Department of Fish and Game – Fisheries Restoration Grant Program
Contract No. P0510325

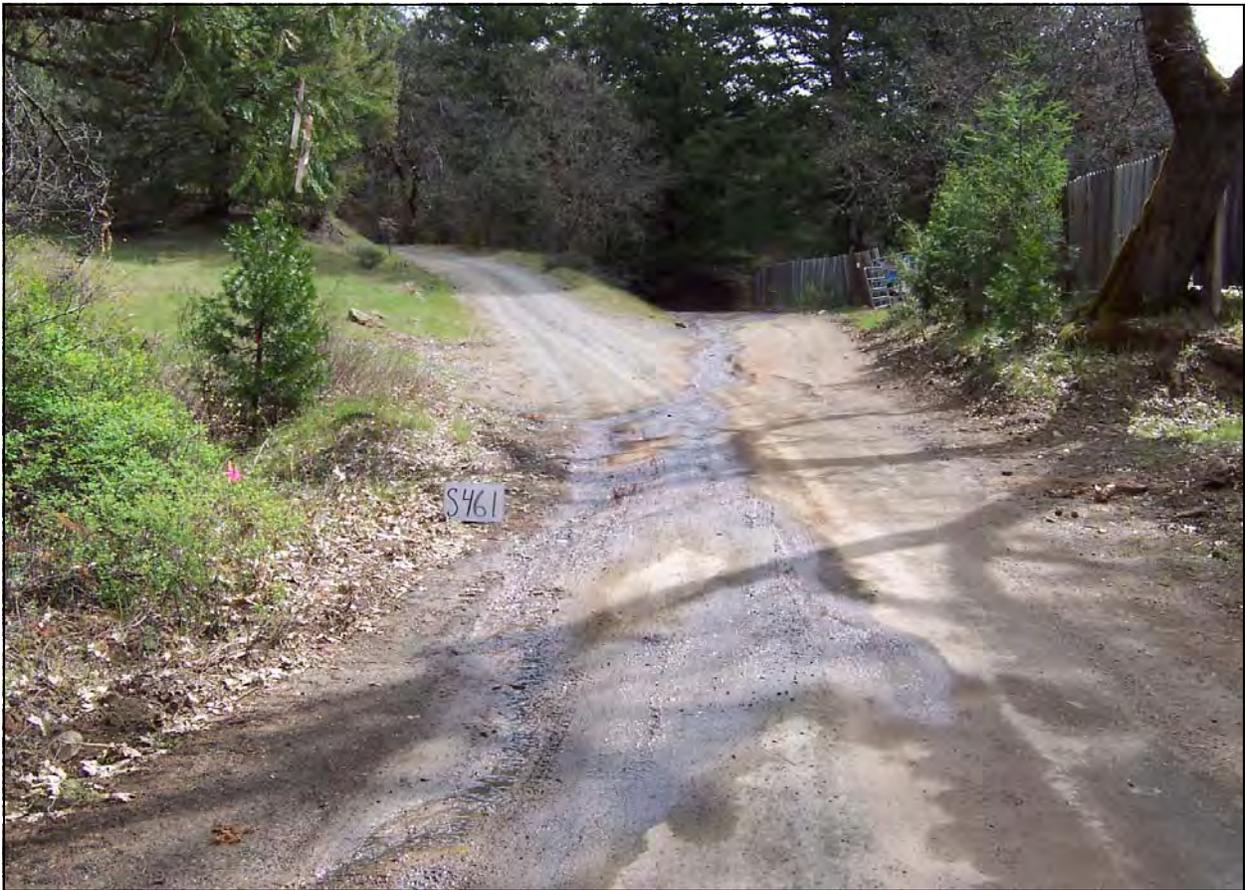
Site 461—Milepost 5.21

Top photo is looking up left county road & at private road delivery/runoff from diversion line
The DOT outsloped & surfaced this section of road from Site 461 to Site 460 (see photos on next page)

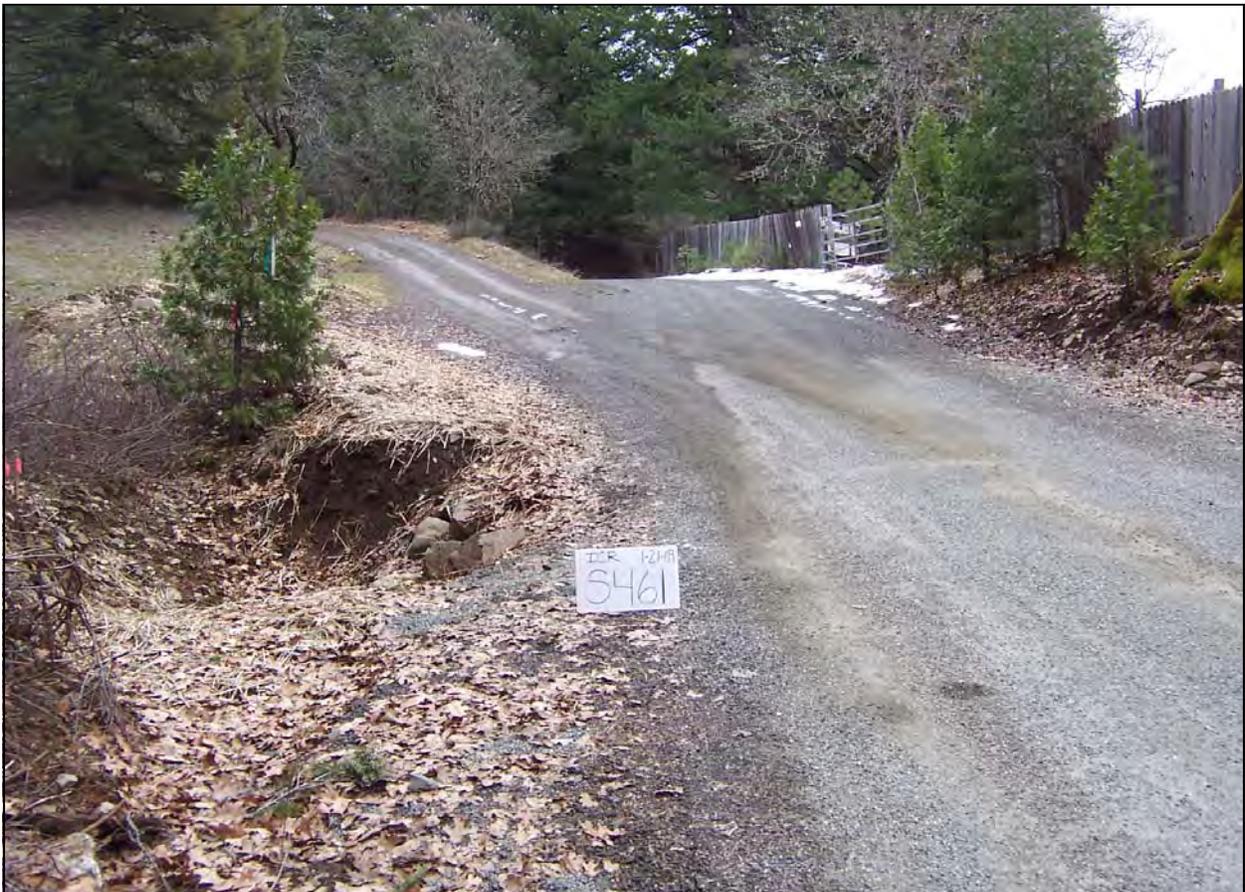
Site 461—Milepost 5.21

Treated Erosion: ~ 350 cyds
Top & Bottom photos are the section of
outsloped & surfaced roadway between Site
461 & Site 460

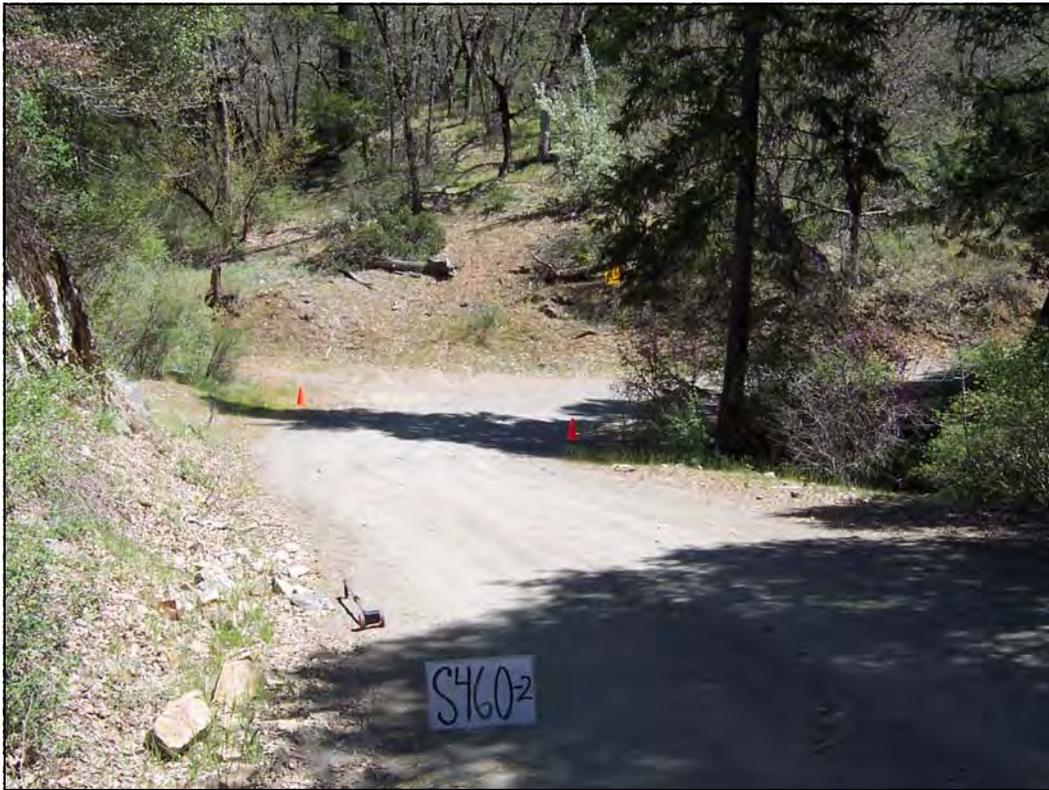
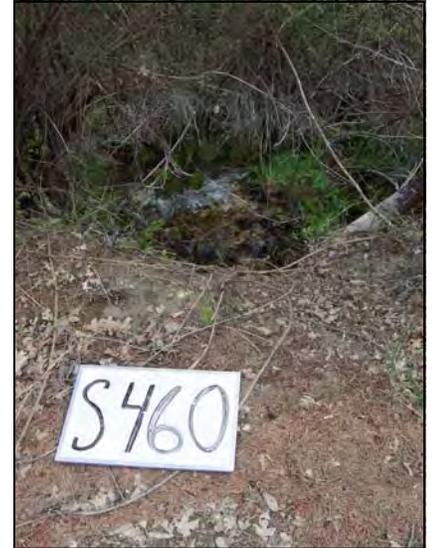
Site 460—Milepost 5.36—Treated Erosion: ~310 cyds

Stream crossing at Joseph Creek with plugged 36" x 50' CMP partly filled with sediment & mineral deposits
Treatment: Excavate mineral material from outlet area; Clean culvert & assess condition; Install critical dip with filter fabric & large rock. Top photos are of the road prism at the crossing & looking down at the outlet area from the outboard road edge (note thick mineral deposits). Bottom photo is off Inlet area post implementation with culvert inlet cleaned; see following pages for photos of Critical Dip

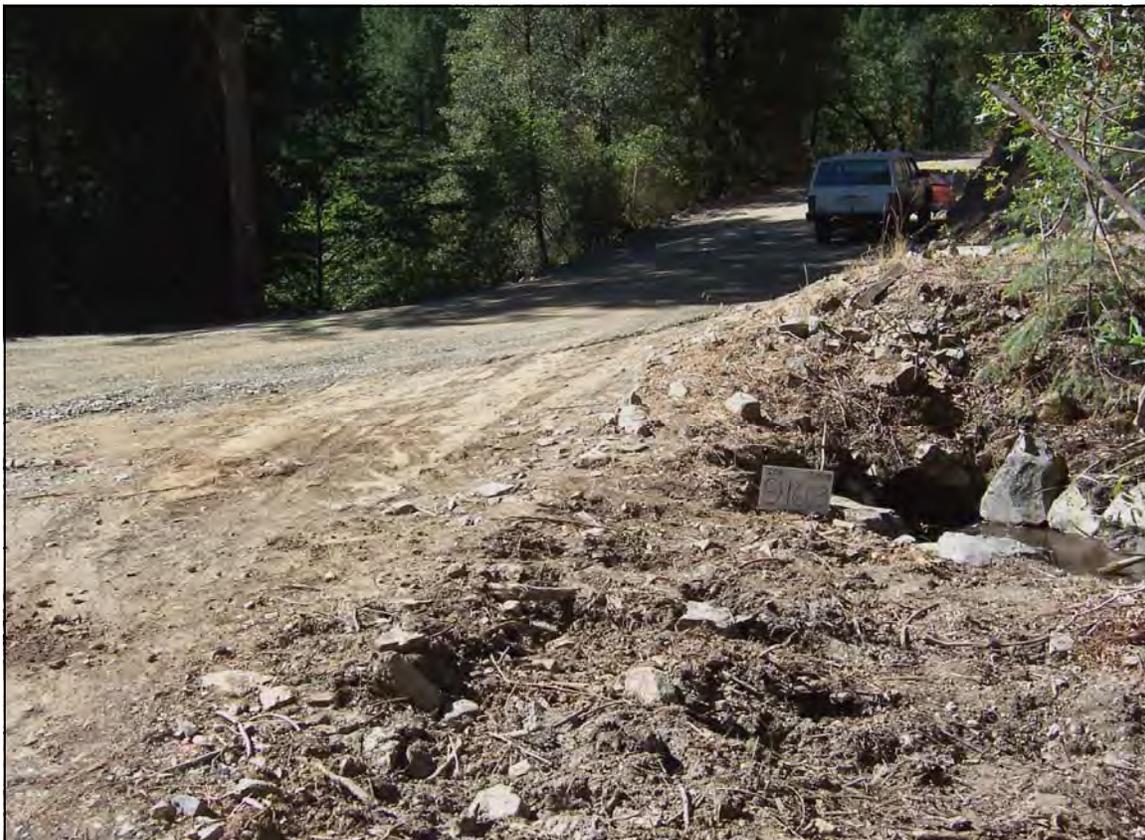
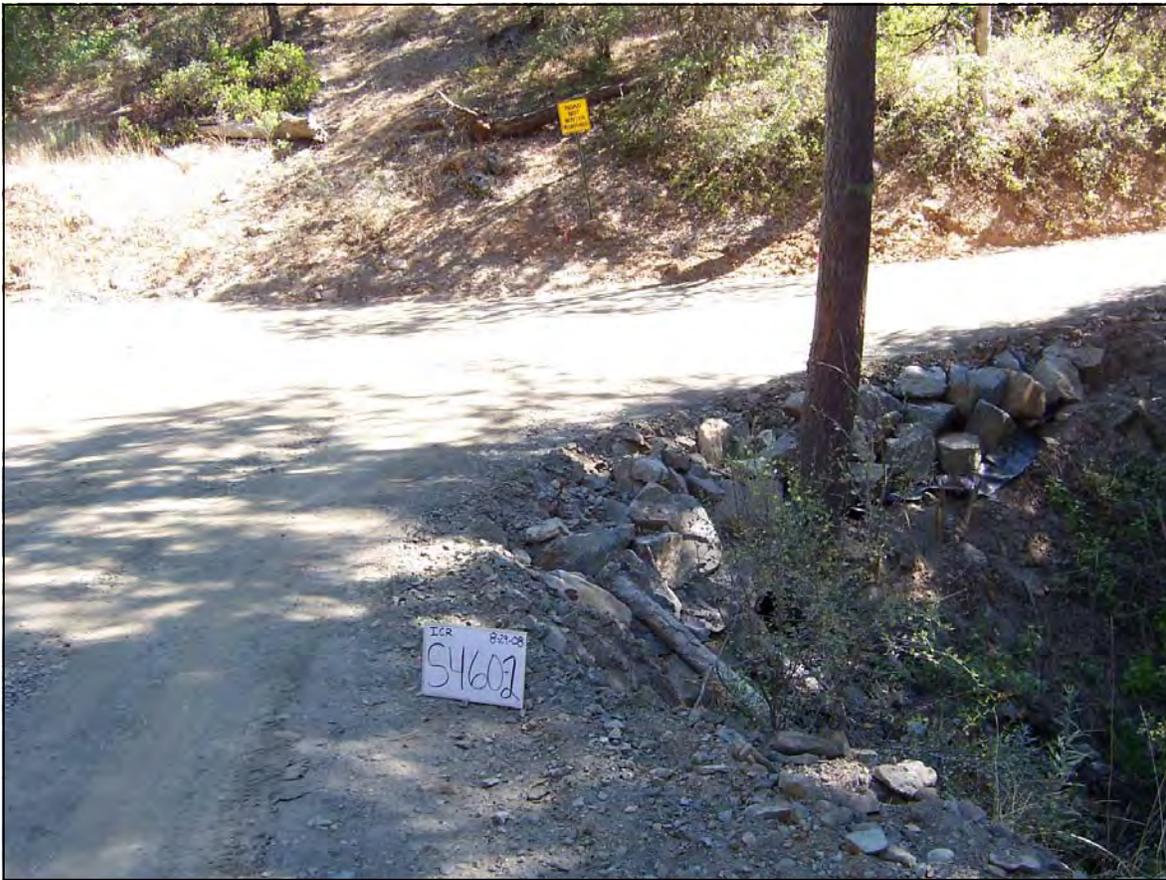
Site 460—Milepost 5.36

Installed critical dip with filter fabric & large rock

Both photos are of the outboard fill face with C-dip rock & fabric installed. Rock extends approximately 10 feet back into the roadfill

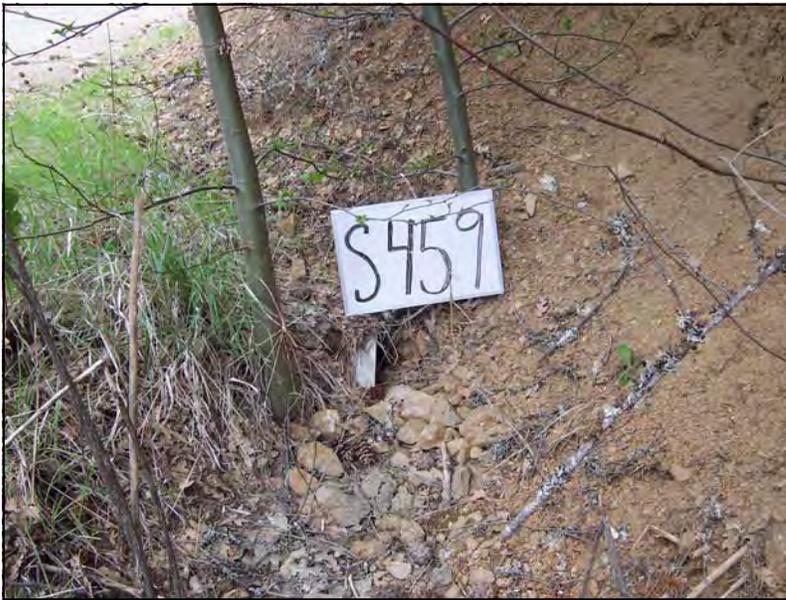
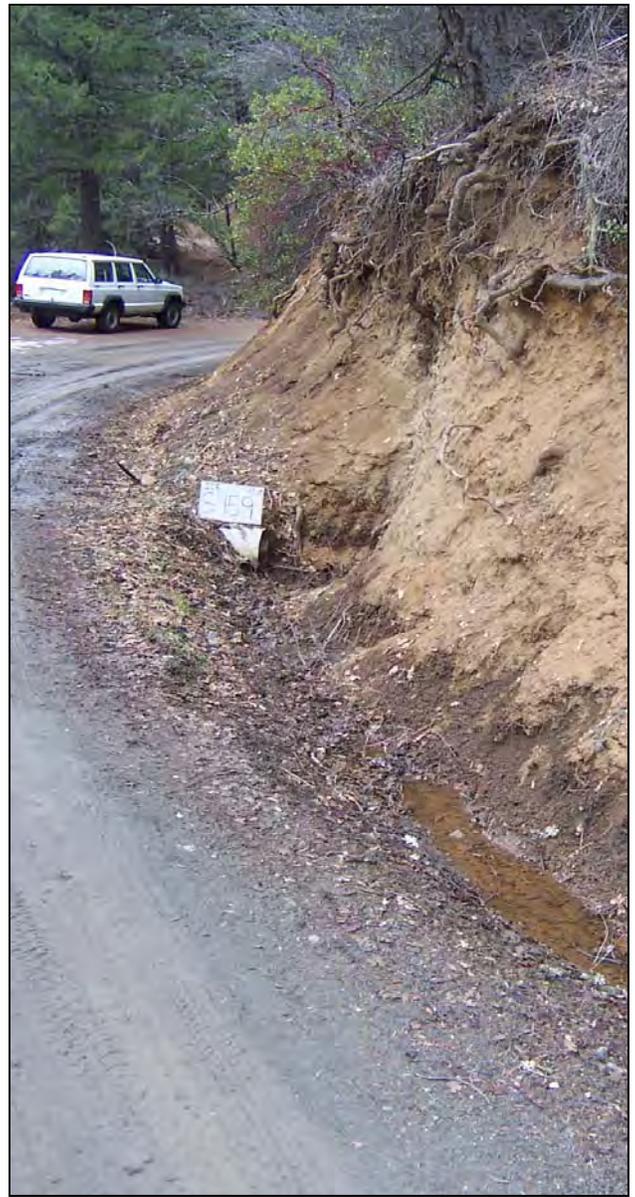
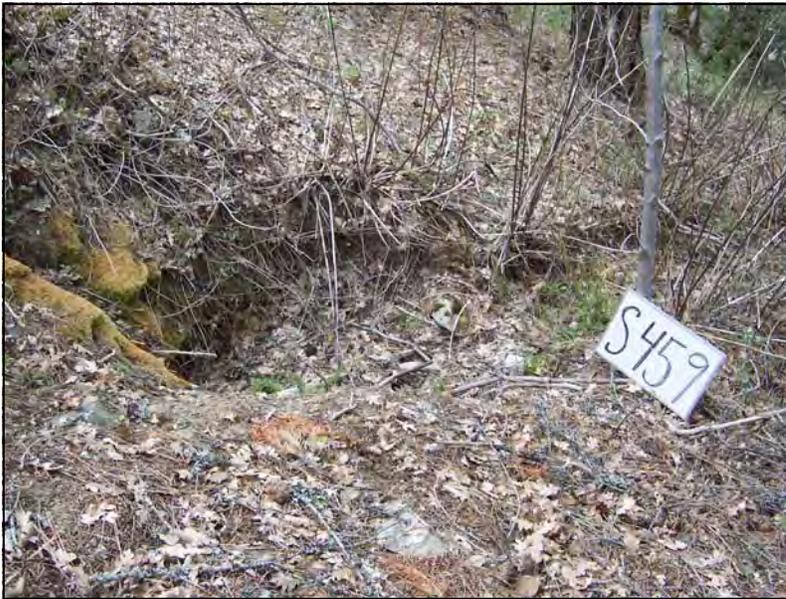
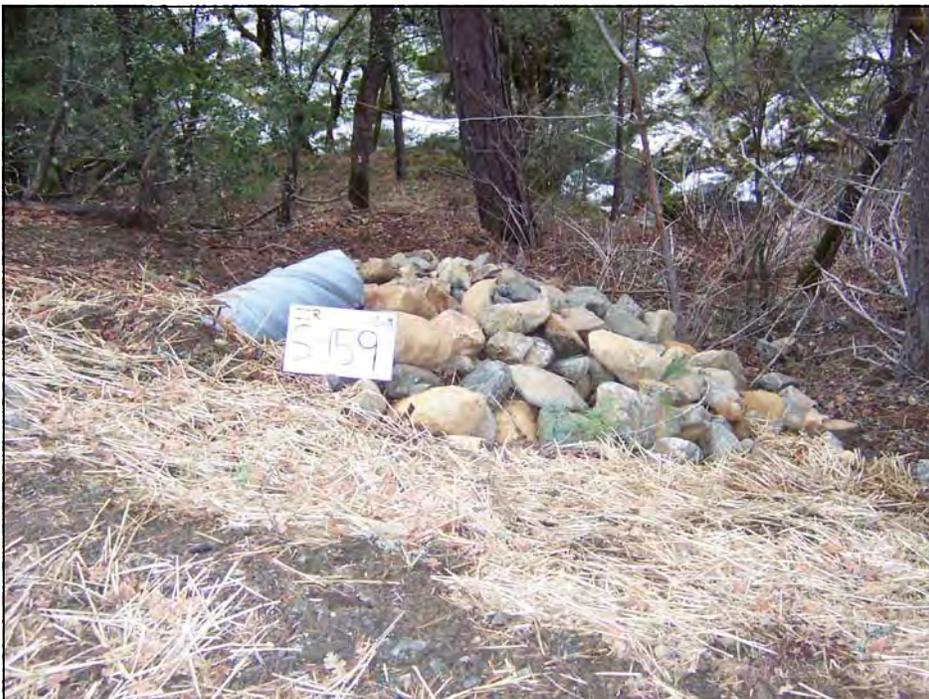
**Site 459—Milepost 5.54
Treated Erosion: ~50 cyds**

DRC that drains the ditch up left & Class 3 fill crossing from Site 458 up left

Top left photo is of plugged inlet—top right photo is same view post implementation

Middle left photo is of the outlet gully & bottom left is the gully area after rock armoring

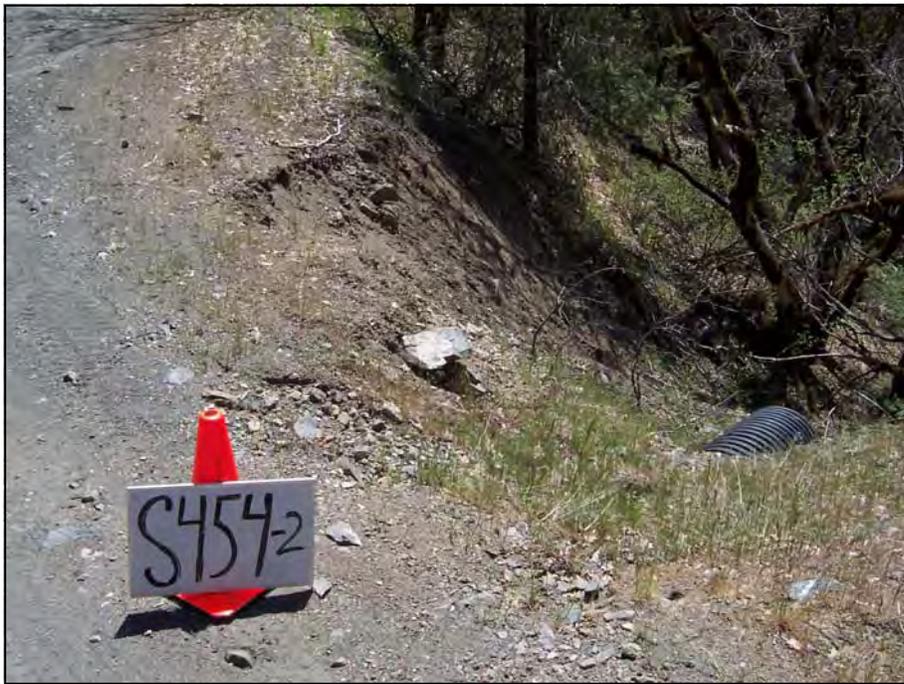
Site 454—Milepost 6.3—Treated Erosion: ~200 cyds

Stream crossing with undersized 18" x 60' plastic pipe with evidence of overtopping. Outboard berm directs runoff to a gully on the outboard fillface & there is a sediment fan upstream of the inlet.

Remove 75' of berm that down left & 50' of berm down right. Top photo is the outlet prior to implementation; note its position half-way between road surface & bottom of fill. Bottom photo is newly installed culvert with outlet at bottom of the fill - see next page for photos of rocked outboard fillface & critical dip

Treatment: Excavate upstream sediment fan to channelize to new culvert inlet; Replace with a 30"x 80' Smooth Bore Plastic pipe at bottom of fill, aligned with channel & at channel grade of 32%; Install critical dip with filter fabric & large rock;

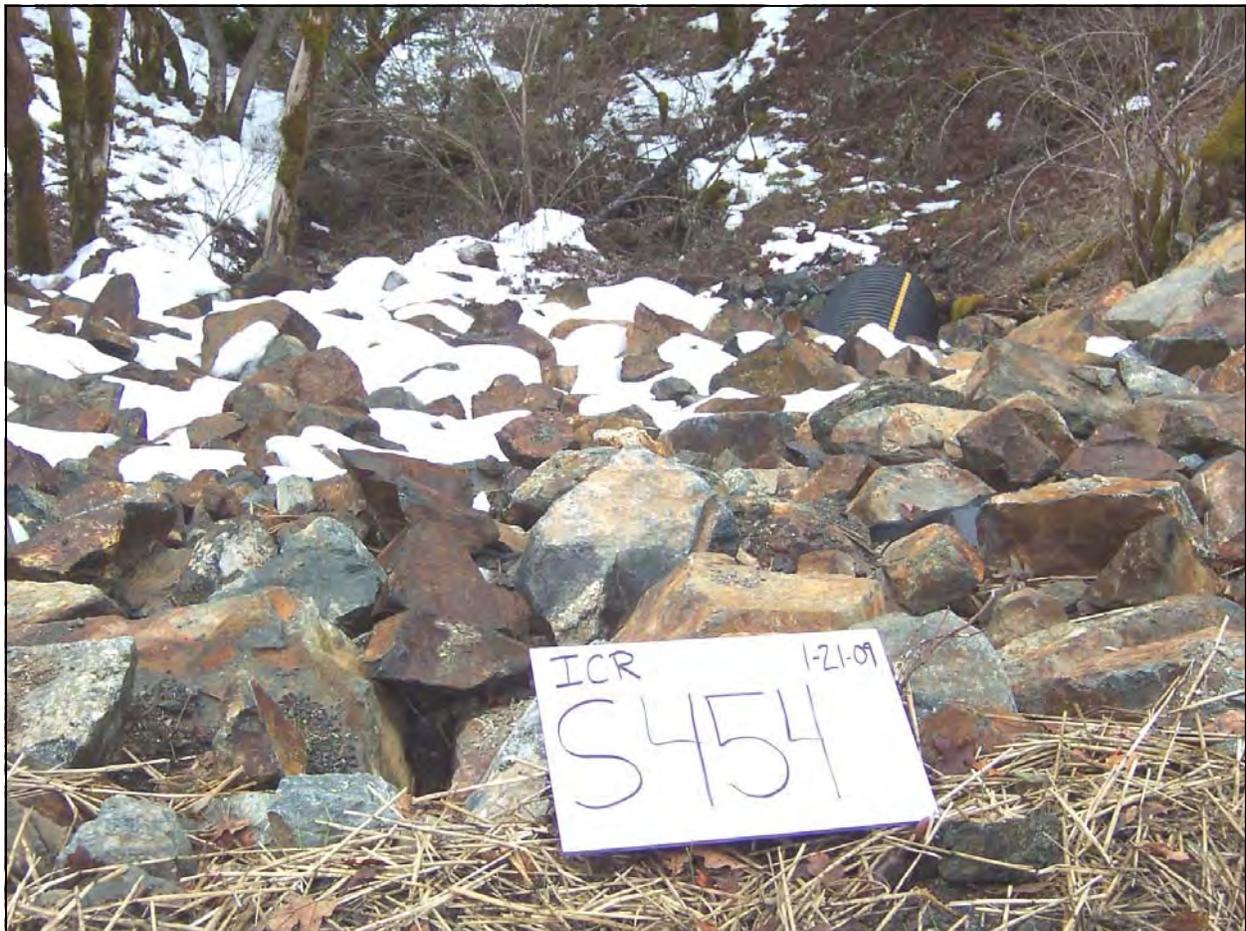
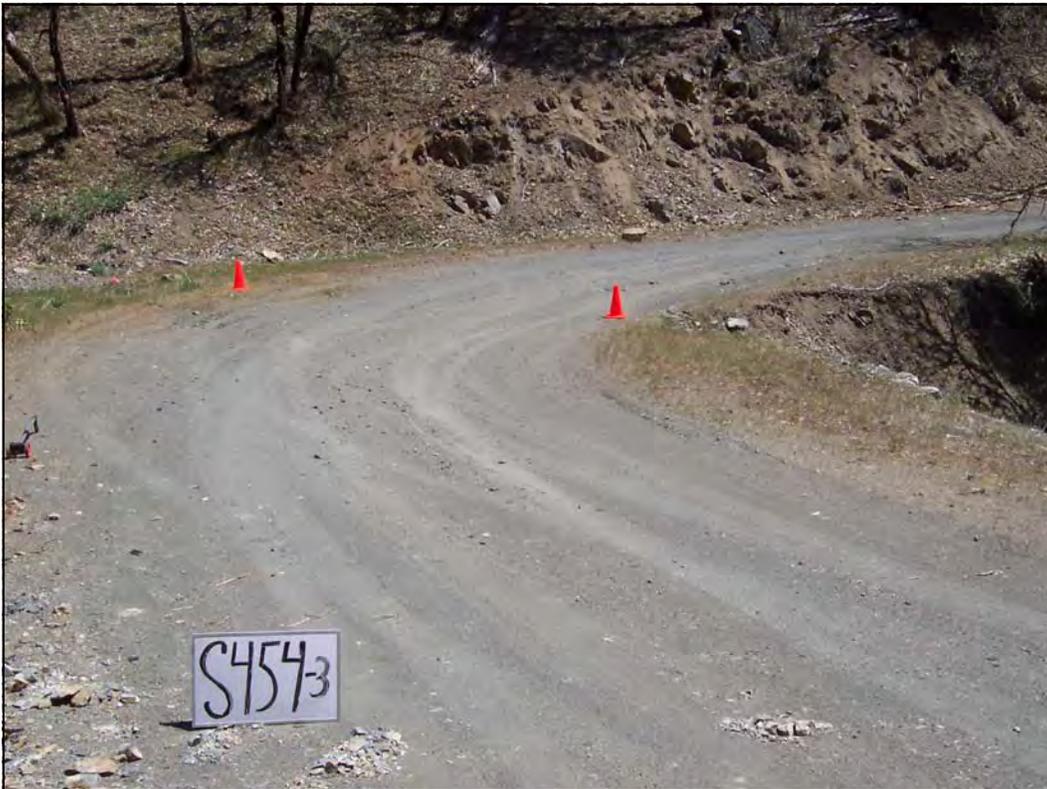
Site 454—Milepost 6.3

Top photo is of the roadway configuration at the crossing prior to implementation
Bottom photo is the critical dip filter fabric & large rock as well as rock armored outboard fillface

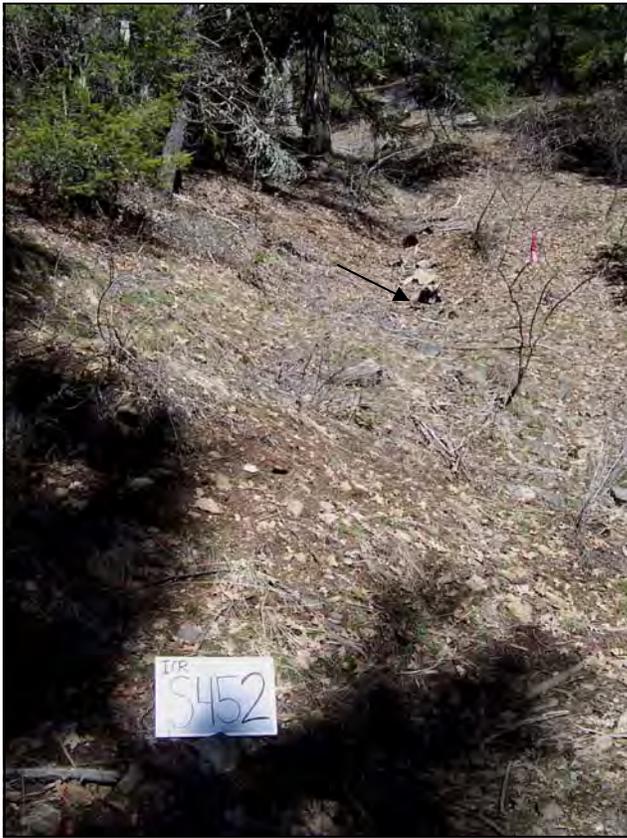
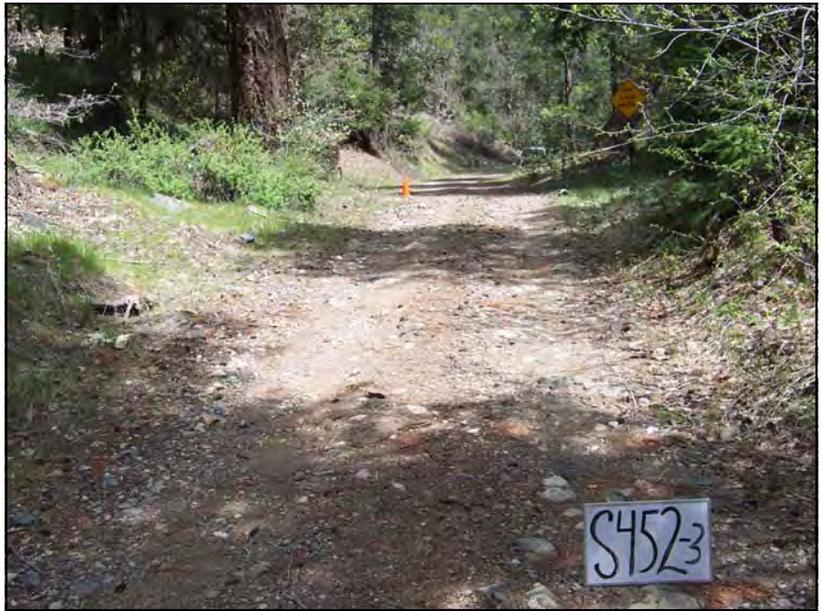
Site 452—Milepost 6.74—Treated Erosion: ~110 cyds
 Class 3 fill crossing ~155' down right of the bridge over Indian Creek near Cannon Ball Flat. Stream parallel to an old road bed.
 Treatment: Install rolling dip ~67 feet down left of the crossing
 Top photos are of crossing channel (black arrow) & the County Road prior to implementation
 Bottom photo is the installed rolling dip with a rocked outside drain on the left—photo board is on the crest of the dip

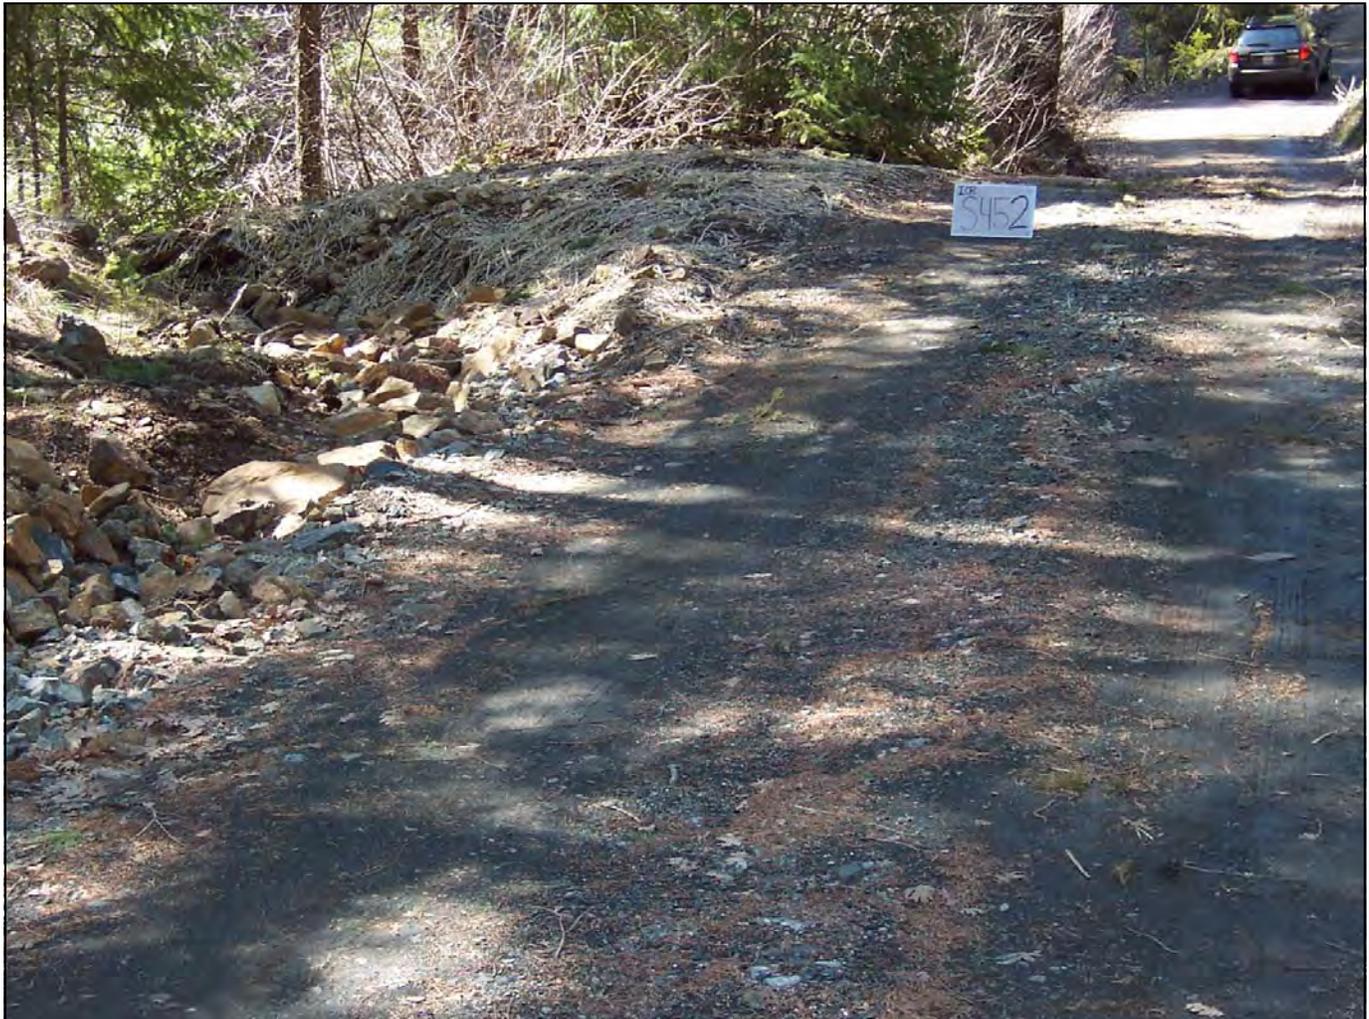
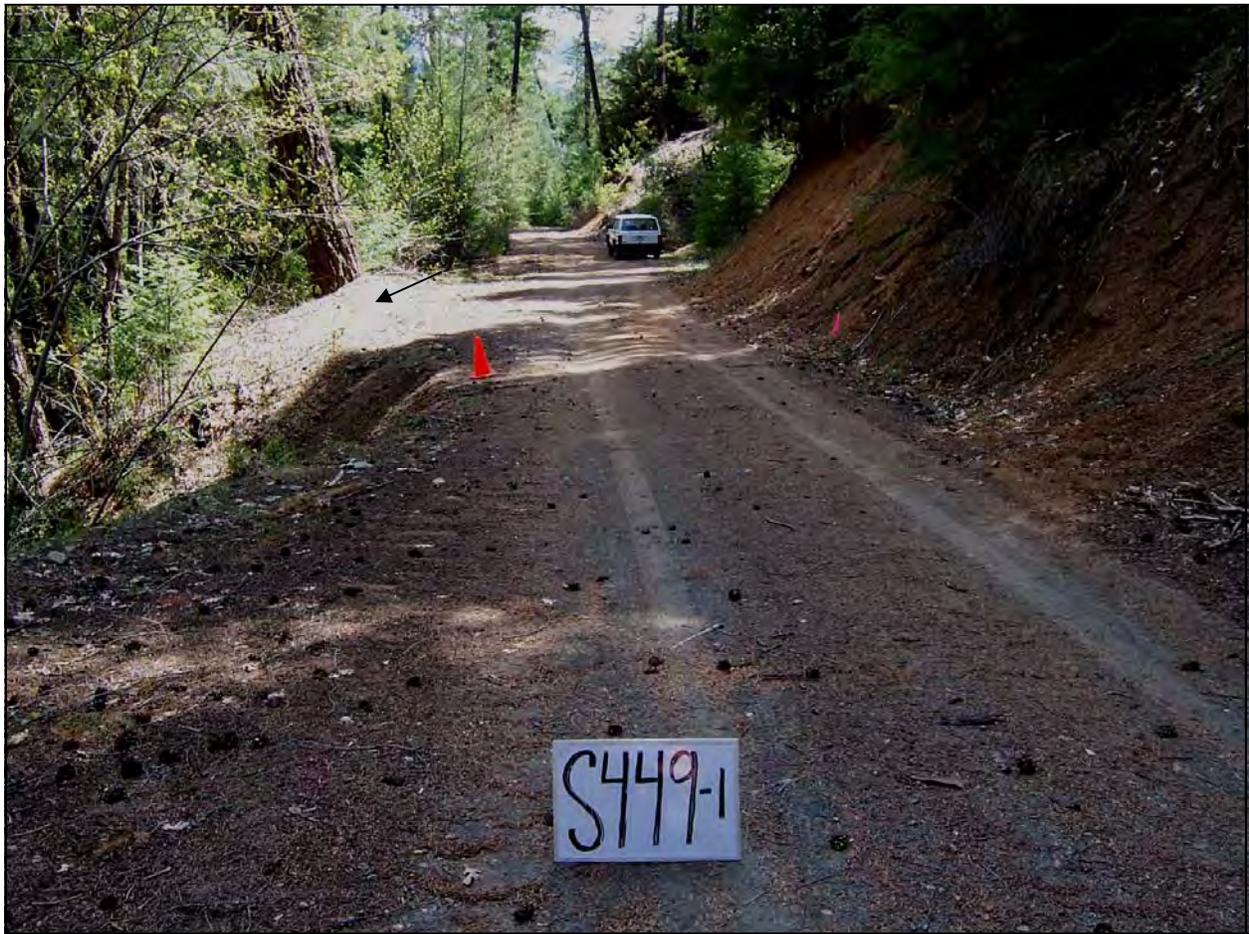
Site 449—Milepost 7.02—Treated Erosion: ~76 cyds

Stream crossing with 18" x 40' CMP set at flat grade & diversion potential. There is ~50' of berm material stored on the outboard edge of the road (marked by black arrow in top photo)

Treatment: Remove the 50 feet of berm from the outboard; clean the culvert; install & rock rolling dip down left
Bottom photo is after treatment implementation with berm removed & dip installed (note rocked outboard fillface).

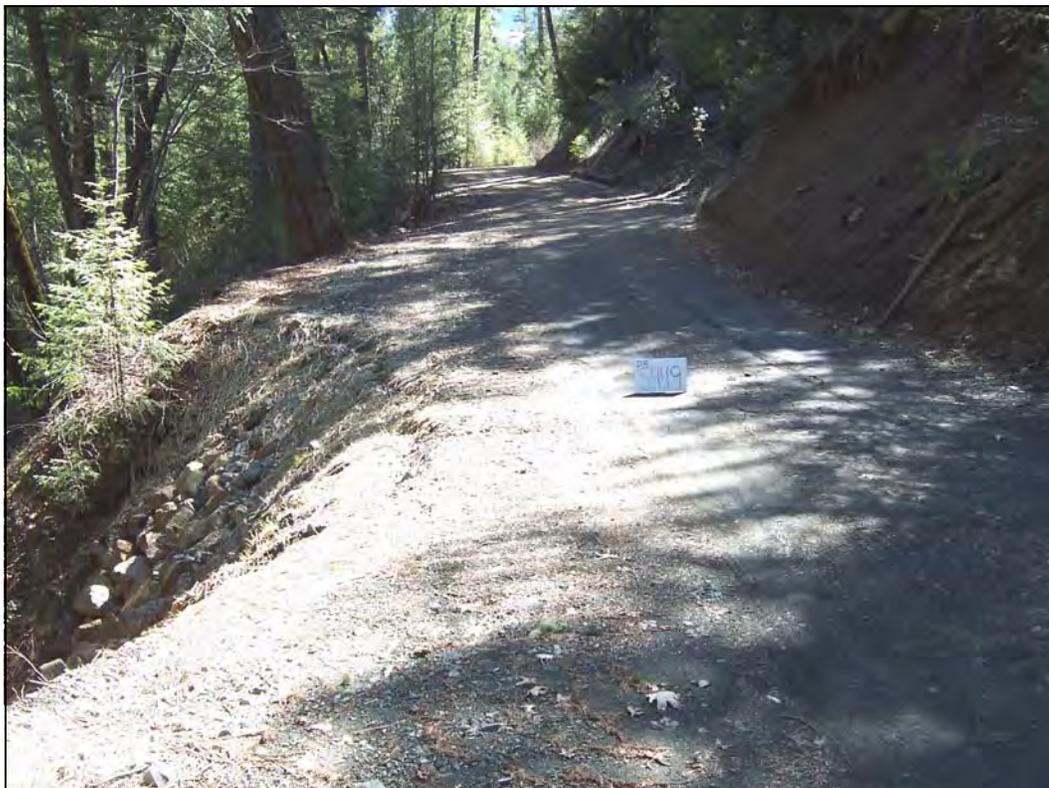
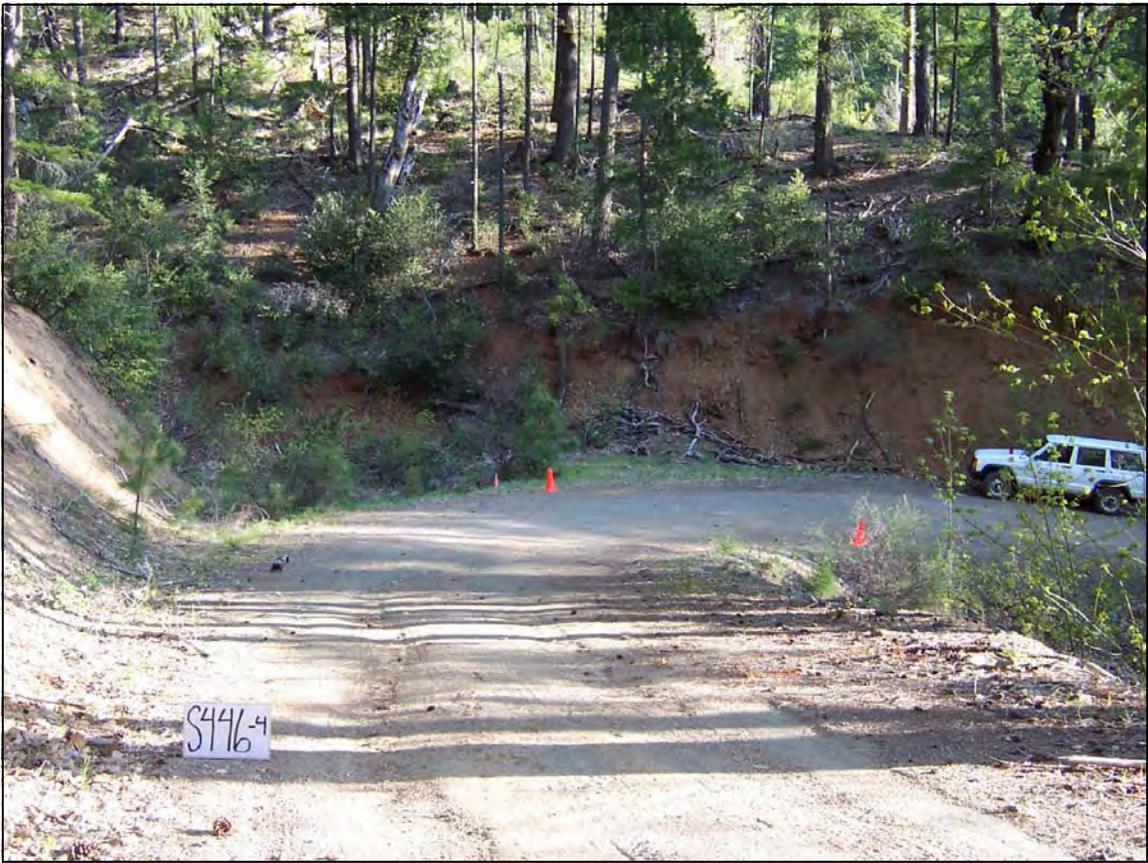
Site 446—Milepost 7.52—Treated Erosion: ~420 cyds

Stream crossing with 30" x 100' Smooth Bore Plastic pipe that was installed ~6 years ago with rock armor at inlet & outlet. Upstream is private timber land & past logging activity has resulted in large amounts of material discharge to this crossing. Treatment: Install a critical dip with filter fabric & large rock. Requires re-grading the road up right to conform to the dip at the crossing. Rock the road after the dip is installed.

Top photo is of the crossing from up left prior to critical dip installation. Bottom photos show the upstream channel area & the road up right fro the crossing. See next page for post-treatment photos.

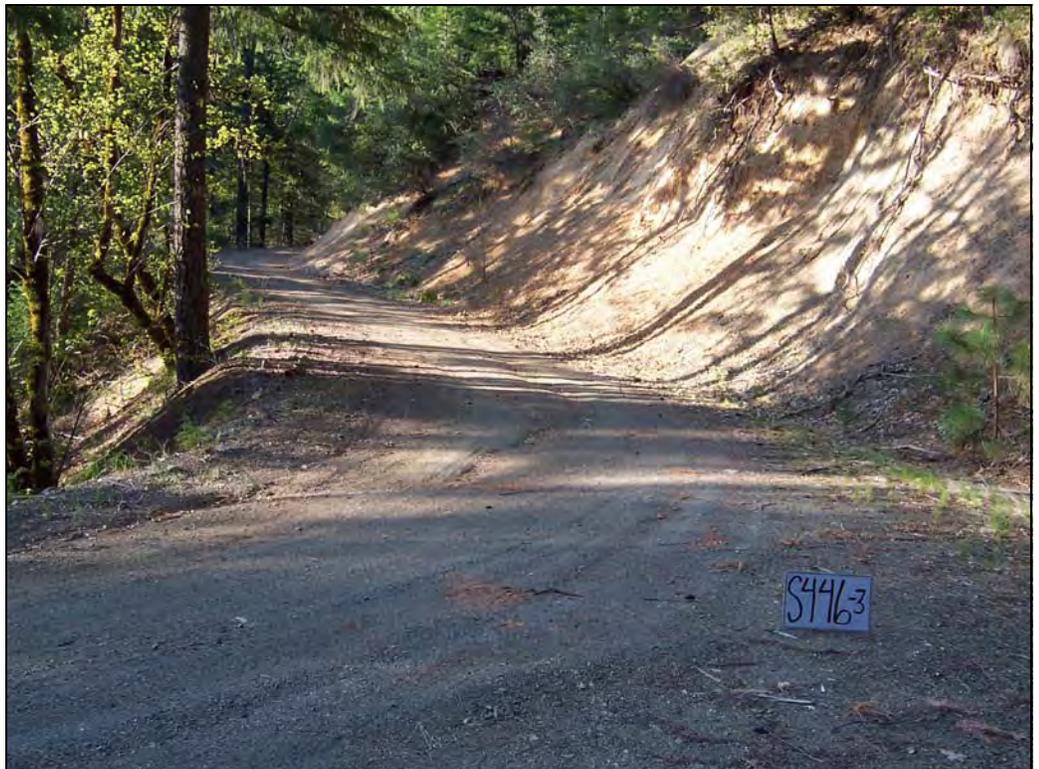
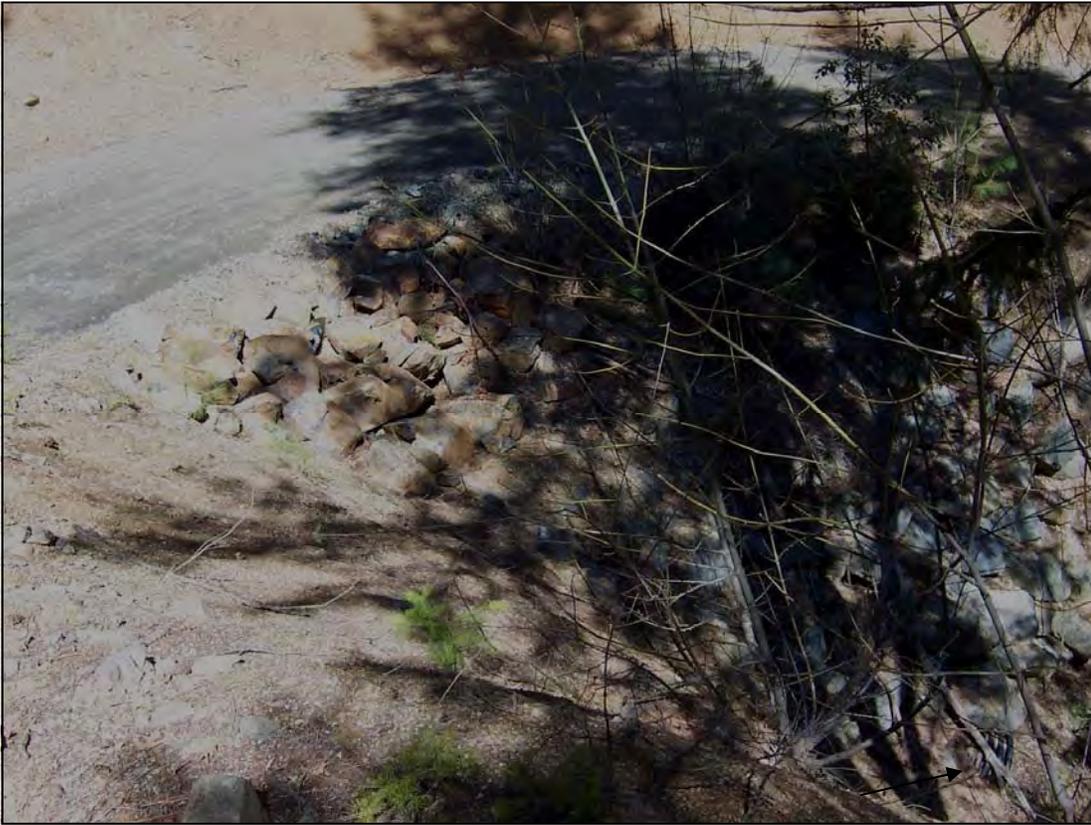
**Site 446
Milepost 7.52**

Top photo is view of installed critical dip & outboard rock armor

Note existing 30" HDPE culvert outlet at bottom of fill (black arrow)

Bottom photo is taken from ~50' up left on the outboard edge of road & shows the overall critical dip installed at the crossing

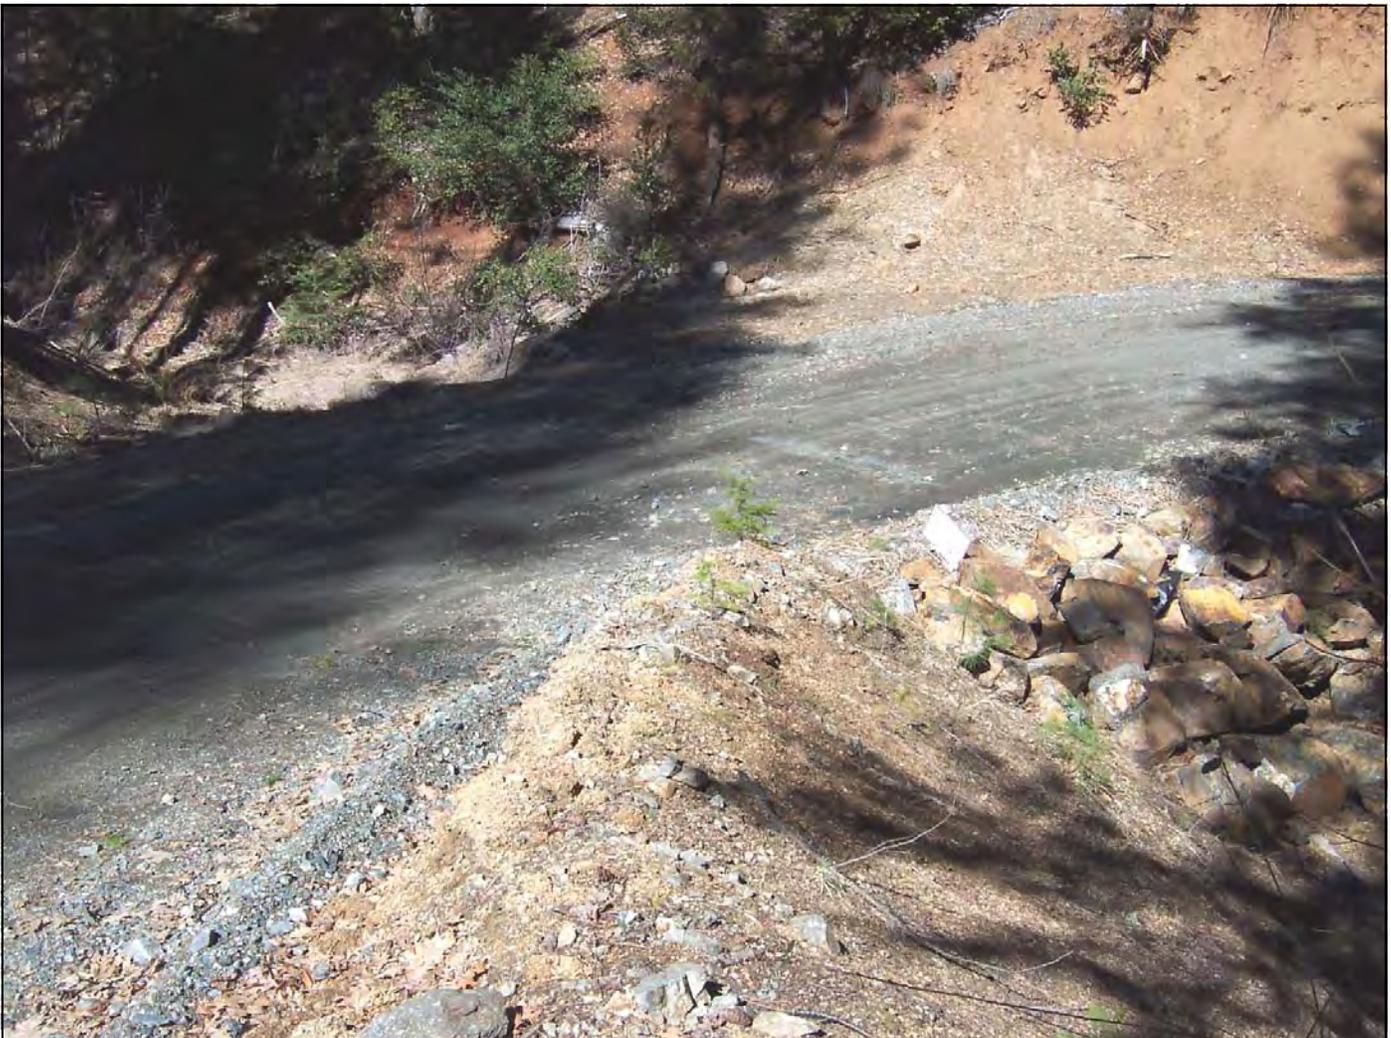
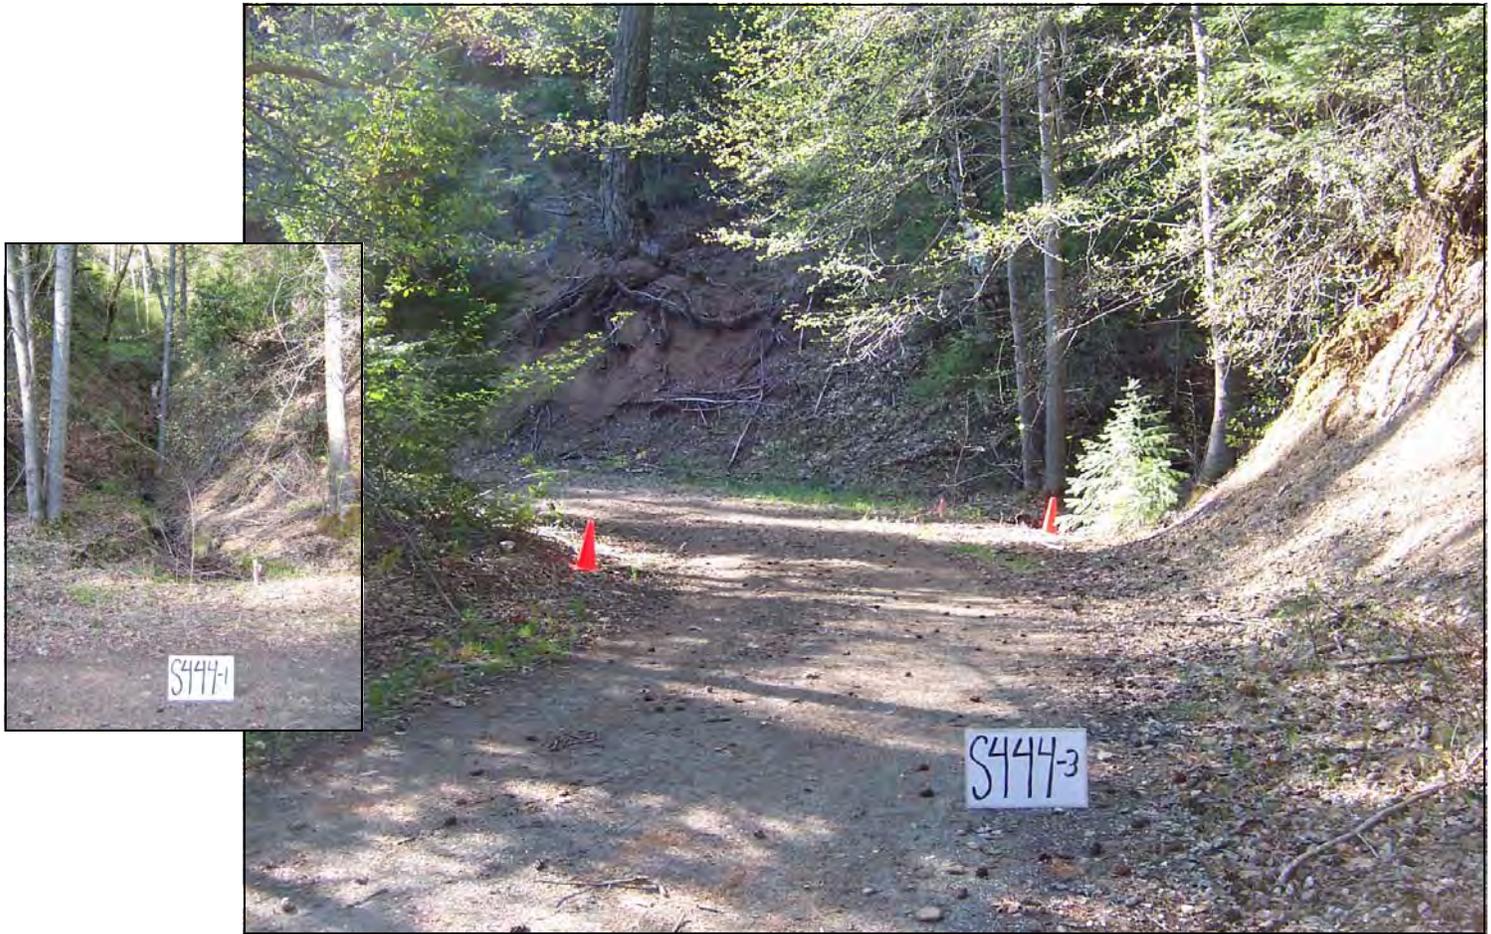
Site 444—Milepost 7.72—Treated Erosion: ~100 cyds

Diverted Class 2 stream with an 18" x 30' CMP installed down left ~ 15' from the channel.

In the top photo, the cones are lined up on the 18" culvert inlet & outlet & the wood stake marks where the new 24" culvert is to be installed location. Left inset is the upstream channel. Bottom photo is the newly installed 24" inlet & rocked headwall. DOT left the existing 18" culvert in place as an overflow culvert (see next page for additional photos)

Treatment: Replace 18" culvert with 24" x 40' CMP aligned with channel; at channel grade of 32% slope & attach a 24" x 60' full round downspout with a "T" on the end to disperse flow.

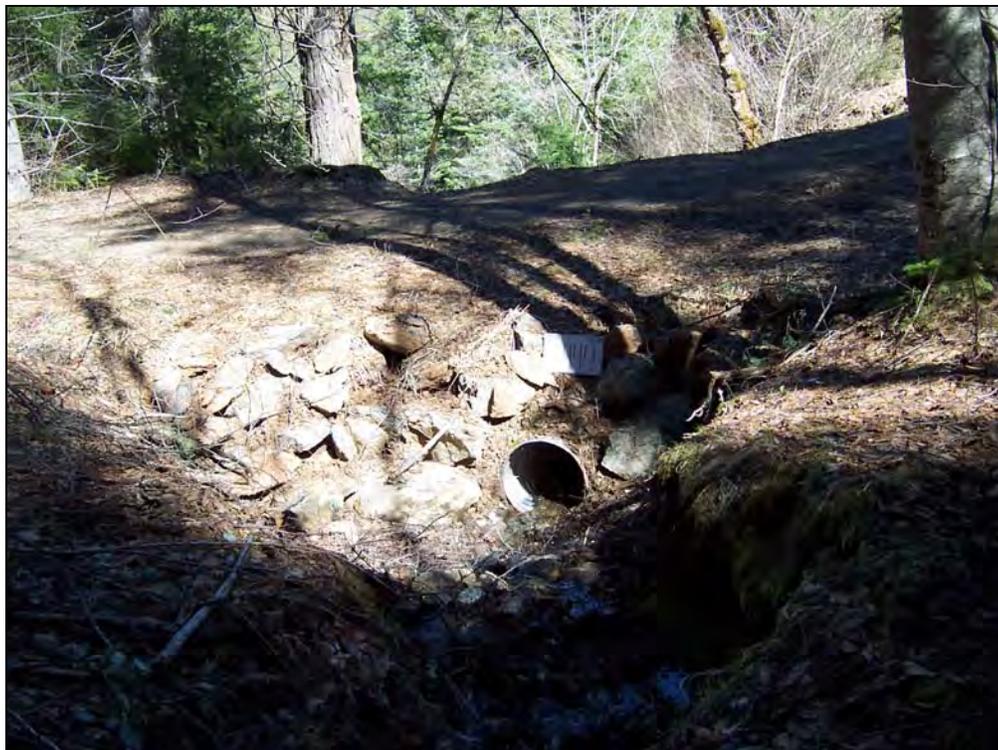
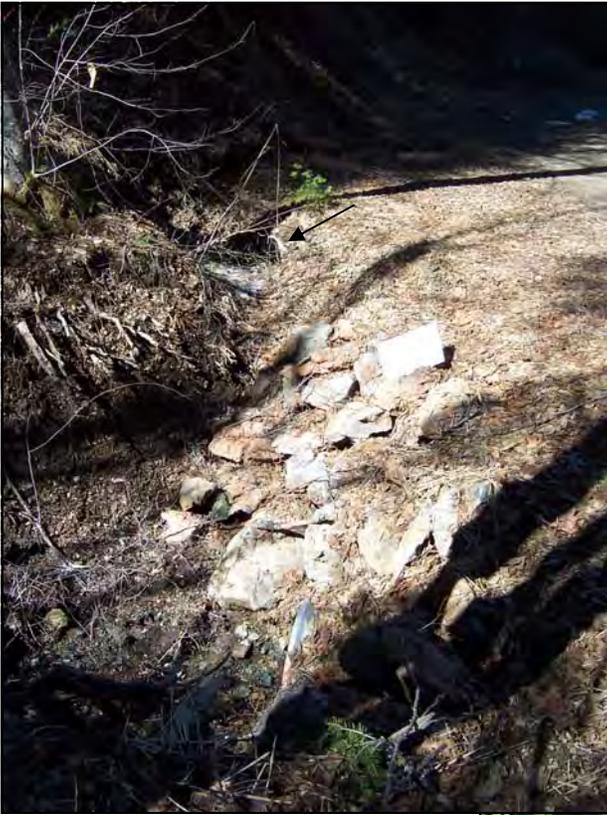
Site 444—Milepost 7.72

Top photo shows the new 24" inlet with the existing 18" culvert inlet on the right hinge (black arrow) that was left in place as an emergency overflow culvert.

Bottom photo is the installed 24" x 60' long full round downspout.
