Indian Creek Road Sediment Reduction Project

Indian Creek – Trinity County – January 2009

FINAL REPORT

California Department of Fish and Game – Fisheries Restoration Grant Program
Contract No. P0510325

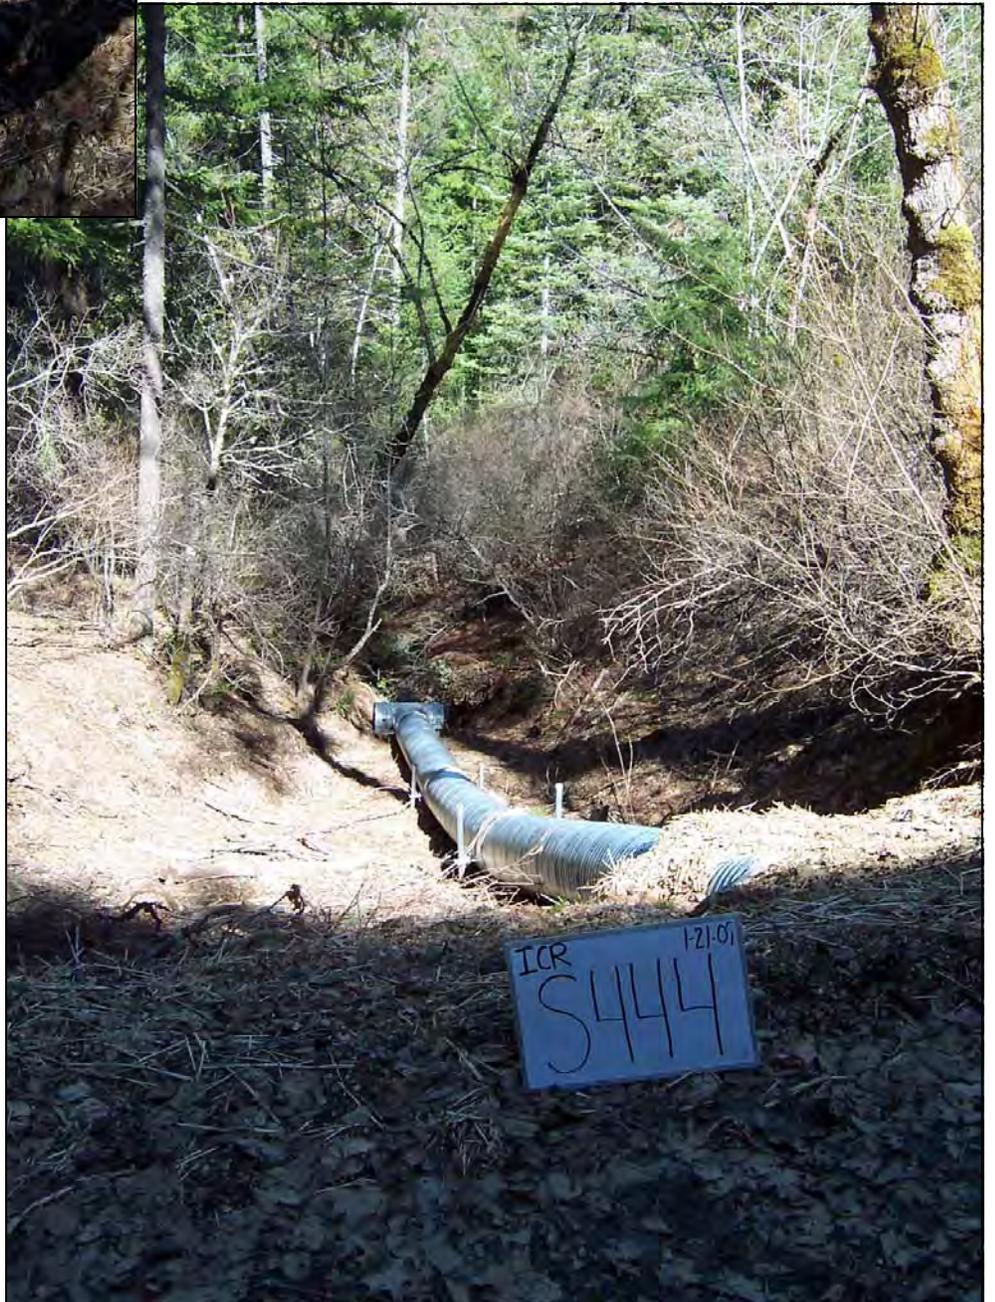
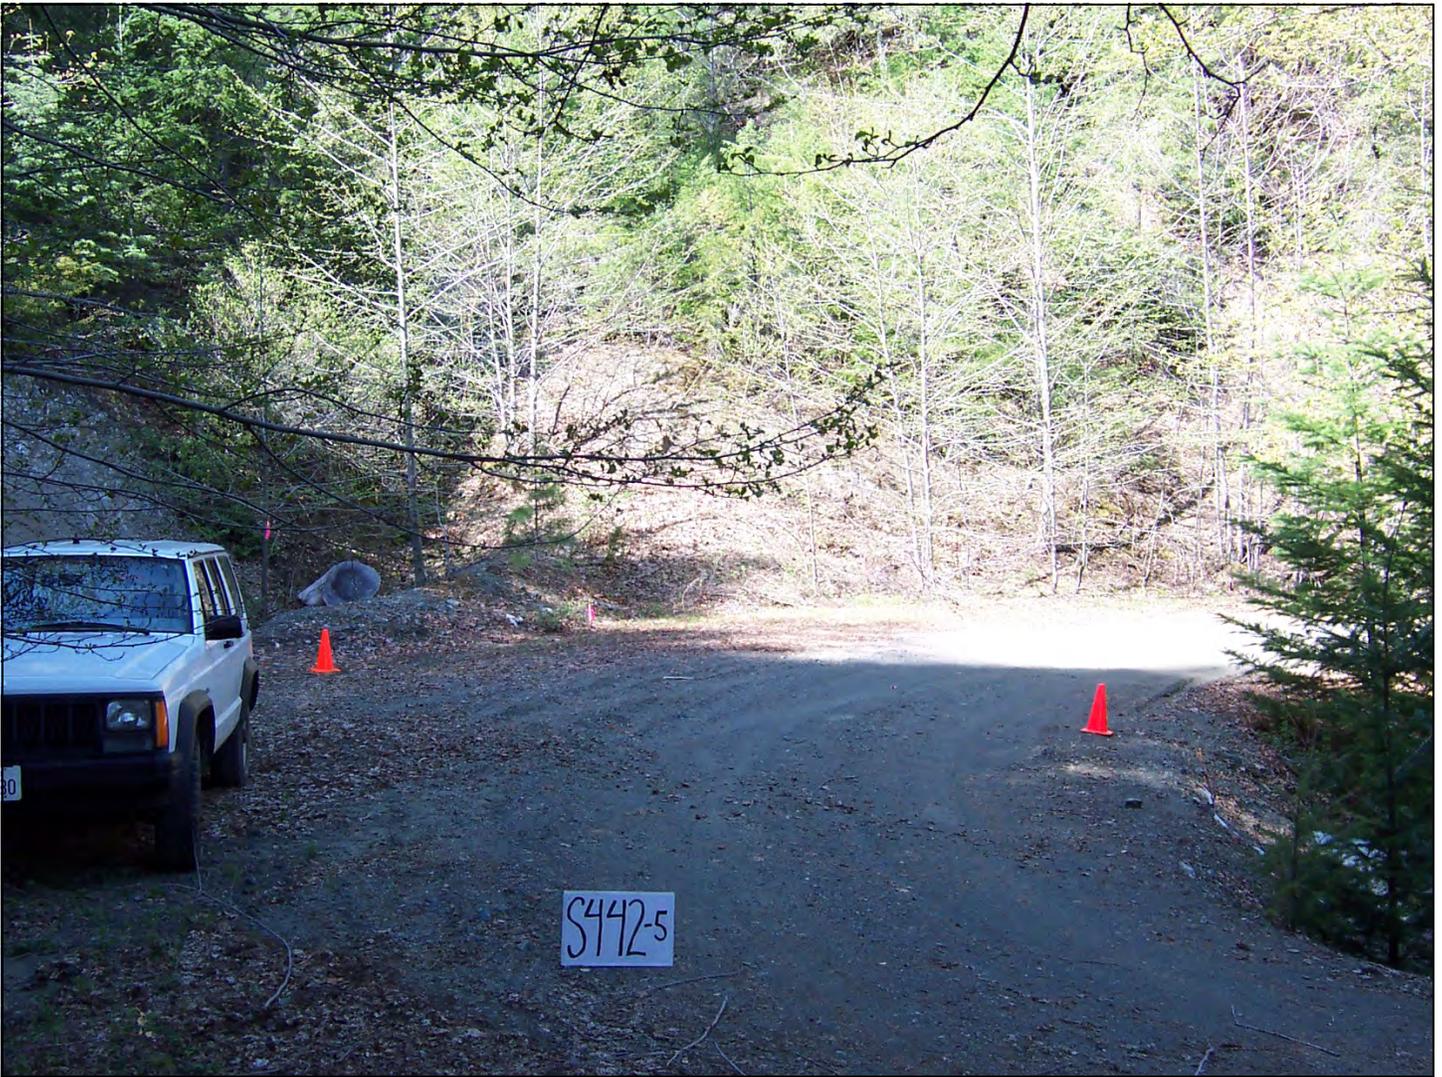
Site 442—Milepost 8.27—Treated Erosion: ~310 cyds

30" x 45' CMP that conveys two Class 2 stream crossings with a 30' long section of downspout.

The wood stake on the inboard marks rolling dip installation location.

Post-project photo is unavailable at time of report submission due to access.

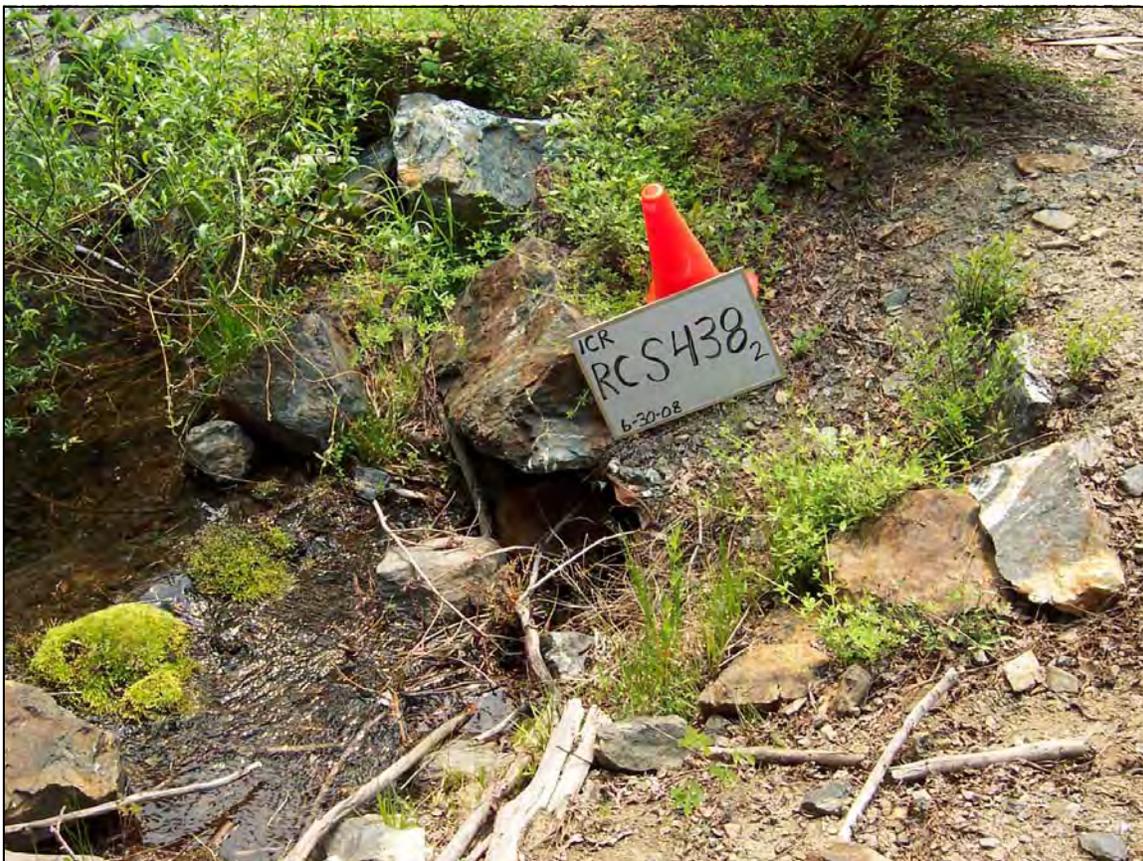
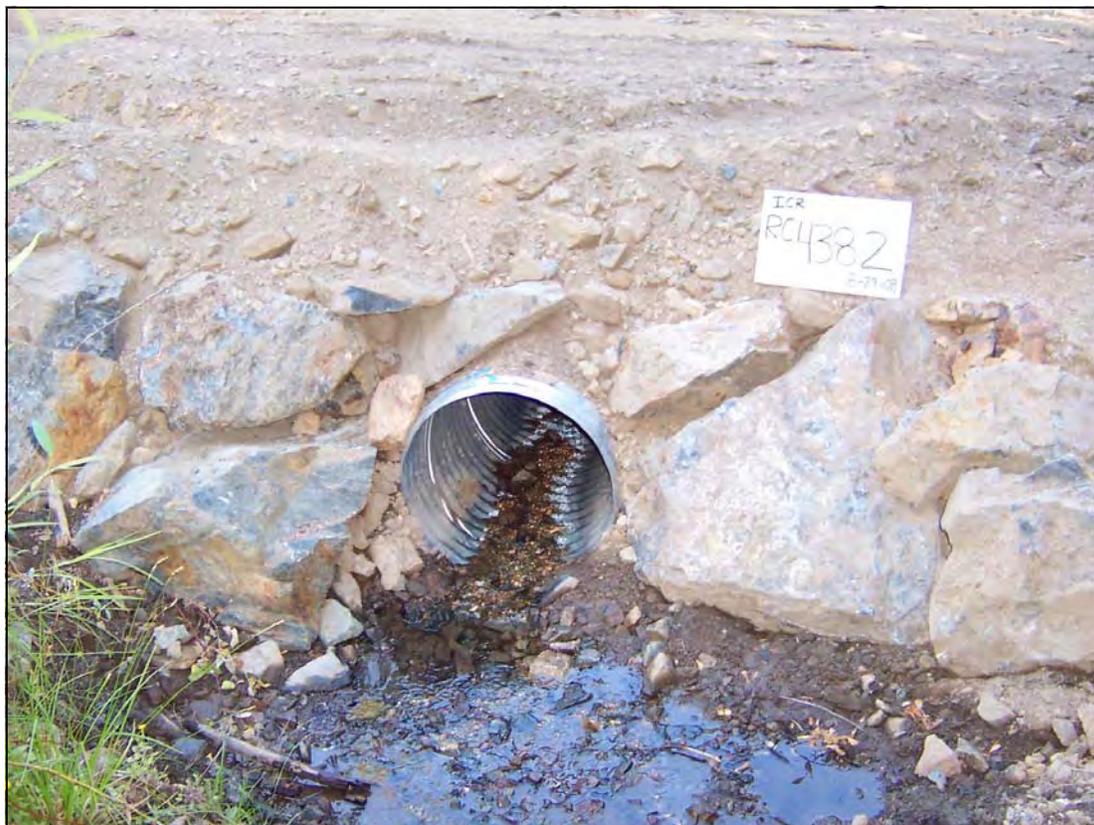
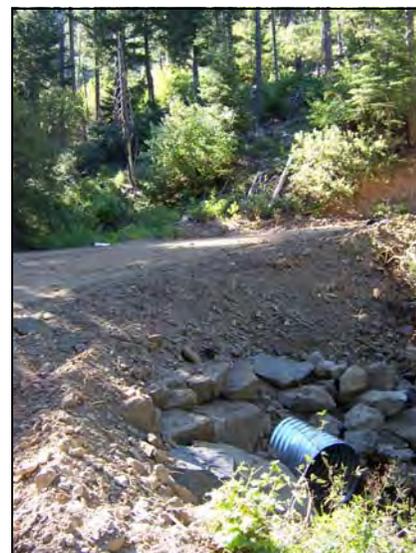
Site 438—Milepost 11.04—Treated Erosion: ~90 cyds

Stream crossing with undersized, plugged 18" x 30' CMP with potential to divert
 Treatment: Replace with a 24" x 40' CMP at the bottom of the fill & at channel grade of 21%; Redefine the rolling dip that is ~ 75' down right of the crossing. Top photo is of inlet prior to implementation
 Bottom left photo is new 24" culvert inlet with rock headwall & bottom right is the outlet

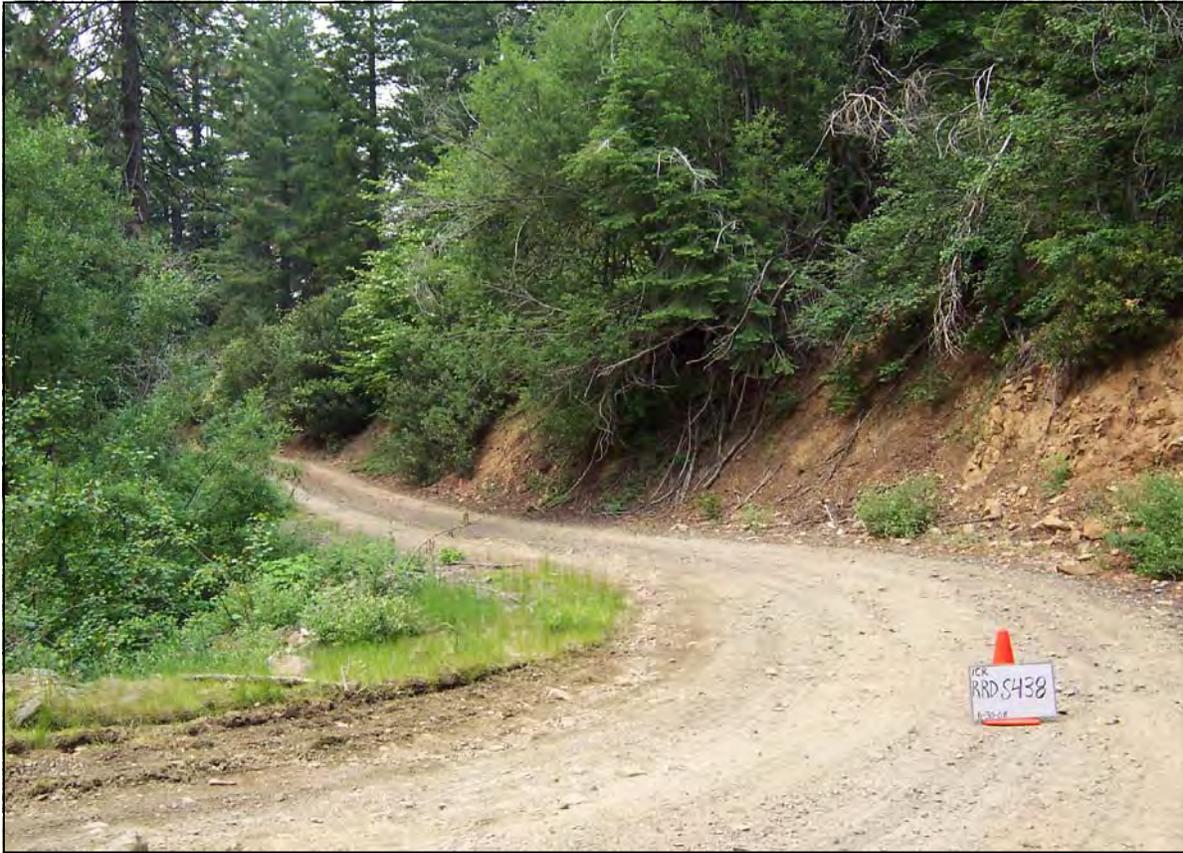
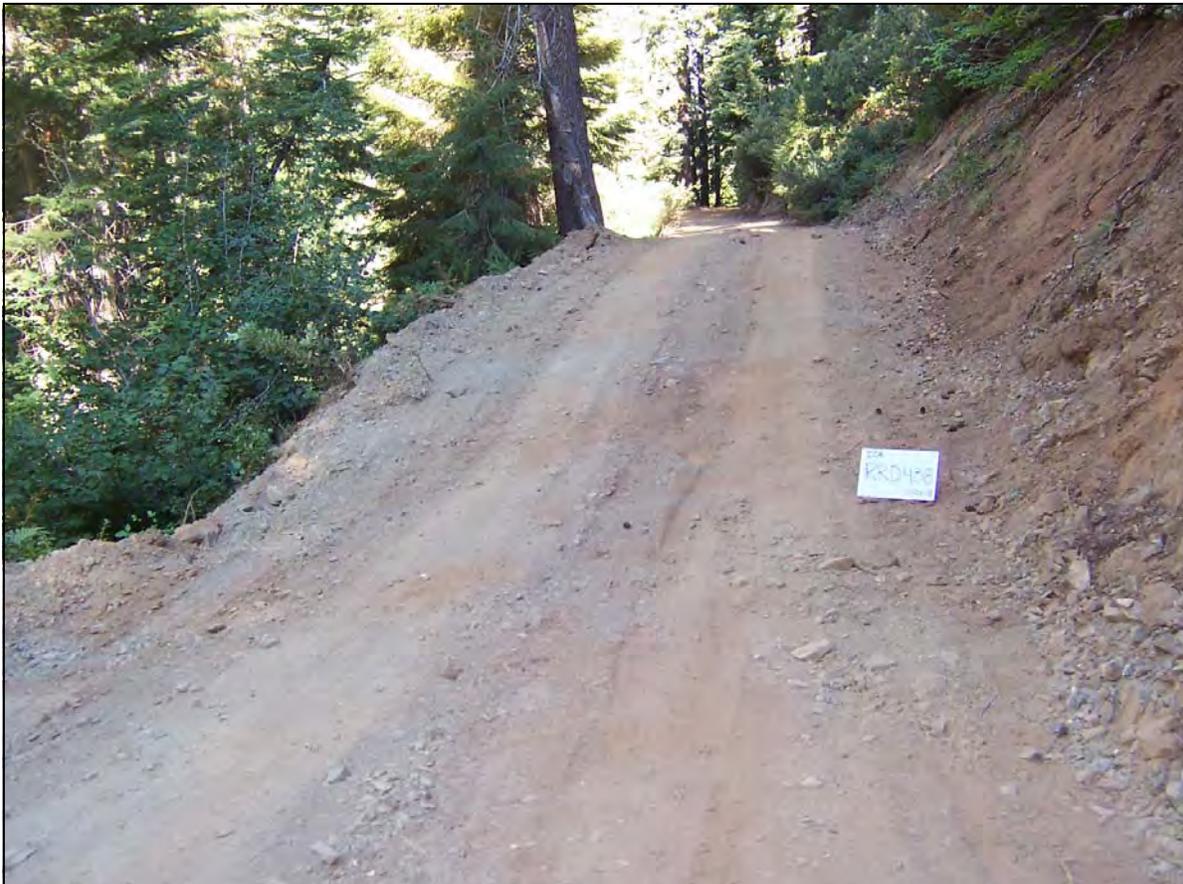
Site 438—Milepost 11.04

Top photo shows wood stake at existing rolling dip ~ 75' down right of the crossing prior to implementation
Bottom photo is the rolling dip after DOT redefined it & redefined the outsloped shape of the road
