APPENDIX B:

CATALOG OF HUMBOLDT COUNTY CULVERTS LOCATED ON FISH-BEARING STREAM REACHES

SITE-SPECIFIC CULVERT INFORMATION

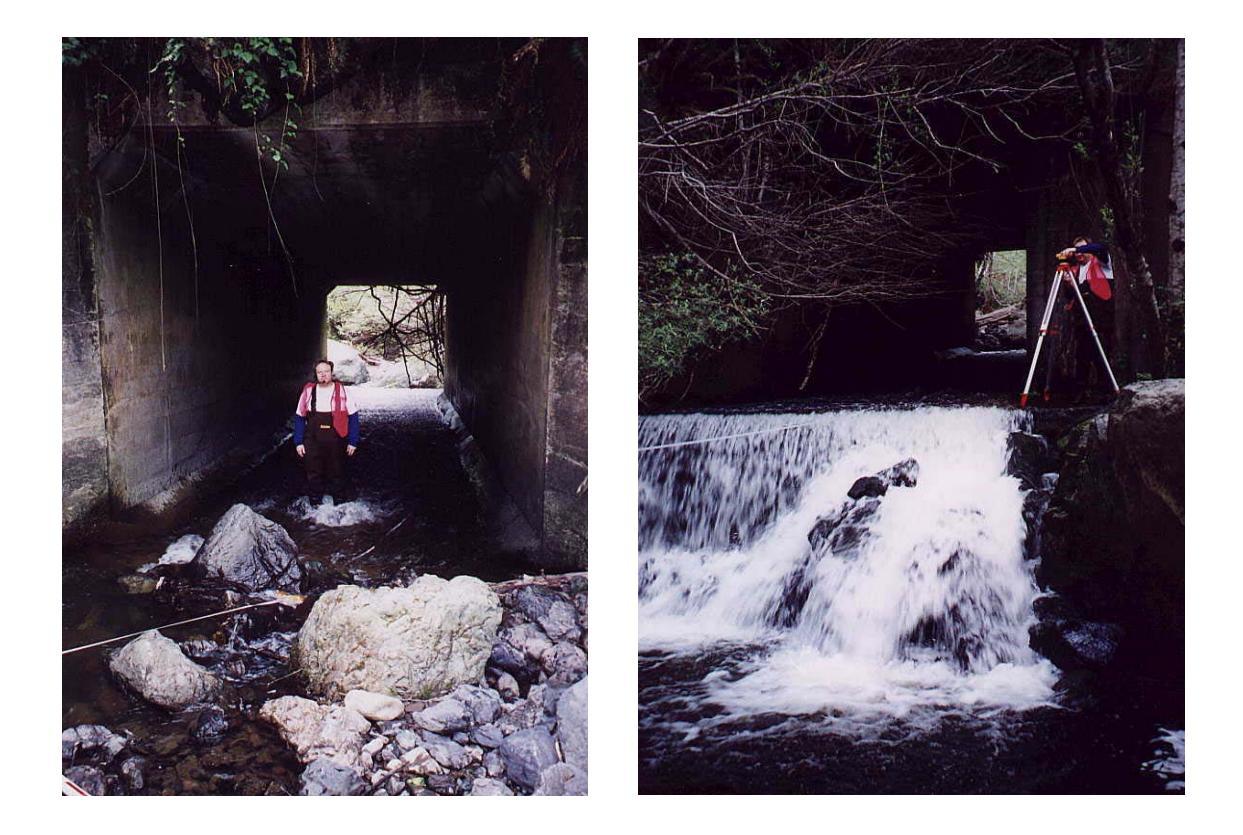
Site #1: Luffenholtz Creek #1; Trinidad Scenic Drive Priority Ranking = #33

Overall condition: Good, floor shows some signs of wear. Sizing: Good.

Barrier Status: Complete at moderate to high flows for excessive jump required into culvert and high velocities caused by steep slope. Lack of depth also a problem at lower migration flows.

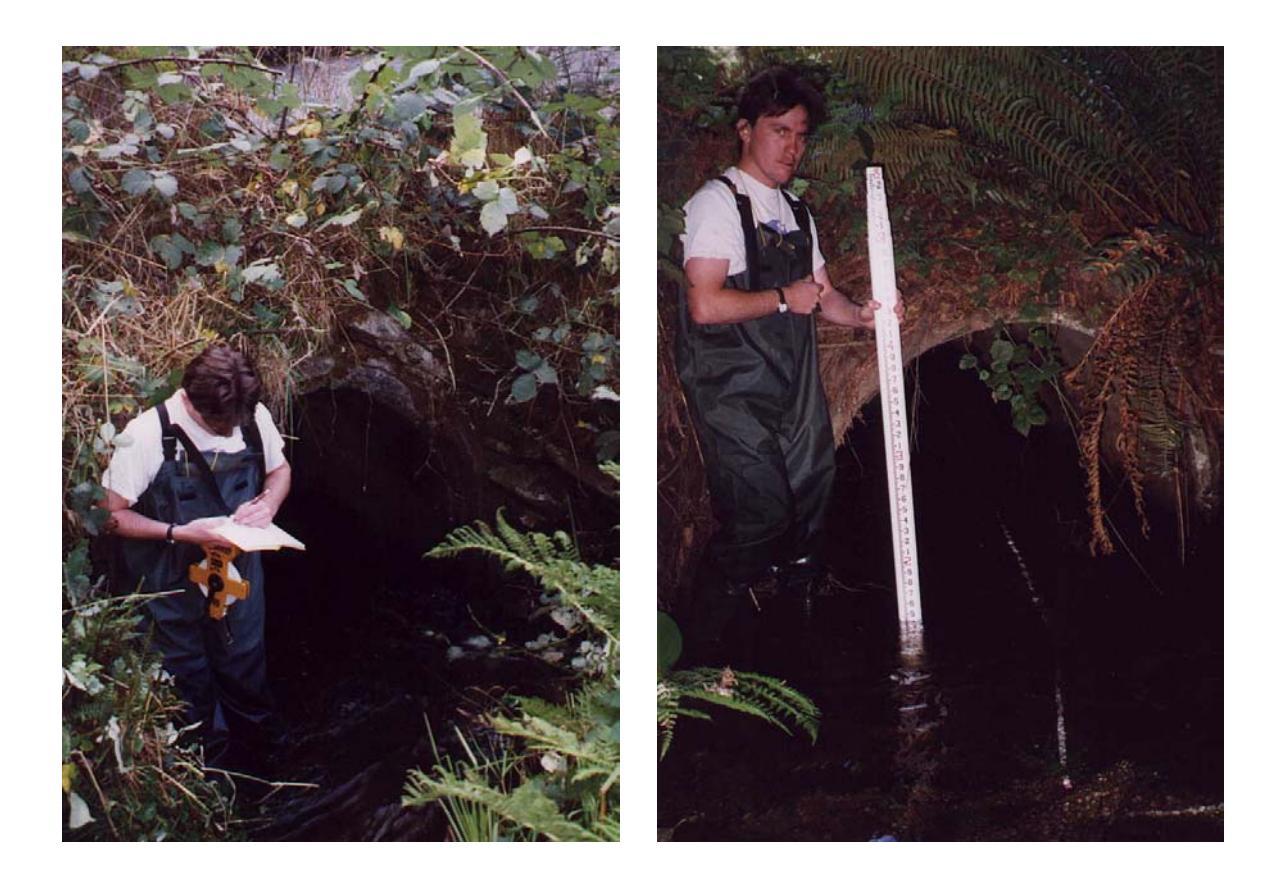
Modifications: None **Fill Estimate:** 452 cubic yards **Overall condition:** Fair, inside of pipe exhibits minimal wear.

Sizing: Extremely undersized, culvert inlet overtops on about two to five-year storm flow. Culvert inlet is also at a 90° alignment to upstream channel (in ditch along road for about 40'). Any replacement should consider placing crossing with channel straight through crossing.

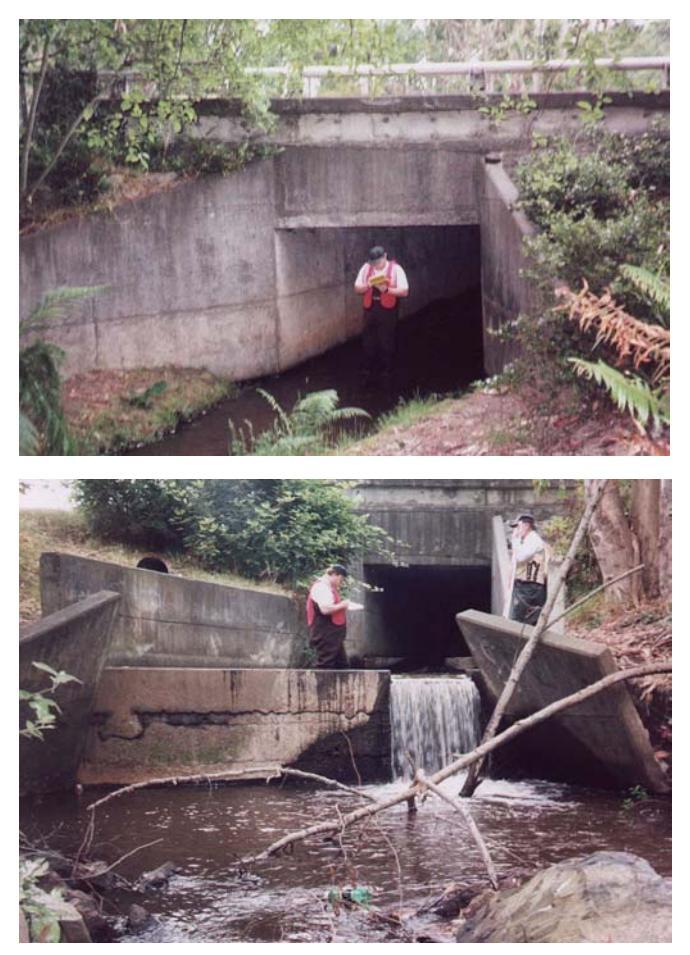
Humboldt County Culvert Inventory and Fish Passage Evaluation April, 2000 Site #5: Widow White Creek #1; Murray Road Priority Ranking = #30

Fill Estimate: 142 cubic yards. **Overall condition:** Fair. Culvert is in good condition, however retaining walls below outlet are collapsing. Baffles near inlet are partially buried in sediment.

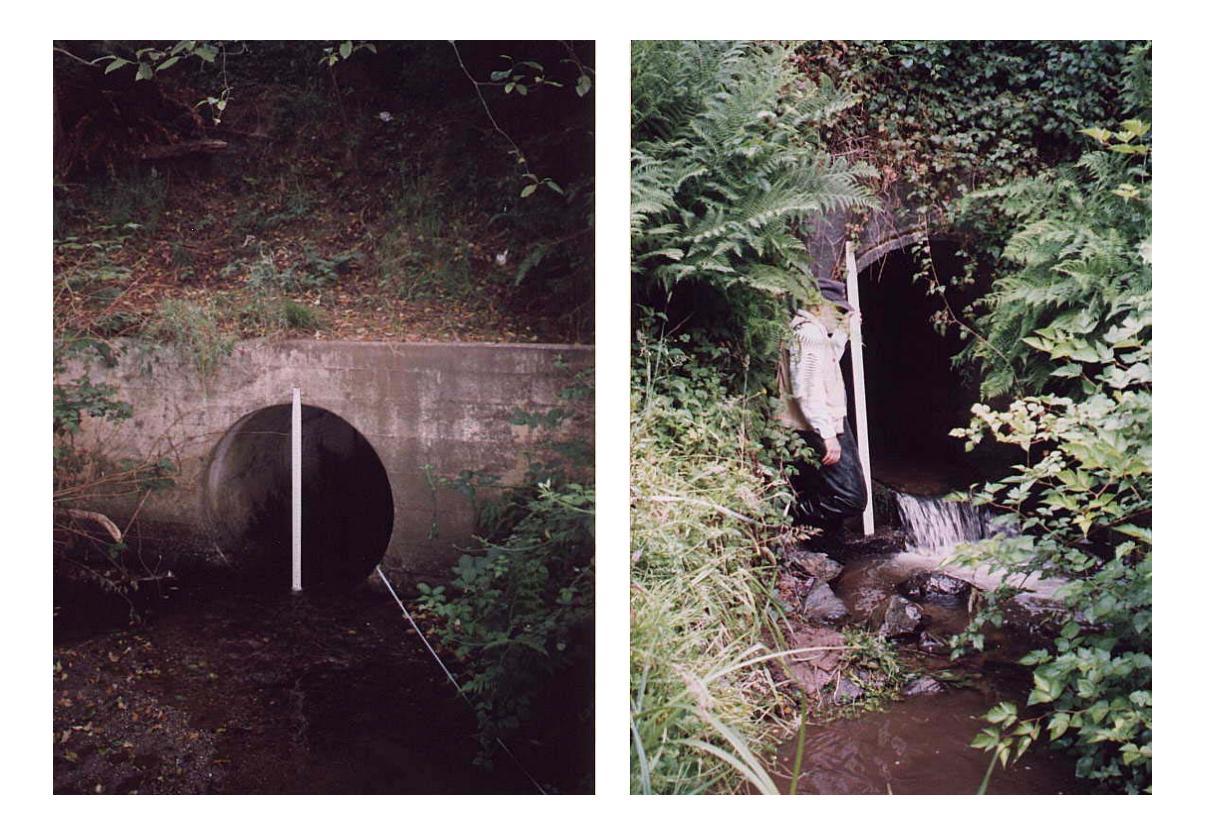
Site #8: Norton Creek; McKinleyville Avenue Priority Ranking = #37

Overall condition: Fair. Culvert is in good condition, however retaining walls below outlet are collapsing.

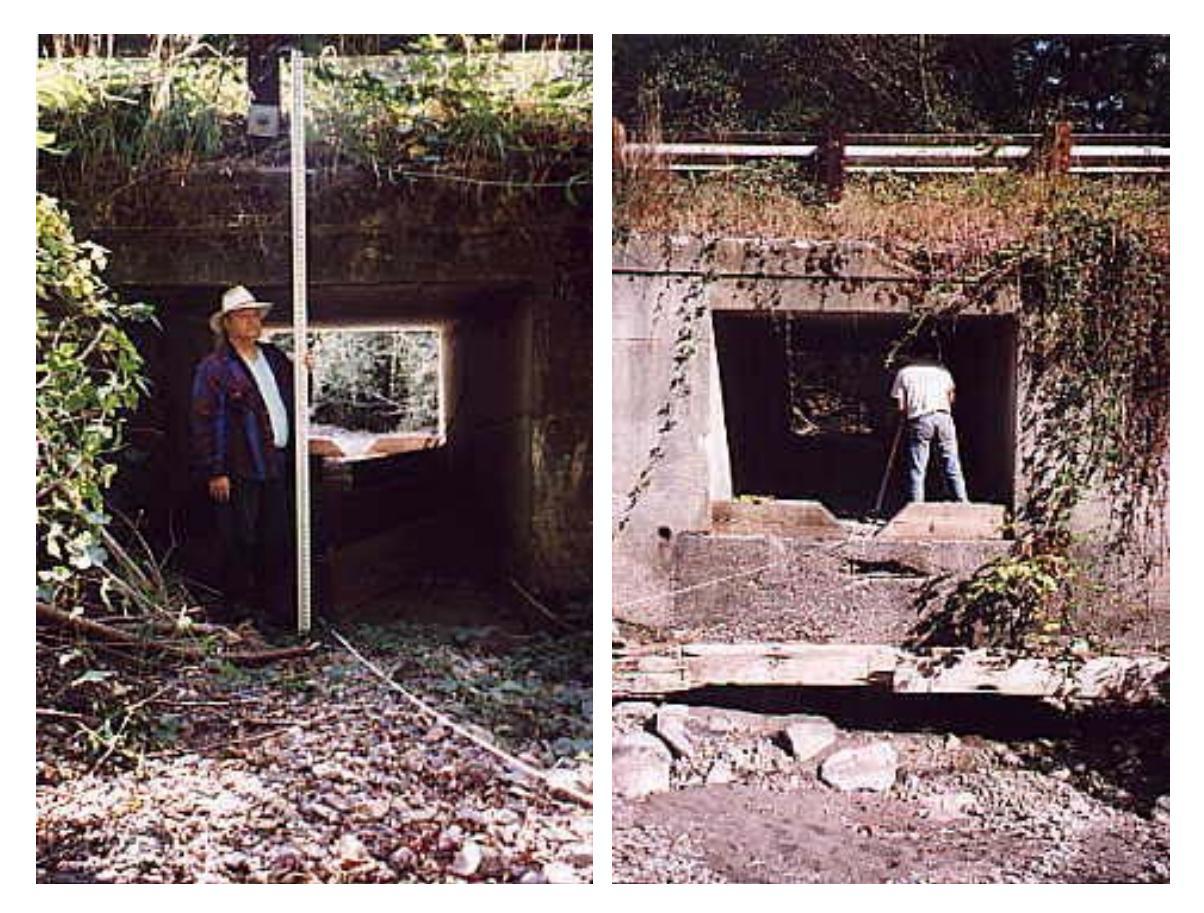
Humboldt County Culvert Inventory and Fish Passage Evaluation April, 2000 Site #13: Grassy Creek; Fieldbrook Road Priority Ranking = #27

Fill Estimate: 1,453 cubic yards. **Overall condition:** Fair/poor, redwood beam under-supports starting to rot and wear away.

Barrier Status: Excessive jump creates total barrier for all species of juvenile salmonids and coastal cutthroat trout. Is a partial barrier to adult coho, chinook, and steelhead. Elevation of backflood pools recently (10/99) increased, may provide better access. Over four winters of observations, only a handful of juveniles seen at this culvert (all failed attempts).

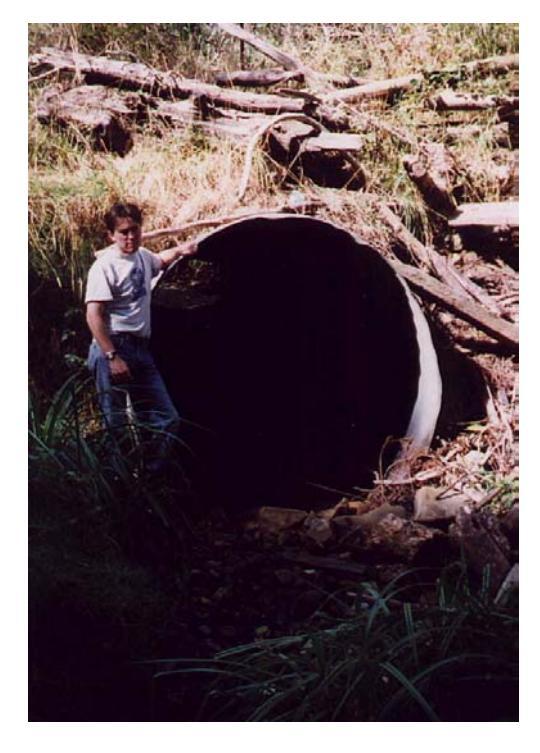
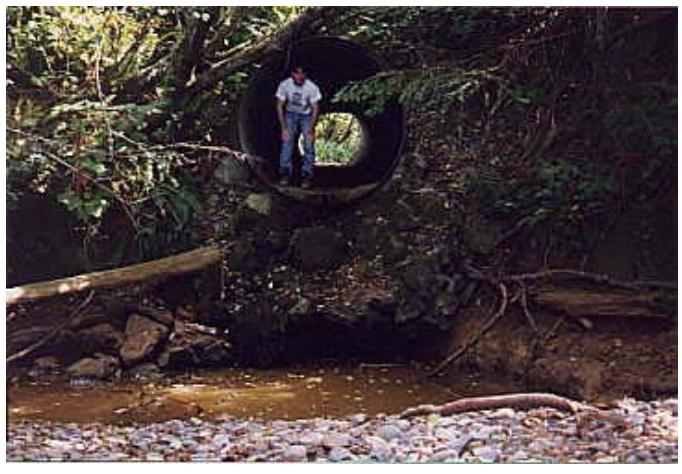
Overall condition: Extremely poor. **Sizing:** Extremely undersized (in photo, note collection of woody debris above inlet).

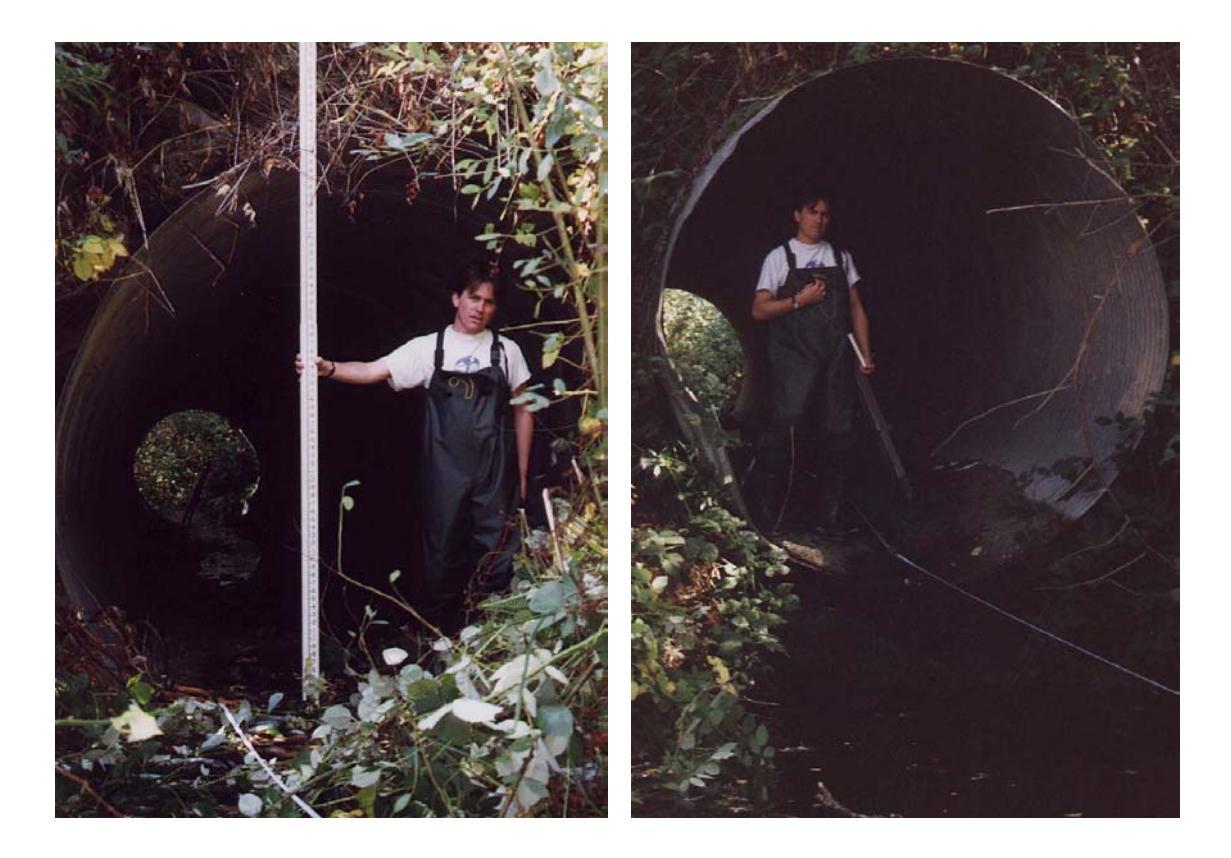
Site #15: South Fork Anker Creek #1; Fieldbrook Road Priority Ranking = #8

Overall condition: Poor, rusted through bottom, then lined with concrete.

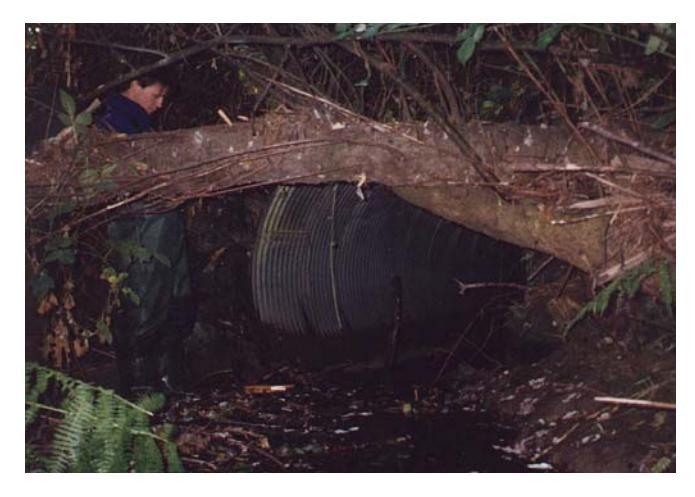
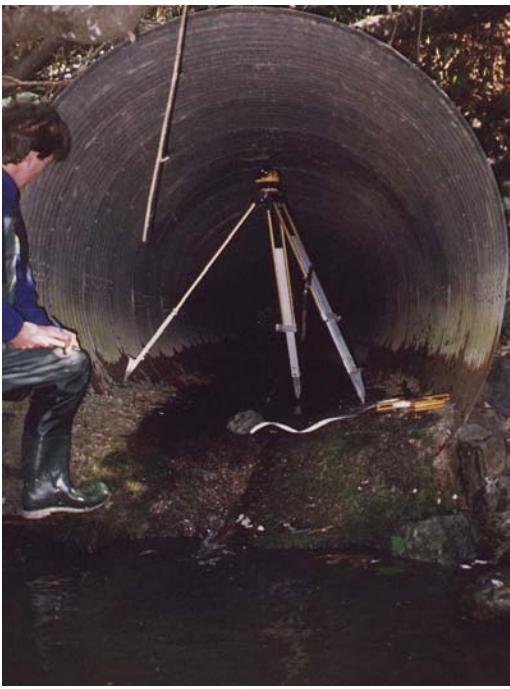
Overall condition: Poor, floor rusted through and then lined with concrete.

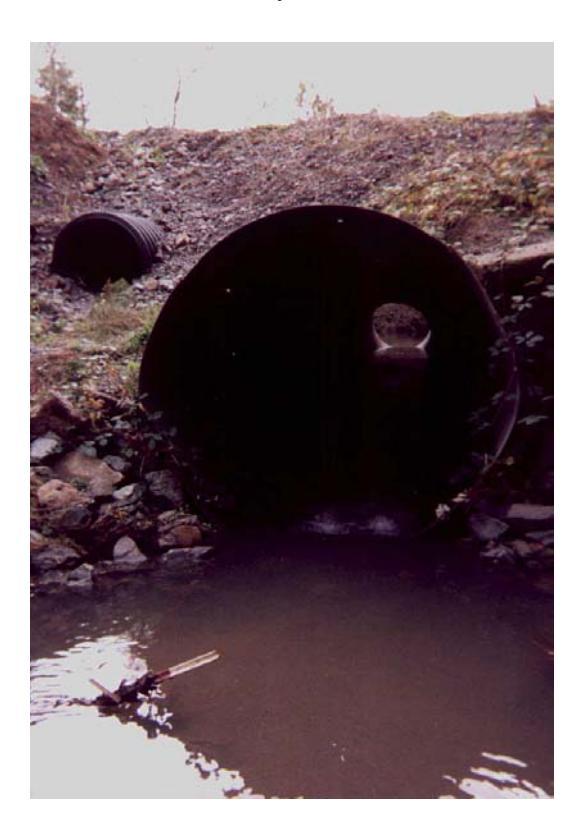
Site #17: Lindsay Creek; Murray Road Priority Ranking = #3

Overall condition: Poor, floor completely rusted in places to extent that low flow fails to reach outlet.

Sizing: Undersized, inlet overtops on a about a 10-year storm flow. During our study this culvert failed and was patched together by county road's crew.

Barrier Status: Excessive length and undersizing create a total velocity barrier to all juvenile salmonids and adult coastal cutthroat trout. Is a temporary barrier to adult coho, chinook, and steelhead. Adult salmon and steelhead have been observed spawning upstream of this culvert. Note: after crossing failed in 1998, passage may be harder due to steep drop at inlet which formed after culvert was "repaired".

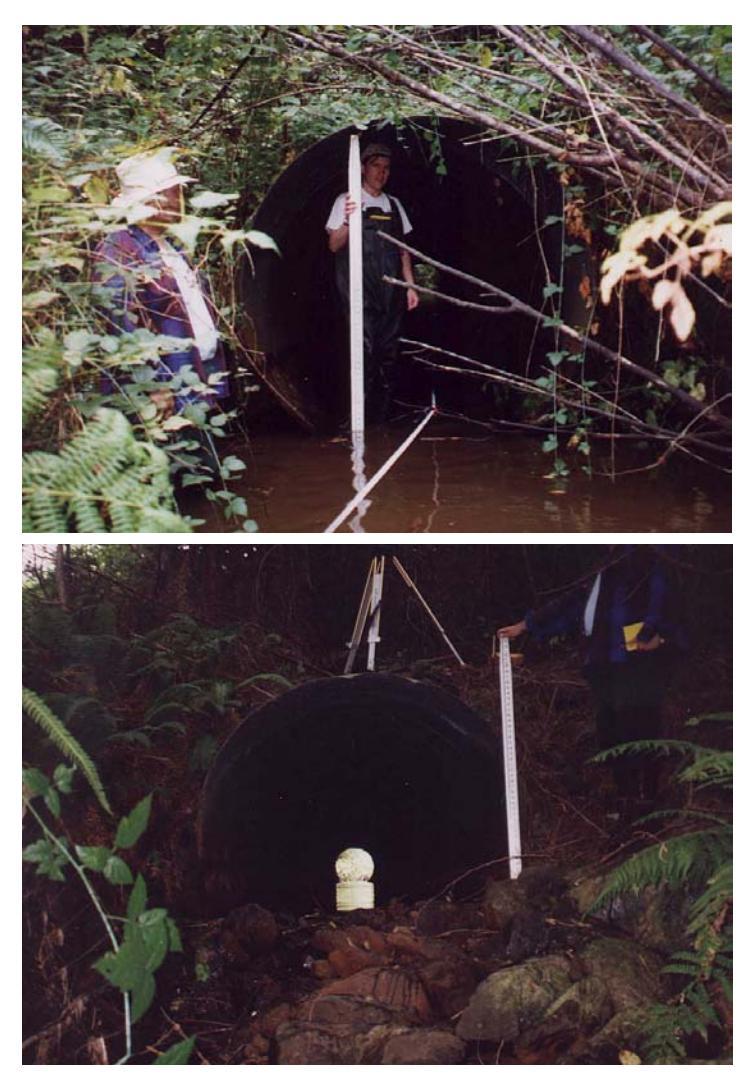
Fill Estimate: 3,287 cubic yards Overall condition: Poor, rusted-through bottom.

Barrier Status: Fish Xing determined culvert is not a barrier to adult salmonids, but is a velocity barrier to juveniles. However, analysis could not consider the steep drop down riprap just below outlet which may be a velocity barrier to adults at some flows. Adult coho have been observed upstream of this crossing.

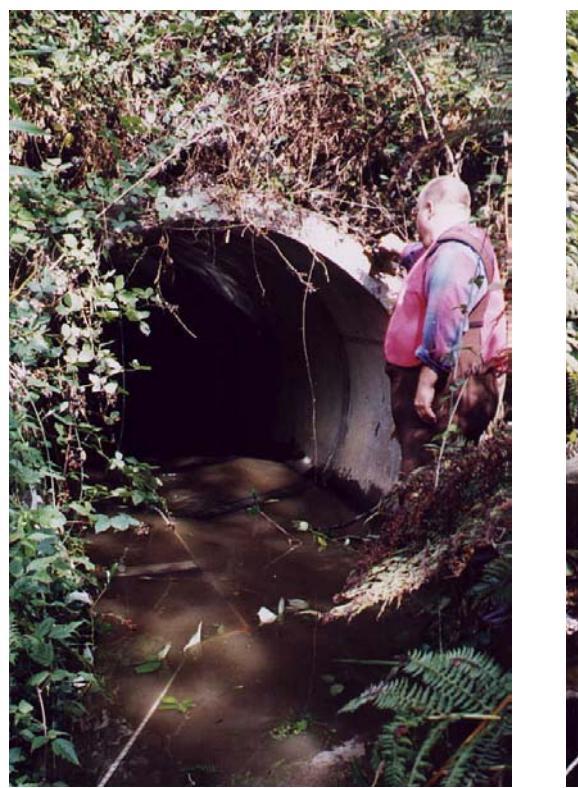
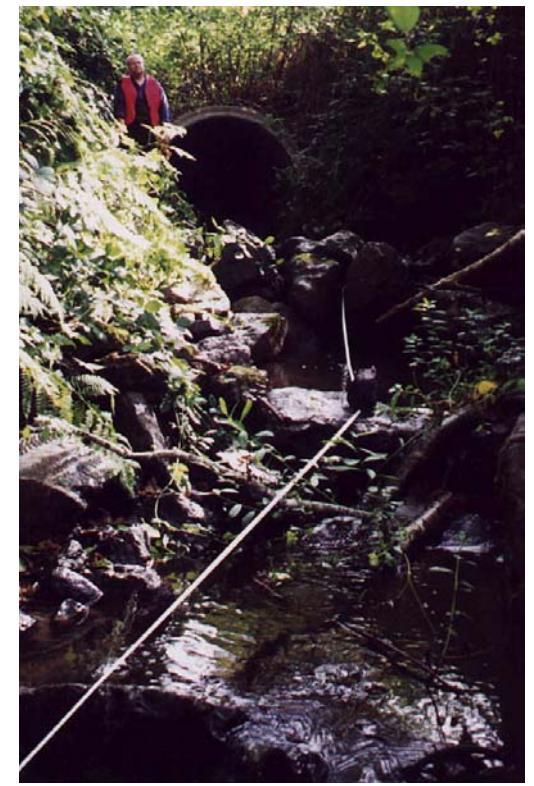
Humboldt County Culvert Inventory and Fish Passage Evaluation April, 2000 Site #19: Warren Creek; Warren Creek Road Priority Ranking = #24

Overall condition: Good/fair. Rip rap below outlet in need of repair to maintain functionality of approach pools. Concrete lining has stopped leakage through iron pipe, yet has reduced the flow capacity of culvert.

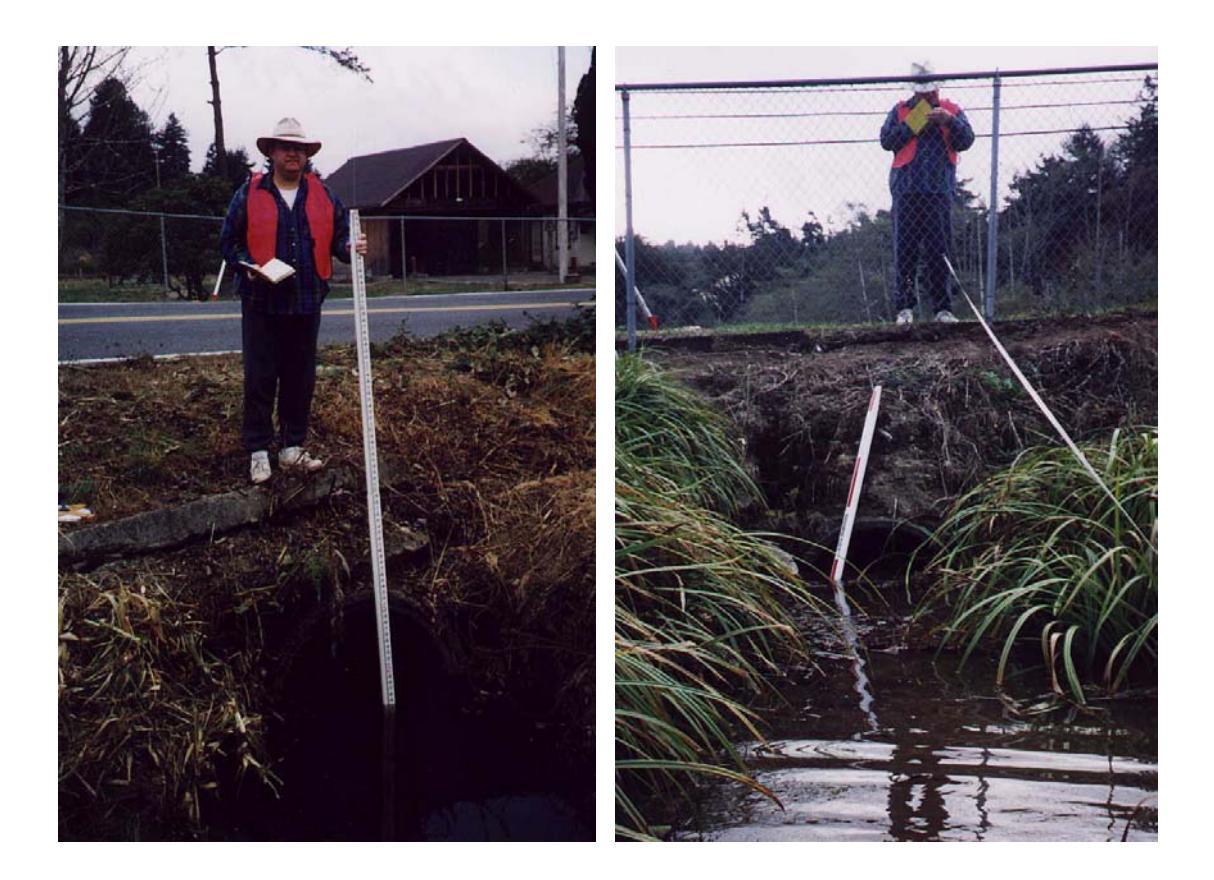
Site #26: Morrison Gulch; Quarry Road Priority Ranking = #1

Overall condition: Poor, culvert floor is rusted, low flow fails to reach outlet.

Barrier Status: Yes, high entry jump (>5') prevents all juveniles and most adults (all species) from entering CSP. Excessive velocities occur in pipe at a moderate range of expected migration flows. Highest levels of observed jump attempts by adult coho salmon.

Overall condition: Poor, one culvert is overgrown and completely plugged with fine sediment. Entire channel flows through one 3' pipe (nearly full at low summer flow).

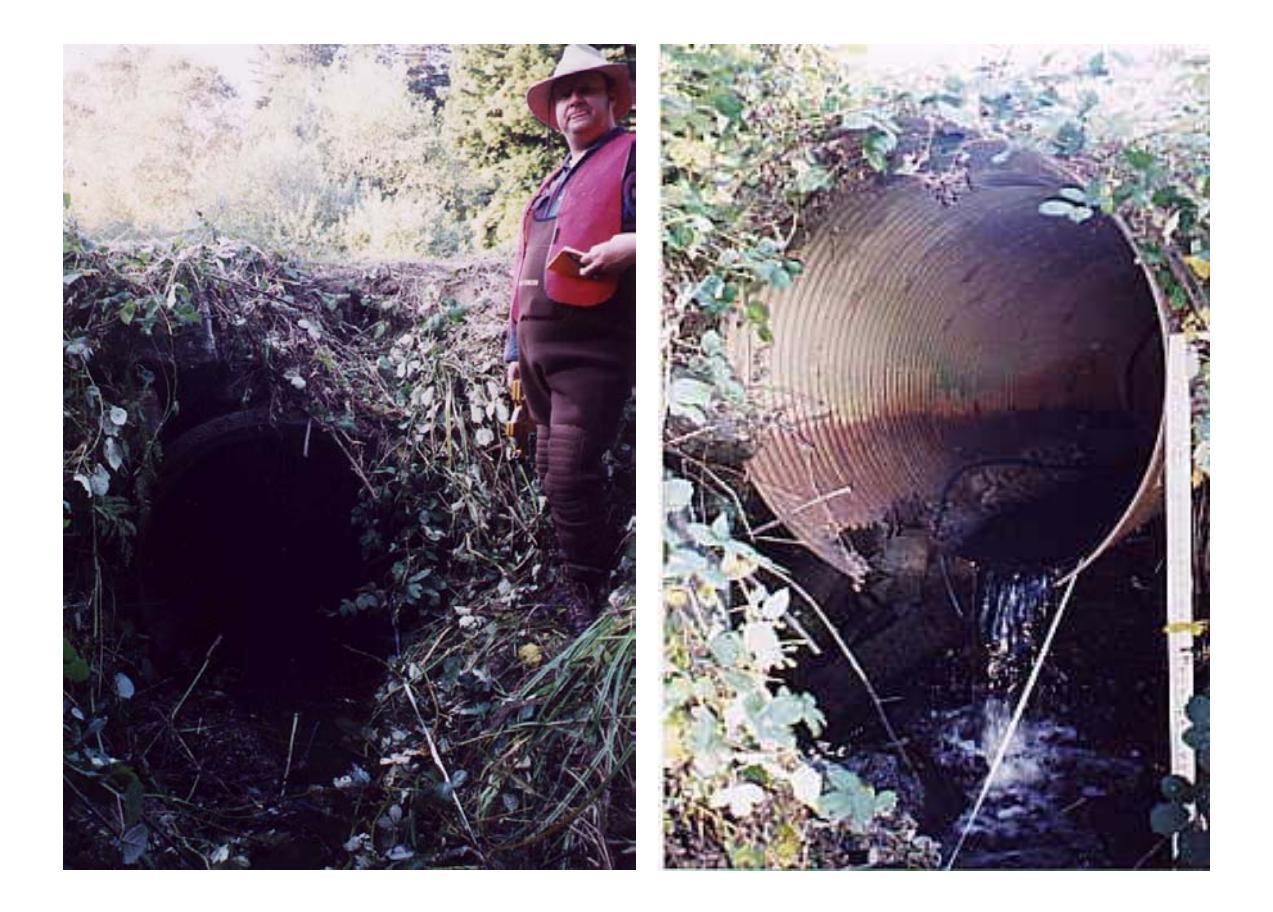
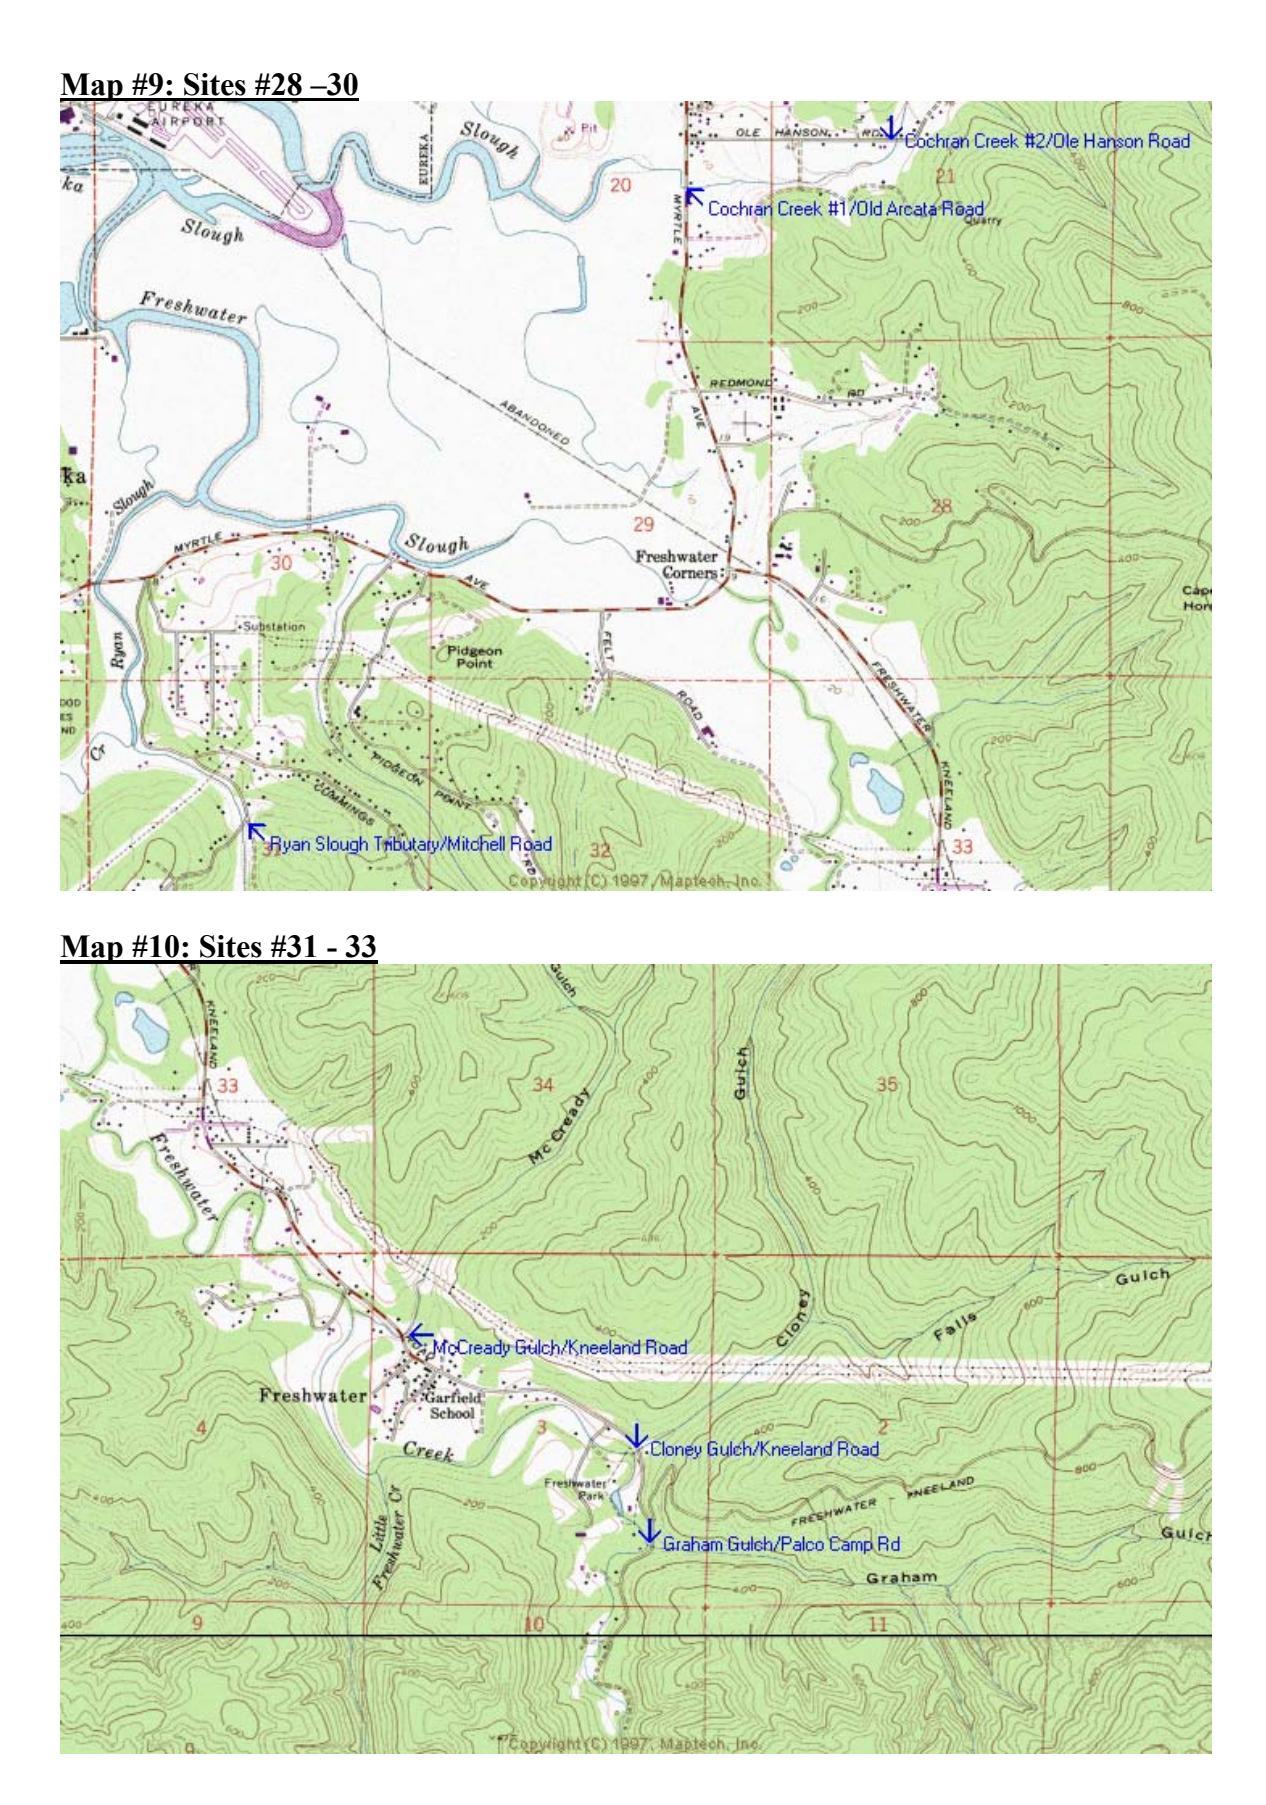
Overall condition: Extremely poor, CSP section is heavily rusted, lower six feet of pipe missing.

Sizing: Extremely poor – fails to pass a two-year flow. Floods Mitchell Road on a regular basis.

Barrier Status: Partial for most adults and complete barrier for all juveniles. Outlet pool lacks depth for jump attempts. Fish Xing determined that jump height is a problem at some flows. The inadequate sizing also creates a velocity barrier at a wide range of migration flows.

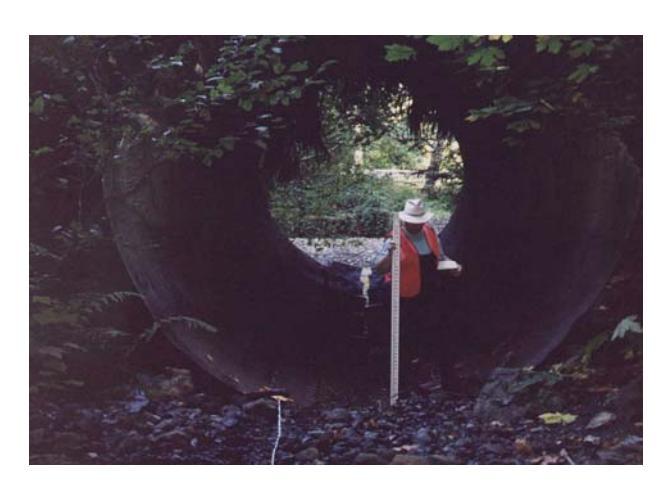
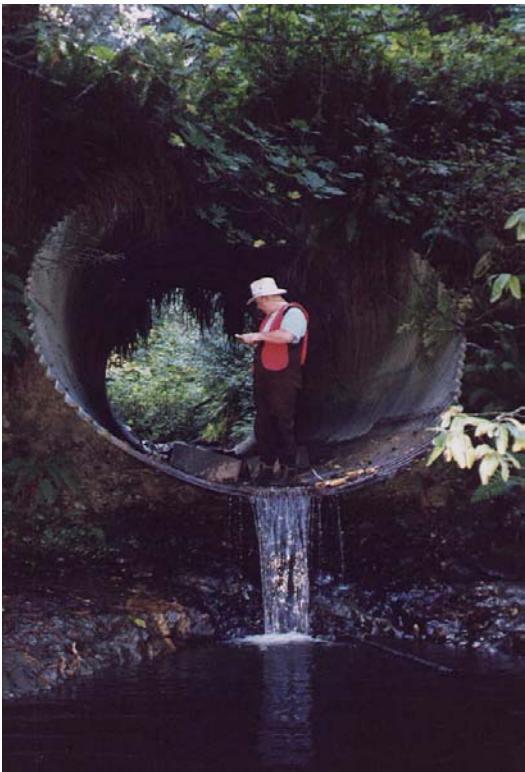
Fill Estimate: 1,853 cubic yards Overall condition: Floor and outlet are rusting, numerous holes in floor.

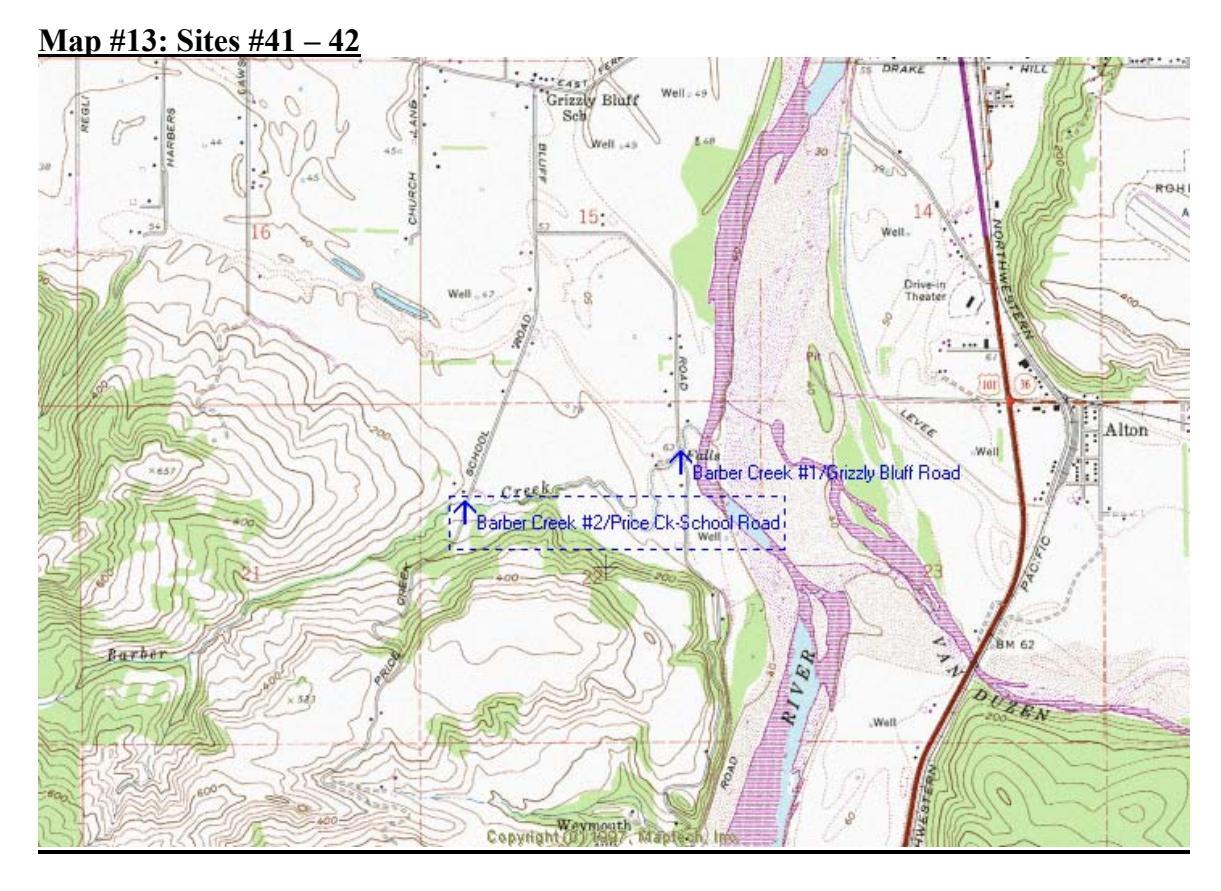
Site #42: Barber Creek #2; Price Creek School Road Priority Ranking = #57

Overall condition: Poor, rusting, crushed, lots of woody debris caught in riparian trees at culvert outlet.
