**POLICIES AND PROCEDURES FOR PROTECTING  
ANADROMOUS SALMONID HABITAT IN  
DEL NORTE, HUMBOLDT, MENDOCINO, TRINITY AND SISKIYOU COUNTIES**

**Field Assessment of Management Practices**

**Prepared for Five Counties Salmonid Conservation Program**

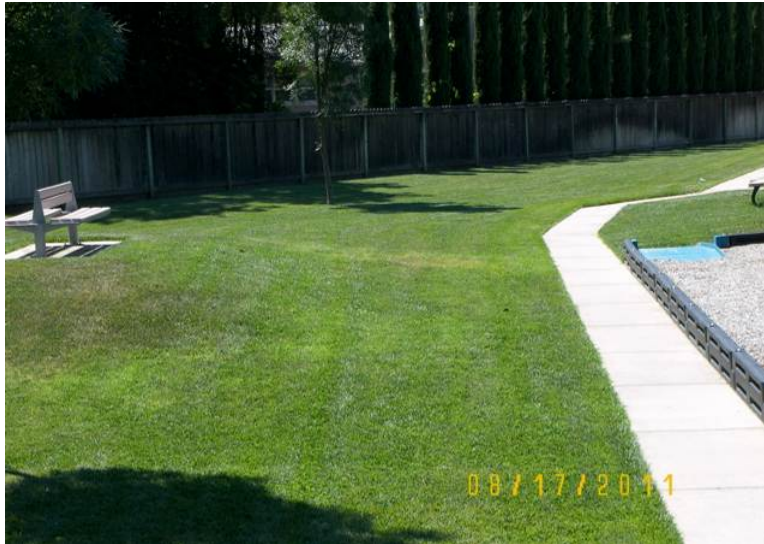
Figure 1: This park is located within the prescribed buffer along the Russian River on the Major Subdivision site. The fence at the left of the picture is less than 20 feet from the top of the bank.

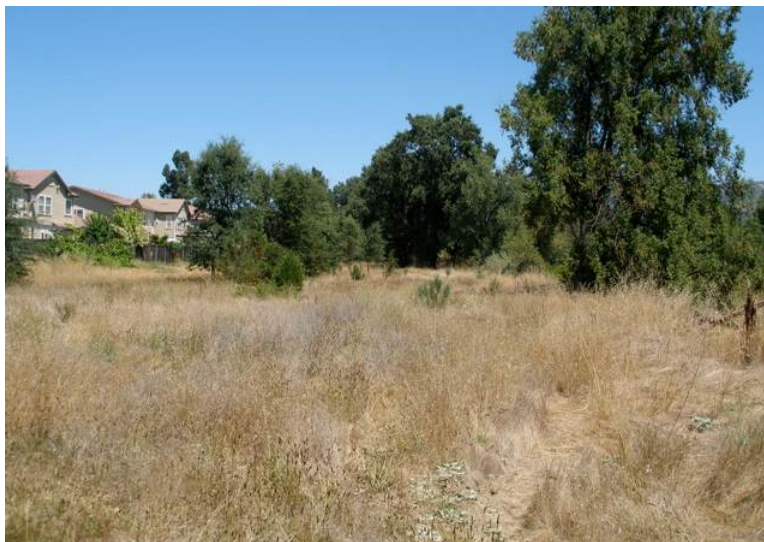
Our observations indicated that the buffer was primarily vegetated by ruderal species and that limited tree cover existed immediately adjacent to the river. This probably reflected the parcel's past use for agriculture (Figure 2). Exotic plants, trash and other debris were present.

Figure 2: The riparian buffer parcel on the Major Subdivision site. There were no indications that it was being managed to enhance riparian

values. The county lacks staffing and resources to do long term project monitoring to ensure compliance with development conditions.

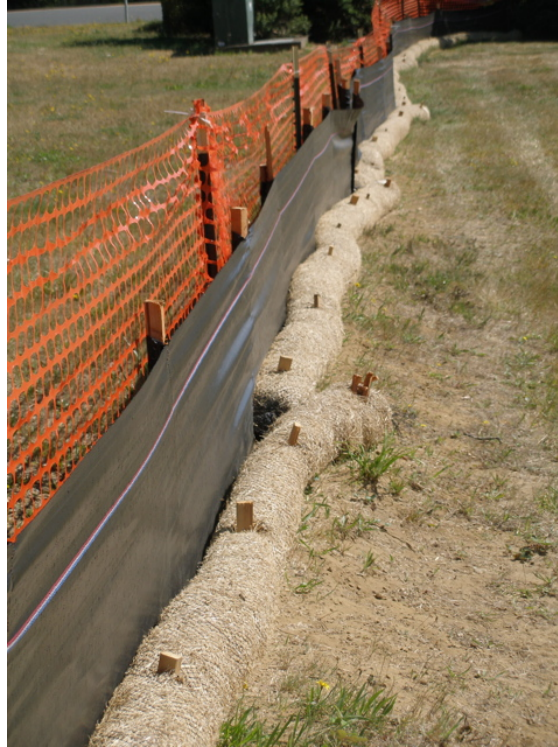
Figure 3: At this commercial site in Del Norte County staked straw rolls and a silt fence were in place along the entire boundary between an adjacent creek and the development (August 2011). We also observed similar measures in place at stockpiled soil.

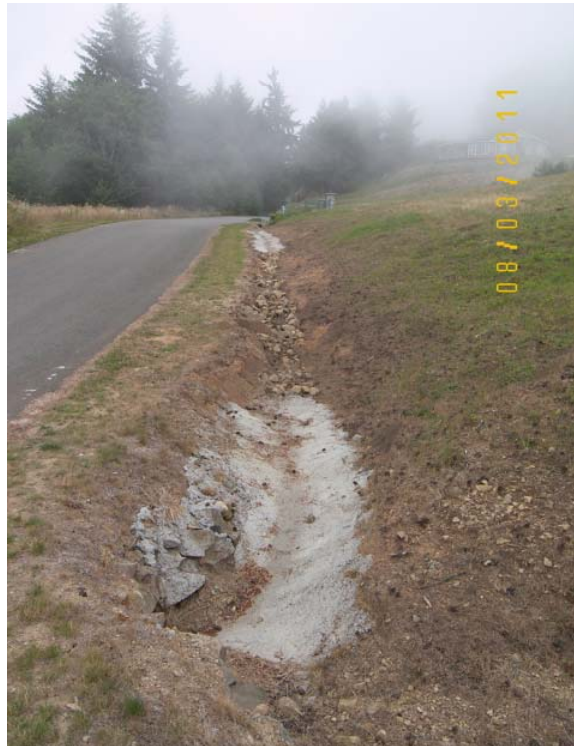
**Major Hillside Subdivision.** The Major Hillside Subdivision in Del Norte County represents a case where controls were available and implemented but ineffective. Moreover, the developer chose to proceed with grading without authorization from the county. This project was first proposed in 1991. Its approval was reinstated in 2002 subject to several conditions. These conditions included no development on slopes greater than 30 percent, no development on slopes between 20-30 percent that had high to very high erosion potential, and a requirement for submittal of engineered grading and drainage plans to the county prior to any earth disturbing activities. Additional required measures included provisions for dissipating runoff velocities in ditches and installation of catch basins. All disturbed areas were to be revegetated.

In 2003 the county alerted the Regional Water Board to unauthorized grading at the site. Upon inspection by Board staff and DFG, it was determined that sediment discharge to the creek had occurred. Erosion control measures that had been installed were not functioning. The Board issued a Cleanup and Abatement Order. Erosion problems persist to this day (Figure 4). At the time of field review, substantial areas of individual lots were still barren and eroding, contrary to a condition on the development that required revegetation.

Figure 4: This drainage ditch along one of the roads in the Major Hillside Subdivision had eroded and incised, creating a potential for plugging the ditch relief culvert. There had been attempts to stop the incision by installing concrete in some locations.

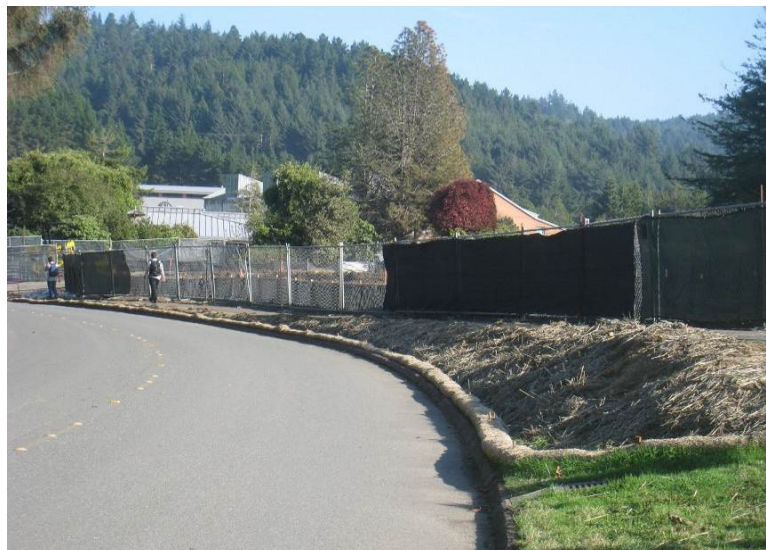
**Other Observations.** Potentially ineffective controls were observed at the college construction site in Humboldt County during the summer season. This included improperly maintained silt fences, lack of silt barriers and use of straw mulch to intercept sediment (an inappropriate application). Based on a supplemental site visit in October, it appeared that corrections were made (Figure 5).

Figure 5: The corrected measures included addition of a coir roll along the disturbed site (above) and on the edge of the road across from the site (not shown).

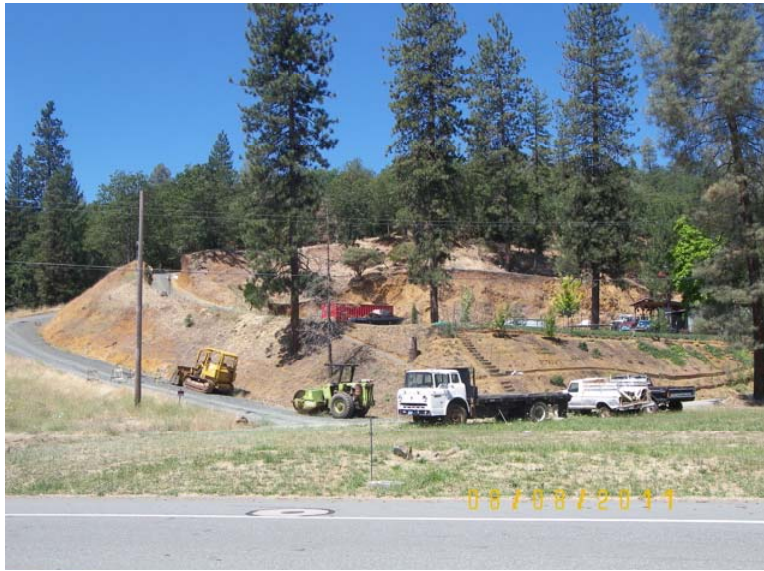
Unregulated grading we observed in Trinity County displayed a complete lack of controls (Figure 6). Trinity County does not require a permit for grading. We observed unregulated and illegal grading (grading in violation of local or state regulations) in other counties as well. The extent of this activity and its significance to anadromous fish is not known. Counties lack the staff or resources to monitor for illegal and/or improper grading.

Figure 6: Unregulated grading near Weaverville, Trinity County. This site has been of considerable interest to the Regional Water Board.

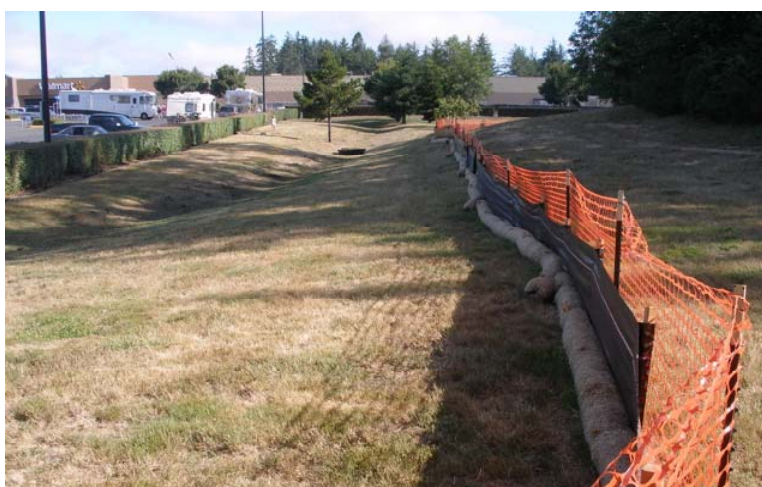
**Major Commercial Development.** At the commercial site in Del Norte County runoff from the development was directed to a grassy swale with underground treatment facilities that appeared to ultimately discharge via three outfalls to a creek. The swale and treatment facilities were designed to both remove pollutants and delay runoff to the stream (Figure 7). The county also required that a stormwater management plan include provisions such as porous pavement, green roofs, vegetated swales, retention basins, etc. to the degree feasible.

Figure 7: The swale on the left in the photograph conveys runoff from the development to three outfalls to an adjacent creek. In the top center of the photograph the entrance to an in-line treatment device is visible.

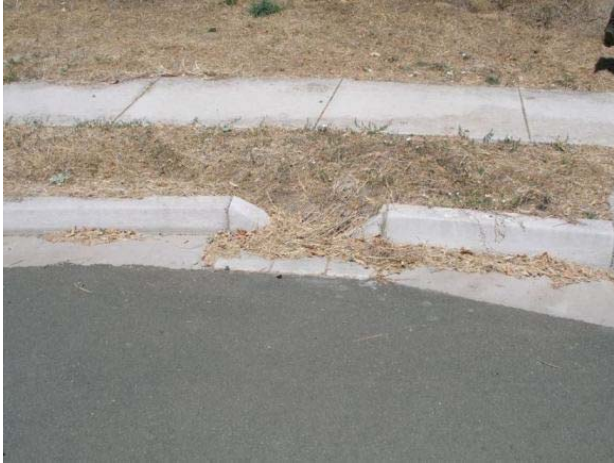
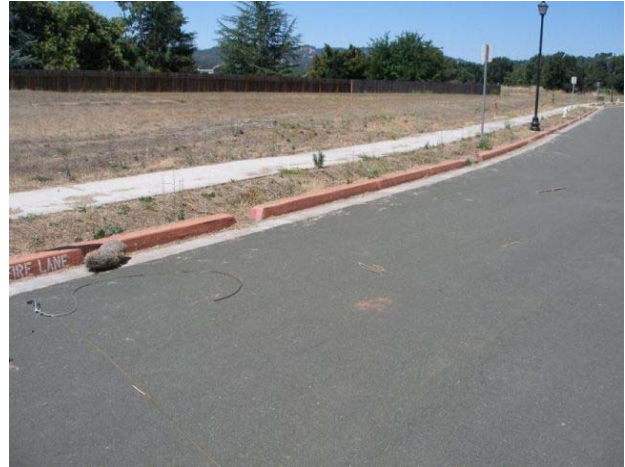
**Low-Income Housing, Major Subdivision.** The low-income housing project in Mendocino County we reviewed exhibited several features that provided on-site stormwater retention. Storm drainage was conveyed to a minor watercourse bordering the site by means of vegetated swales lining the streets and paralleling property boundaries. No specific design standards for these swales were required. The effectiveness of the placement and design of those used in this project is uncertain (see Figures 8 and 9).

Figures 8 and 9: These show the inlets of the street side swales. Based on the placement and topography, it is uncertain how much runoff would enter or bypass the swales.

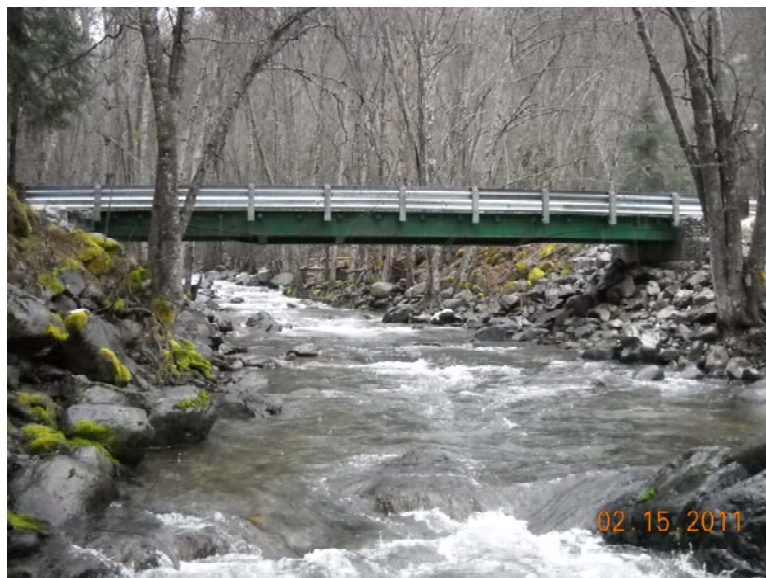
The Canyon Creek bridge project consisted of the replacement of a structurally unsound bridge with a rail car bridge (Figure 10). The project was initiated in 2002 but was not done then because of funding limitations. Permits from DFG, the Water Board, and Corps were obtained at that time. In 2007, the county procured a rail car bridge and re-initiated the project. New permits were received from all regulatory agencies and the Forest Service approved the action in 2008.

Figure 10: The new Canyon Creek Bridge

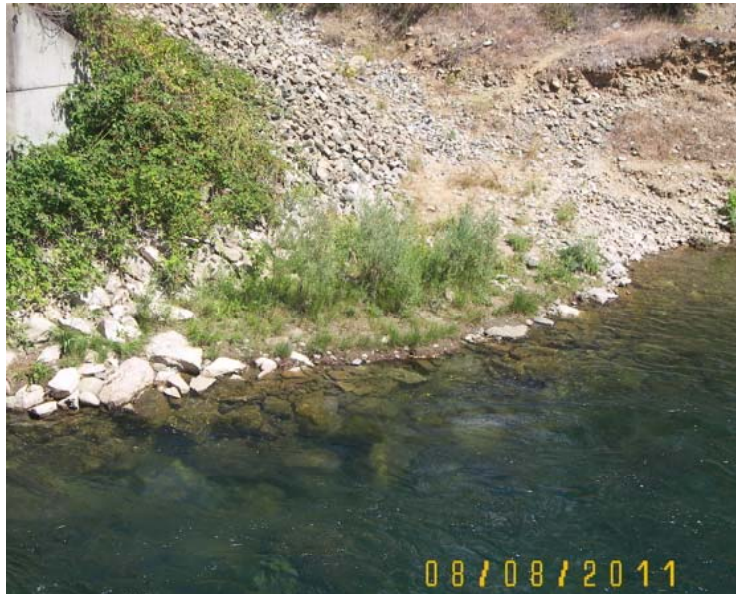
It was ultimately determined that the placement of rock slope protection would just replace rock that had been scoured away with larger rock and that there would be no net loss of instream habitat. Also, a jump was installed at the outlet of the overflow channel to prevent migrating salmon from becoming stranded when flows recede. The project was implemented during low flow conditions. It required the construction of a ramp to the stream for equipment and the removal of an alder and a willow tree. No equipment operations occurred in flowing water. Large, angular rock was used to minimize the chance of rock rolling into the adjacent pool. Fish were observed in the pool before, during and after construction. After completion of the project, the ramp was rocked and blocked to prevent erosion and vehicle access (Figure 11).

Figure 11: Rock slope protection placed at downstream end of Bucktail Bridge. The access ramp in the center of picture was rocked and blocked off to prevent vehicle access.

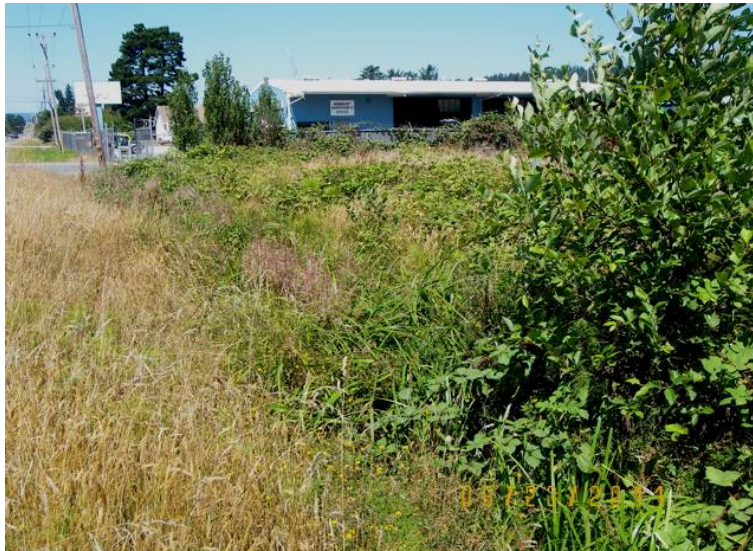
Widow White Creek in the McKinleyville area is a stream that supports anadromous fish. The project involved the construction of a pedestrian bridge and sidewalk extension at and near an existing crossing on Central Avenue. A bridge was installed rather than a culvert to ensure that fish passage was not adversely affected. In conjunction with the project, the county expanded and enhanced drainage ditches in the vicinity of the crossing. This included replacing pipe with open ditch, placing check dams in ditches and allowing ditches to revegetate naturally. The work on the ditches had positive effects on non-point source pollution and sediment discharge to the creek (Figure 12).

Figure 12: This drainage ditch that empties into Widow White Creek was equipped with check dams to catch sediment in conjunction with the pedestrian bridge project. Maintaining full vegetative cover in the ditch also reduces sediment delivery.

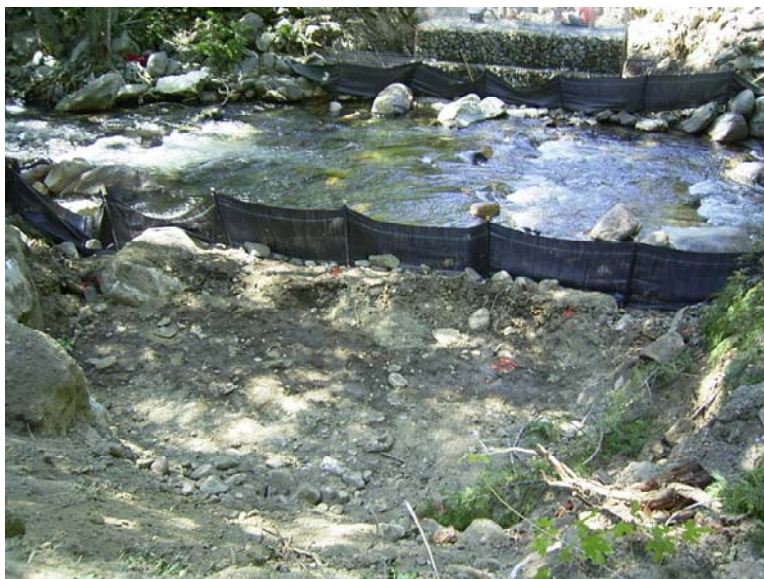
Figure 13: Silt fence installed at a bridge replacement site to prevent sedimentation in the stream.

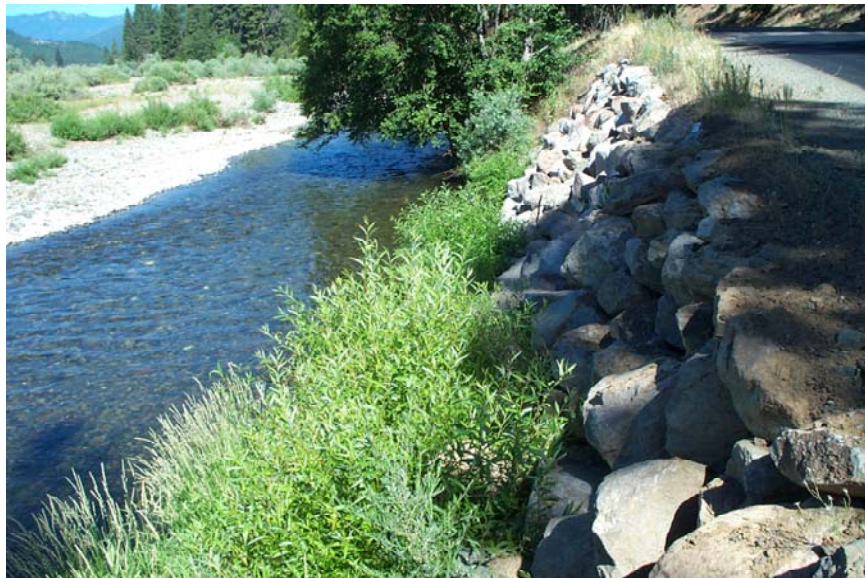
The DFG Streambed Alteration Agreement specified certain conditions to avoid impacts on anadromous fish and their habitat. A temporary bypass channel around the work site was constructed. Any fish present were to be “encouraged” to leave the work site or be dip netted and relocated. Work was generally restricted to areas outside of flowing water during the low flow season, though equipment did have to cross the stream during low flow. In addition to the use of rock rip-rap, live willow poles were installed at the base of the slope (Figure 14).

Figure 14: Bank stabilization on the Scott River Road utilizing a bioengineering approach. The site has remained stable for the past four years.

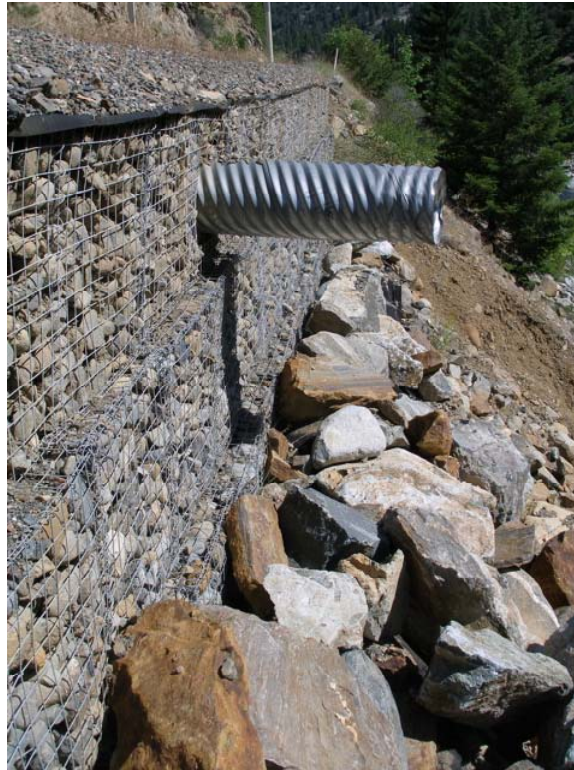
A biological assessment and design memorandum was prepared for the project. NMFS informally consulted on the project and determined that it would have no adverse impacts on coho salmon. The Water Board issued a waiver of waste discharge requirements and water quality certification. The Corps 404 authorization did not include any specific conditions. This was also true for the DFG Streambed Alteration Agreement. In general, the design that was ultimately adopted for the project was environmentally superior to a previous design that would have required construction within the streambed (Figure 15).

Figure 15: Retaining wall along Scott River Road above Scott River. Note rock slope protection applied at base of wall that also serves to dissipate energy from the culvert outfall.

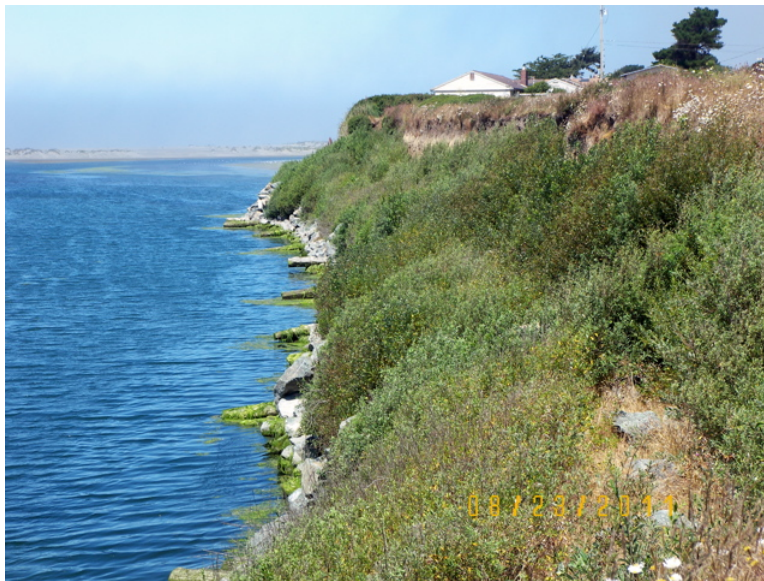
The slope stabilization project on the Mad River is acknowledged as perhaps the largest bioengineering project undertaken in Humboldt County. It is located near the mouth of the river near McKinleyville. The project was done to prevent further erosion and bank retreat that was threatening to undermine several nearby houses. The design evolved over time from a conventional rip-rip to a bioengineered solution incorporating rock, large wood, and willows (Figure 16).

Figure 16: Bioengineered bank stabilization on the Mad River.

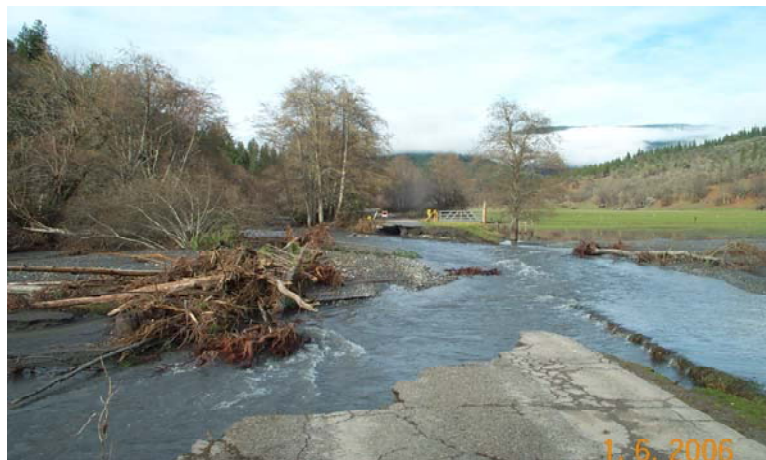
Bar Road is located adjacent to Horse Creek, a tributary to the Klamath River. During the winter storms of 2005-06, high water in Horse Creek uprooted trees that diverted creek flow directly at the road. As a result, approximately 390 feet of road was washed out (Figure 17).

Figure 17: Damage to Bar Road caused by flooding in Horse Creek, January 2006.

The county’s initial response was to place a temporary soil berm between the stream and the road to deflect flow. This did not succeed and the berm, consisting of loose soil and rock, was washed out by subsequent high flows. The county then installed a steel beam at the channel bank to deflect flow. This prevented further losses of the road and allowed the county to reconstruct the roadway in isolation from the active channel. That concluded the emergency work (Figure 18). To accomplish the permanent work, the county obtained a permit from the Corps and water quality certification from the Regional Water Board.

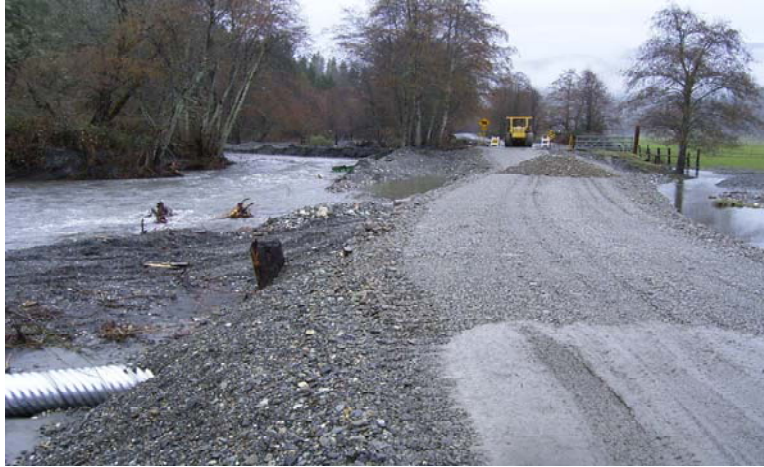
Figure 18: Bar Road at the completion of emergency road repair. Note the barren condition of the stream bank.

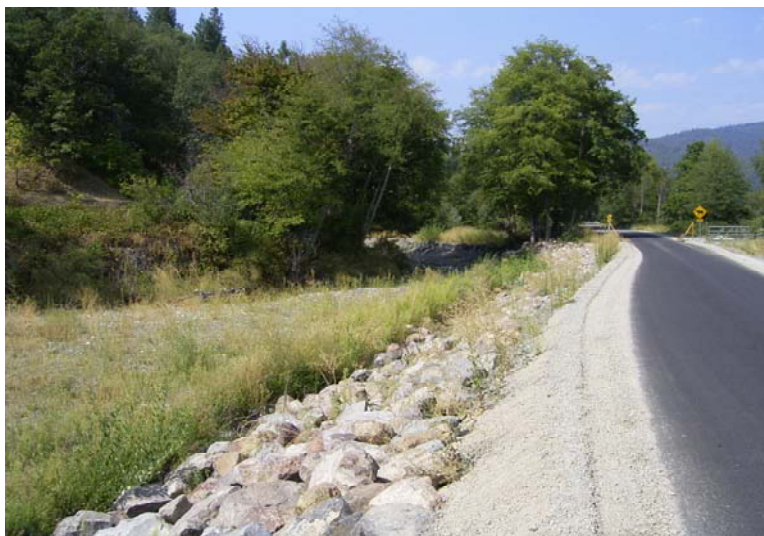
Figure 19: Rock slope protection and willow revegetation along Bar Road, one year after installation.

During August and September of 2006 the county took steps to permanently stabilize the road fill. It excavated a toe trench along the road in which willow cuttings, geotextile fabric and rock was placed. At the time of our field assessment, this stabilization was densely vegetated to the extent that the rock was not noticeable (Figure 19).

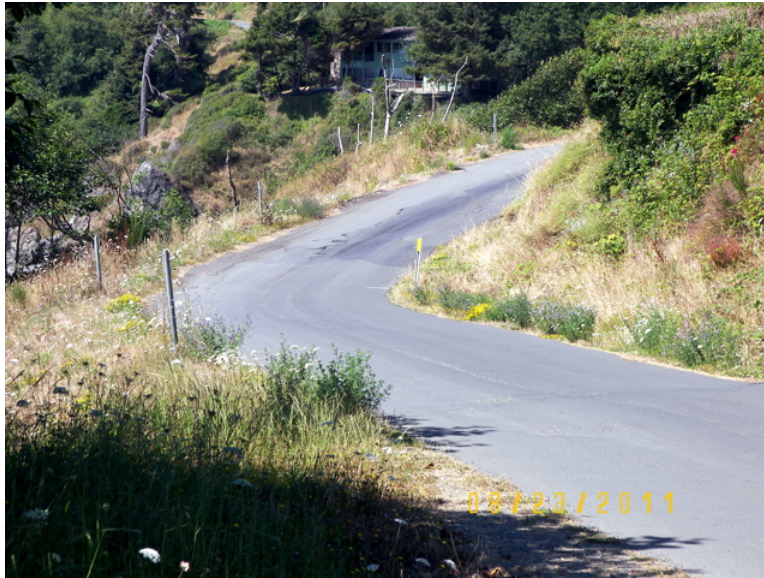
The project entailed grading, resurfacing the road, and installing a ditch relief culvert (Figure 20). Erosion control measures applied to the disturbed area included jute matting, hydroseeding, and straw wattles.

Figure 20: Section of Scenic Drive where failing road surface was repaired.

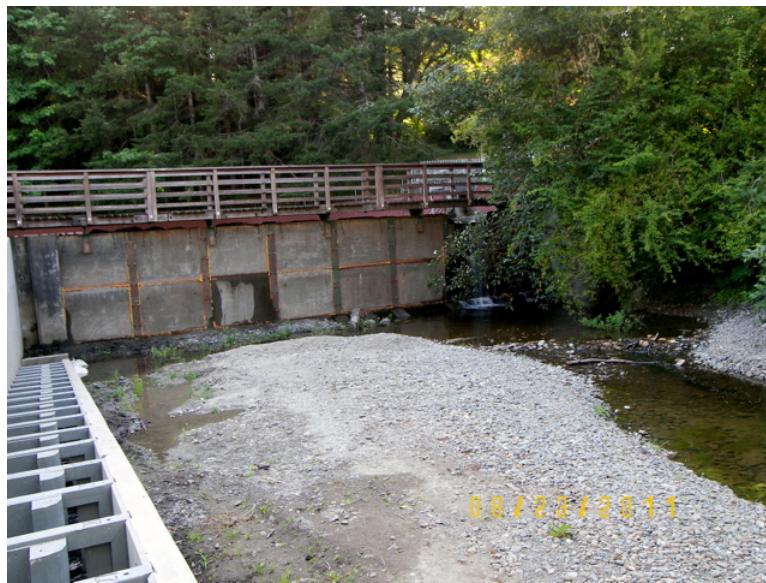
The Freshwater Creek fish ladder is on a dam that is installed seasonally to create a swimming hole. The dam is in a county park and has operated since 1922. In 2001, the county was required to provide for fish passage at the dam due to the federal listing of the coho salmon under the Endangered Species Act. A temporary fish ladder was installed in 2002. The permanent concrete ladder was installed in 2009 (Figure 21).

Figure 21: Seasonal dam on Freshwater Creek. The entire structure is installed every year in June and removed in late August. The fish ladder is on the left of the picture. The side channel connecting the ladder to the main channel is at the base of the dam.

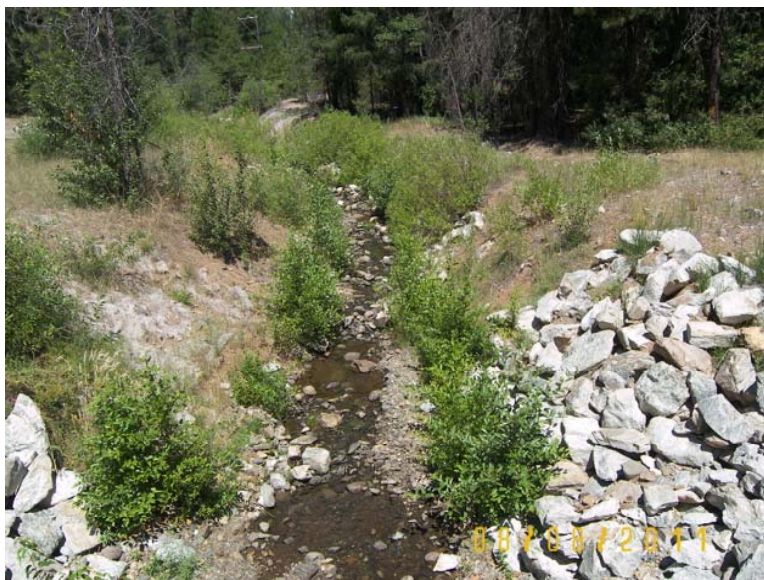
The deficient culverts were replaced with a cast in place concrete bridge on pile footings. An engineered "roughened" channel was installed upstream and downstream from the new bridge to facilitate fish passage at all flows. Stream bank stabilization was accomplished using bioengineering techniques. Post-project monitoring is underway and includes out-migrant fish trapping, photo-points, redd surveys, and channel surveys with longitudinal profiles (Figure 22). Salmonids have been observed upstream of the project site.

Figure 22: The channel upstream from the Little Brown's Creek bridge was engineered to promote fish passage and provide habitat structures. Banks were stabilized with rock and riparian plantings.

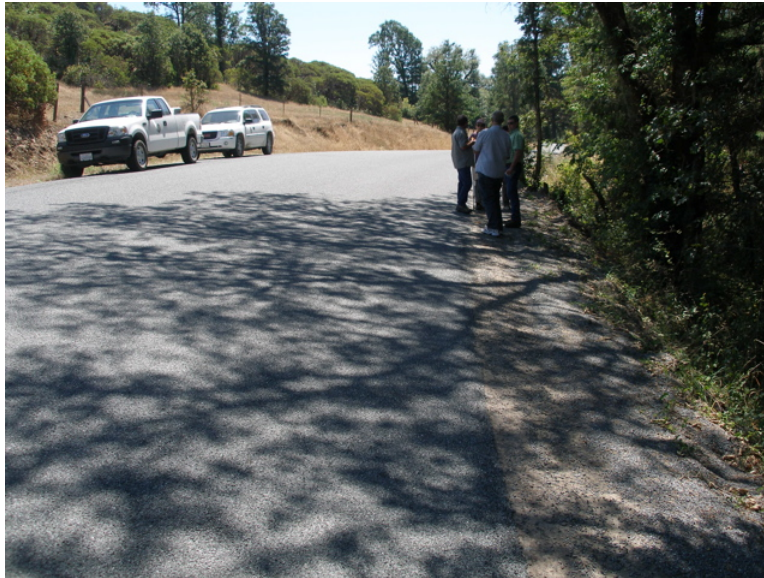
In Mendocino County we evaluated two projects that involved chip sealing to reduce road surface erosion and outsloping to reduce hydrologic impacts (Figure 23). The coupling of these two practices represents something that was not observed in the 1998 assessment.

Figure 23: Chip sealing and outsloping on the Tomki Road, Mendocino County.

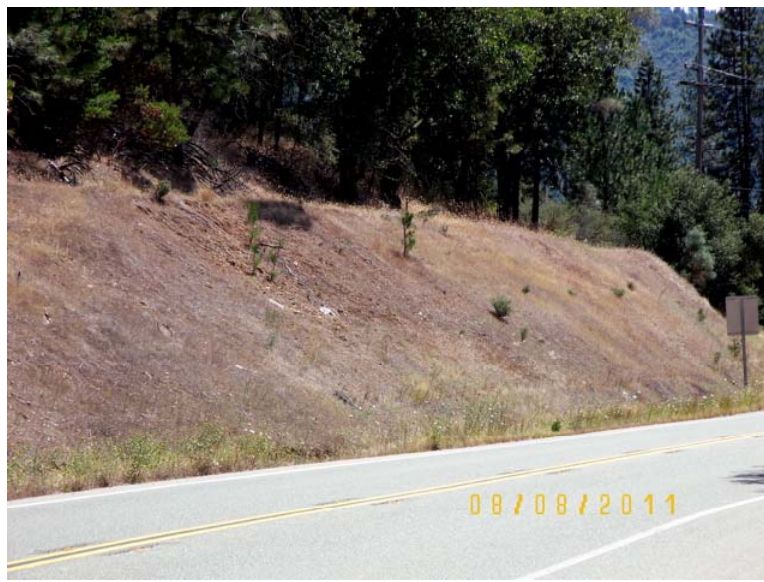
Our observations at Rush Creek disclosed a few problems. Cut slopes were not adequately revegetated and were eroding, delivering sediment to the drainage ditch (Figure 24). Also, spoils had been improperly disposed of in a site that was near an ephemeral stream. These spoils had the potential for entering the watercourse. In the latter case, the county had been advised of the infraction. As a result, the county no longer leaves disposal of spoils to the contractor's discretion.

Figure 24: Cut slopes along the Rush Creek Road widening project were not fully revegetated after construction and were eroding, delivering sediment to the roadside ditch.

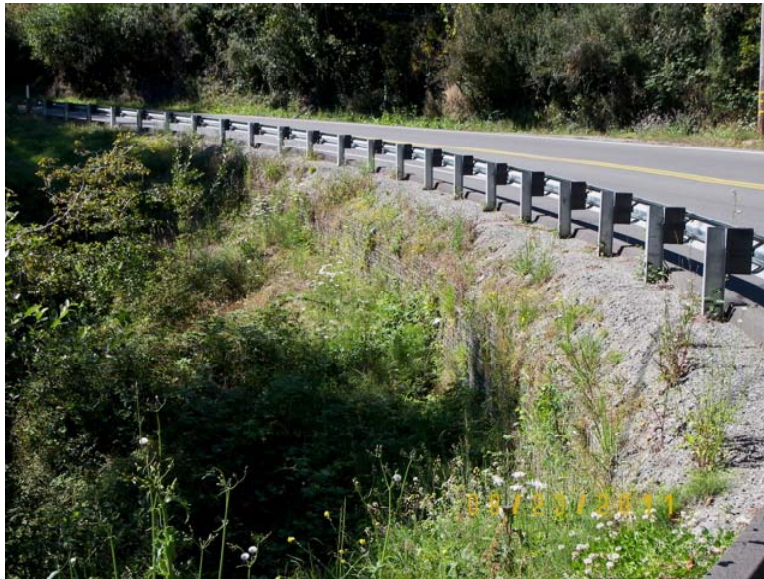
The widening of Scenic Drive in Trinidad, Humboldt County required a permit from the Coastal Commission that stipulated implementation of erosion control measures and revegetation after project completion. The project was about three quarters of a mile long. No anadromous fish stream was nearby and no new stream crossings were installed. Widening and straightening the road required cutting into the uphill slope. A gabion wall was installed at an existing stream crossing to enhance downhill slope stability (Figure 25). Additional features included placing a drainage ditch into a pipe to reduce plugging by sediment, armoring the ditch outfall, and placing rock into a stream to prevent incision. The project required fairly extensive grading that was done during the dry season to minimize the potential for erosion, but there were some short-term impacts.

Figure 25: This gabion wall was installed at stream crossing on Scenic Drive to reduce likelihood of slope failure.

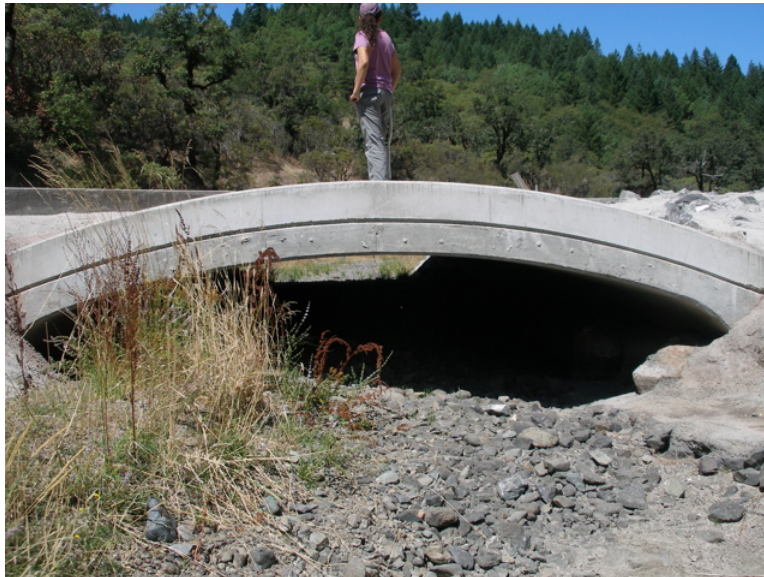
“Construction involved excavation for two strip footings located at the approximate limits of the bankfull channel and set below the anticipated scour depth. Once footings cured, the structure components were lowered into place with a crane. Once set, water proofed and grouted, the structure was backfilled with material from footing excavation and import material to the desired finished road grade. The structure embankments and roadway was encapsulated with concrete to prevent erosion during high flow events. The stream channel within the immediate area that was severely impacted by vehicular traffic was reconfigured so as to conform to the anticipated stable channel grade and bankfull dimensions. Upstream and down stream segments were revegetated to help improve stream habitat conditions and provide for bank stability. The existing road alignment was slightly realigned for approximately 200 feet in order to reduce skew for hydraulic considerations, allow for an elevated road elevation for structural and hydraulic considerations, and meet minimum road width and turning radii requirements. No site dewatering and sensitive species relocation was needed because the stream was dry prior to initiation of construction.” (Figure 26)

Figure 26: Tomki Road vented ford. The bottomless arch is surrounded by concrete to prevent undermining and erosion.

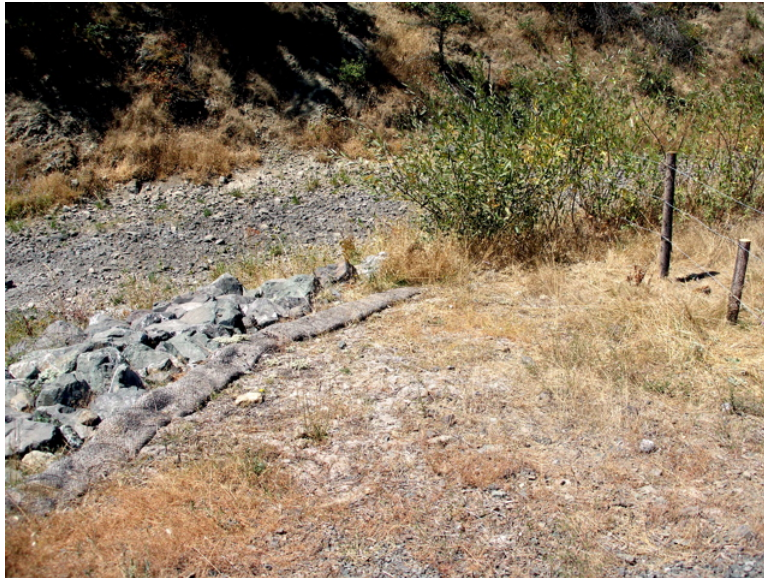
Installation of the structure was subject to numerous conditions to minimize impacts on stream habitat and construction-related erosion and sedimentation. Avoiding de-watering and species relocation was beneficial and negated the potential for incidental take. A riparian revegetation plan was prepared based on a biological assessment. It included installation of an underground irrigation system, a pilot effort that may be used in the future. Treatments included brush layer bank protection, rock slope protection, and planting willow cuttings (Figure 27). Post-project monitoring was required.

Figure 27: Streambank stabilization and riparian planting at the Tomki Road vented ford.

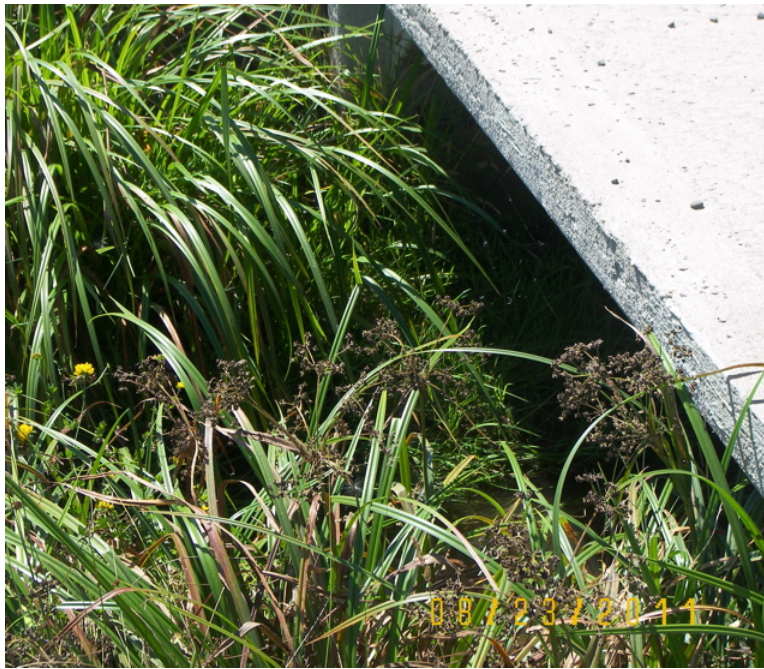
The project was a collaboration of the county, a neighboring landowner, and a timber company that uses the road for hauling. Planning and permitting the project required formal consultation with NMFS pursuant to the Corps 404 permit, a Streambed Alteration Agreement from DFG, and a 401 water quality certification. The stream was assumed to support coho salmon and other anadromous fish. Permit conditions applied to fish relocation, diversion of flow around the construction site, and exclusion of fish from the site during construction. NMFS required extensive provisions for minimizing incidental take during relocation including documentation of all relocated fish. Provisions for controlling sedimentation were also specified and implemented. NMFS requested that the new facility be capable of passing a 100-year flow but this was not feasible because of the elevation of the channel relative to the road (i.e., there was not enough room for a box culvert larger than the one installed) (Figure 28).

Figure 28: The entrance to the Crannell Road box culvert. Although the streambed was disturbed during removal of the old culvert and installation of the new one, it had completely revegetated naturally.

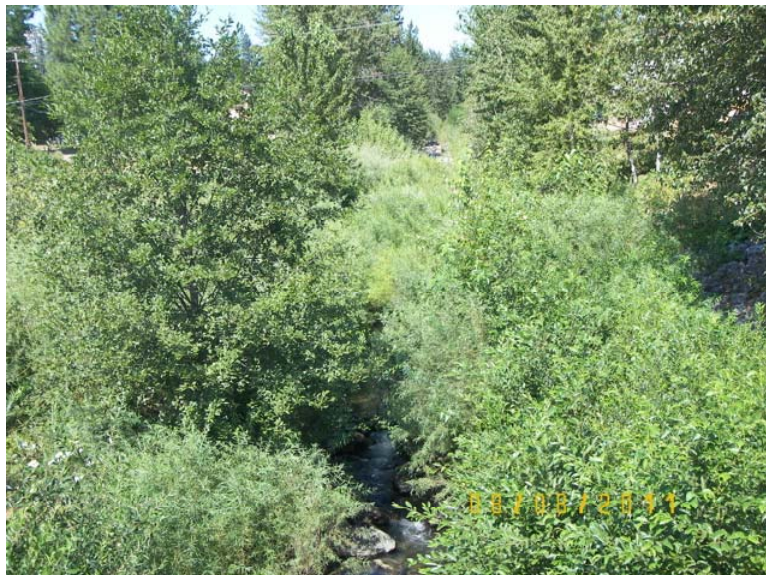
Trinity County is responsible for maintaining the levees and flood control channel along East Weaver Creek in downtown Weaverville. This project was initially installed in 1965 under the auspices of the Corps of Engineers and remains within its system. In recognition of the value of the stream to anadromous salmonids, the county negotiated an agreement with DFG on channel maintenance. The essential elements of the agreement are that the county would retain mature riparian vegetation and do vegetation management on alternating 100-foot sections of the levee banks and channel. As a result of these practices, the stream has a dense and vigorous riparian corridor in some segments (Figure 29).

Figure 29: Riparian vegetation on East Weaver Creek in the vicinity of downtown Weaverville.
