Northwest California
Resource Conservation & Development Council, Inc.

Five Counties Salmonid Conservation Program (5C)

E- NEWSLETTER

Volume 6, July 2011

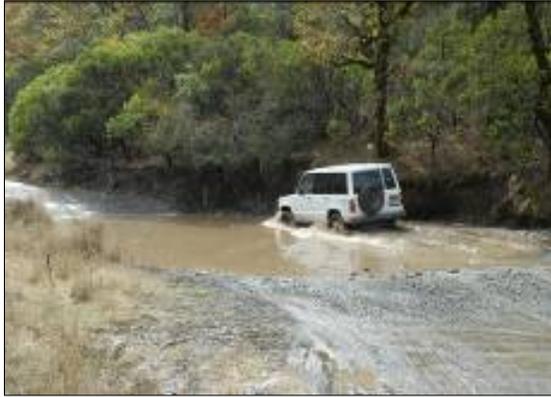
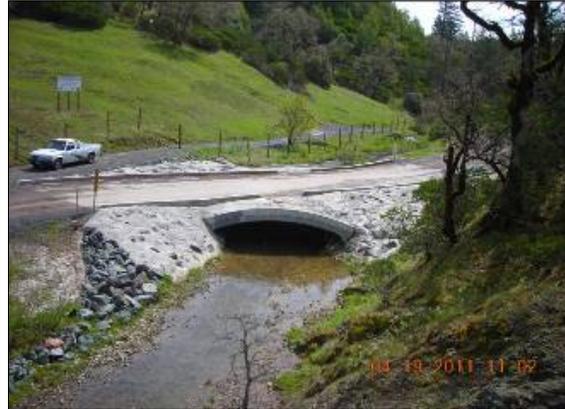
This low water crossing (left) was replaced with an arch culvert that can be safely overtopped in large floods (right). There are 8 more crossings that need to be addressed on this road.

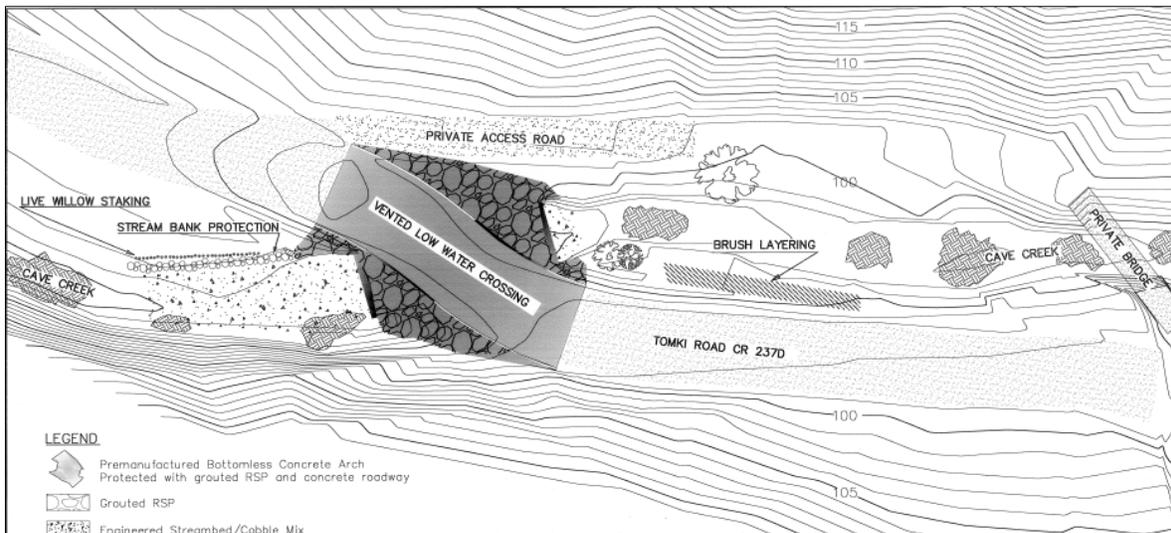
Below, the overview plan for this project shows the unique and complicated features addressed – including a skewed road, a vented arch, and the placement of willow streambank stabilization.

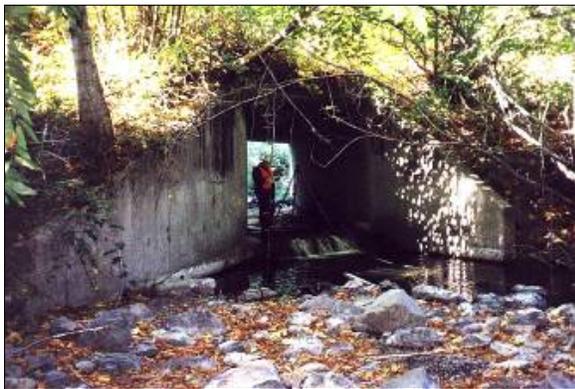
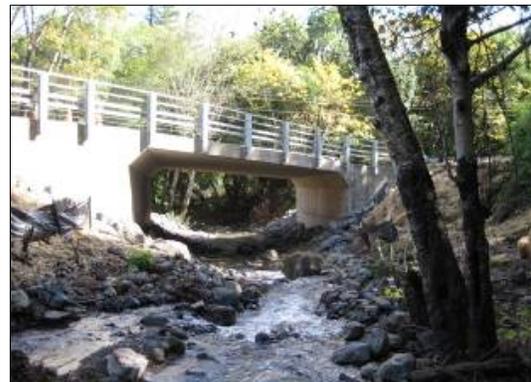
Below, the 10-ft wide x 10-ft high concrete box culvert with a 1-2 ft vertical drop at the outlet compared with the new bridge installed in fall of 2010.

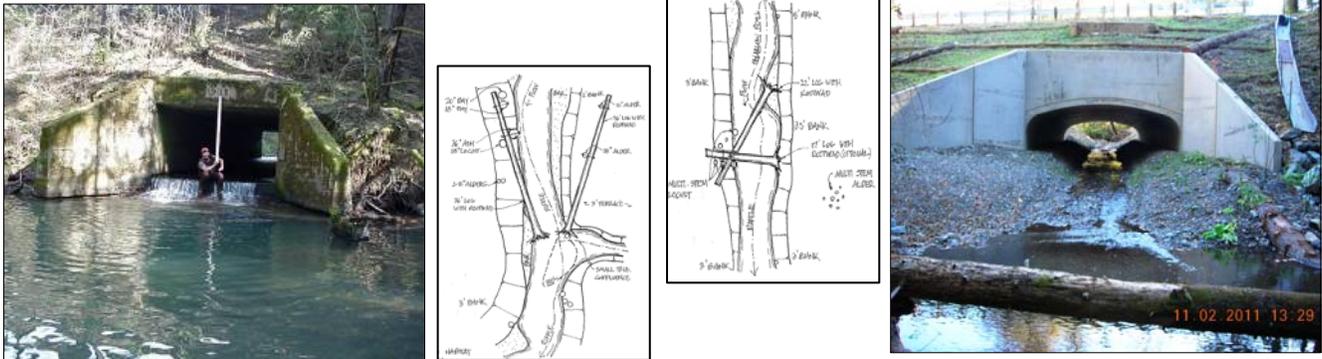
Large woody debris (LWD) removed from the fill over the box culvert will be relocated upstream and downstream to create numerous small pools and provide cover for fish

Below Right: crossing over Ryan Creek. **Middle and left:** examples of design plans for LWD placement

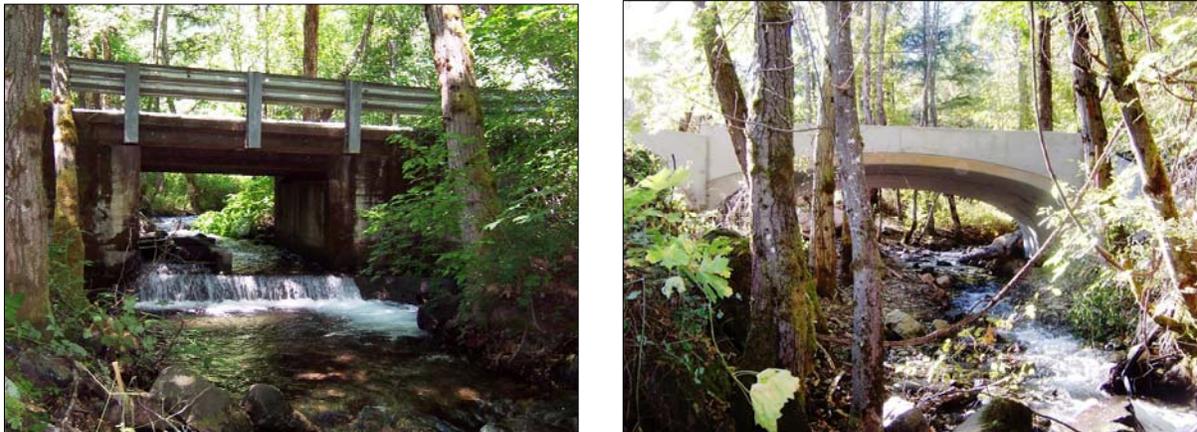
An existing box culvert with a jump at the outlet and high velocity flows was replaced with a bridge to accommodate 100-year flows and fish migration. The upper 41% of the watershed burned in a 2008 fire. An upstream partial barrier will be removed in 2012.

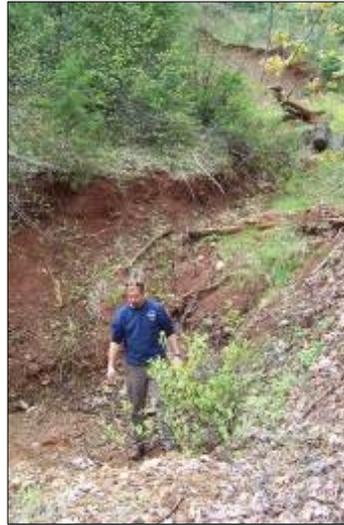
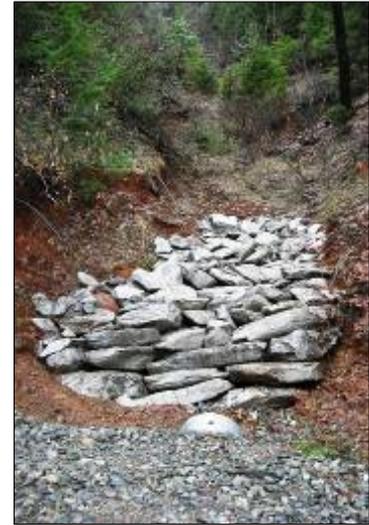
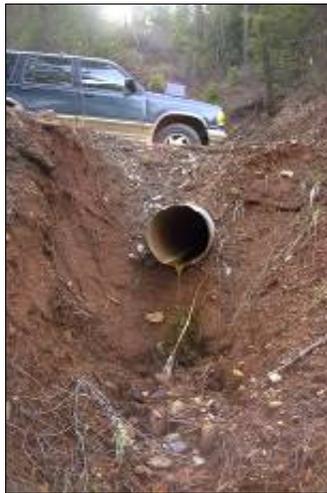
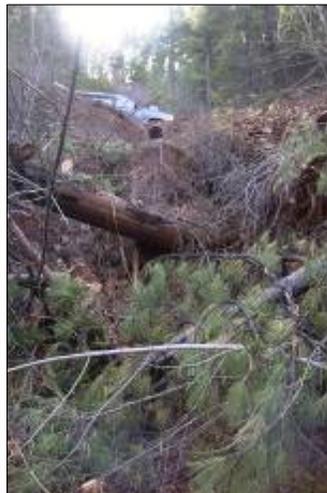
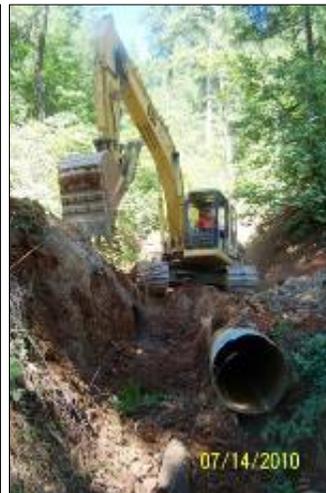
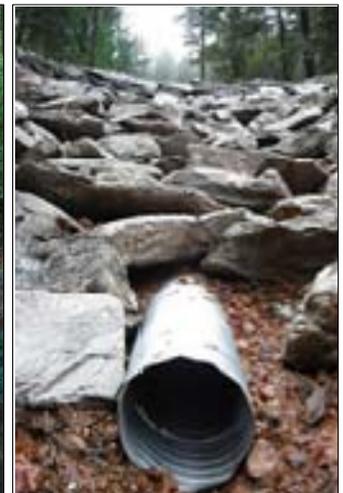
Ten road erosion sites within a 1-mile stretch of China Gulch Road in Trinity County were addressed during 2010. The picture to the immediate right shows an upslope, partially-gutted debris slide and culvert inlet before project implementation. Large rock slope protection (RSP) was installed upstream of the stream crossing. A larger culvert was placed at the crossing and a critical dip was installed across the road (far right). Final grading and rocking are pending.

At the China Gulch Road crossing, a shallow, undersized 30' x 18" culvert with outlet scour created a plunge site (left). Buried wood in the outboard fill as well as accumulated surface wood (center-left) created additional problems. Excavating removed the old culvert, woody debris and fill (center right). Installed 60' x 24" culvert set near channel gradient (~14' below road grade) with critical dip and RSP installed (right).

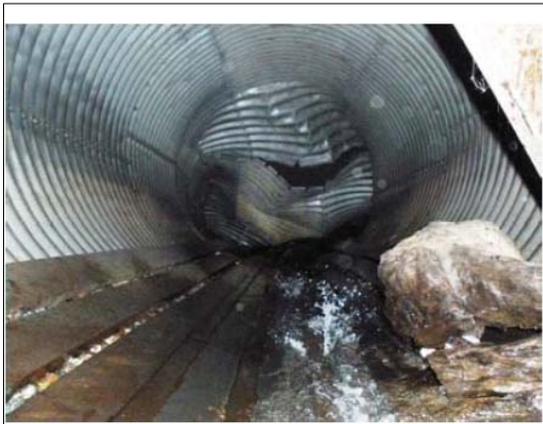
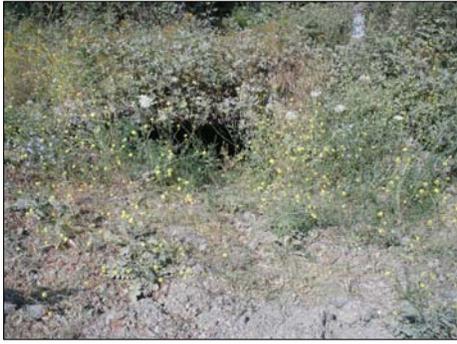
In July 2009, a similar situation was discovered on Cappell Road, crossing Rube Creek (Klamath River), when investigation of road failures revealed that an eight-foot-diameter, 220-foot-long, steel multi-plate culvert had partially collapsed under 60 feet of road prism. It is likely that a tree entering the culvert tore a portion of the middle of the culvert away and saturated fill material washed out. Rather than a temporary repair that would necessitate future ground disturbance, the decision was made for a permanent replacement using County road funds.

Left: Shows a 6-ft-diameter sinkhole on the road shoulder due to high flows coming up through the failed section of culvert. The sinkhole is located ~ 10 feet from the edge of the slipout (**right**).

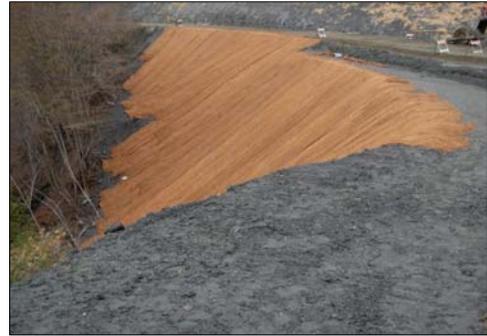
Right: Shows coconut fiber geotextile matting installed on downslope. Upslope side contains straw wattles and mulch.

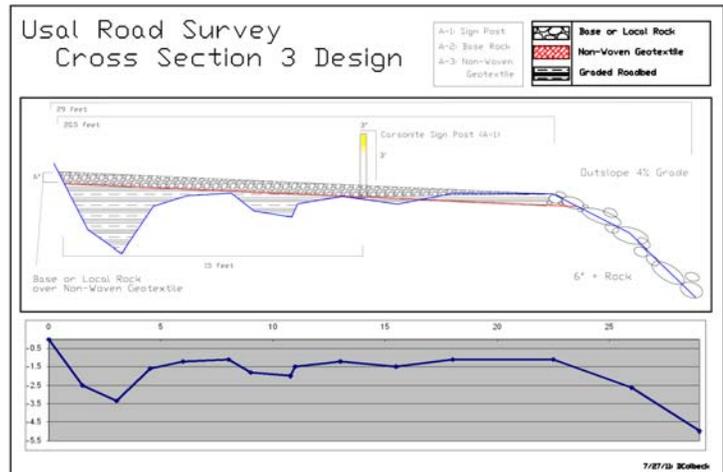
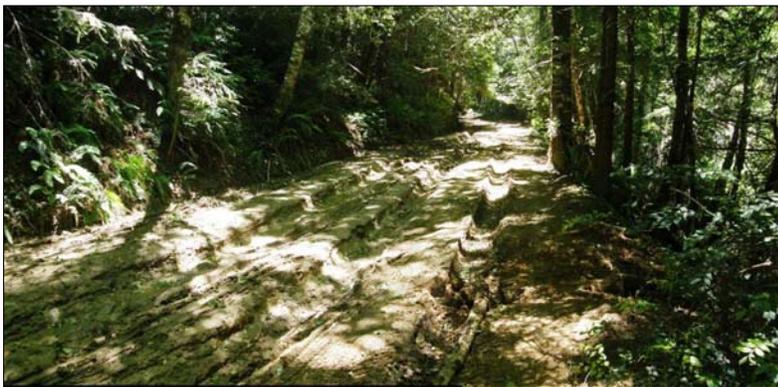
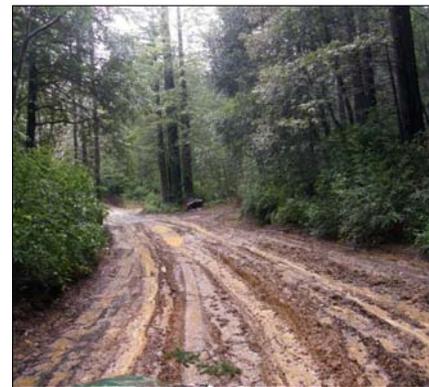
Left: A cross-section of Usal Road in Waterfall Gulch, a tributary to Usal Creek.

Above: The same general area as the cross section surveyed.

The Usal Road project represents a unique opportunity to experiment with geo-textile fabric and varying depths of base rock in combination with road drainage and woody material treatments. The cost and effectiveness of various treatments will be studied and results presented in a paper. If proven effective, additional Road BMP's may be developed.

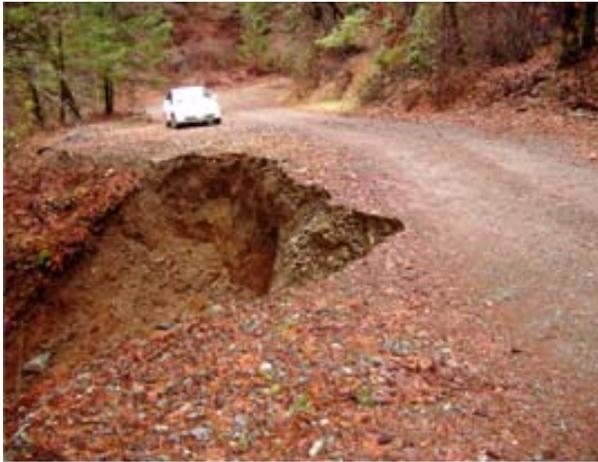
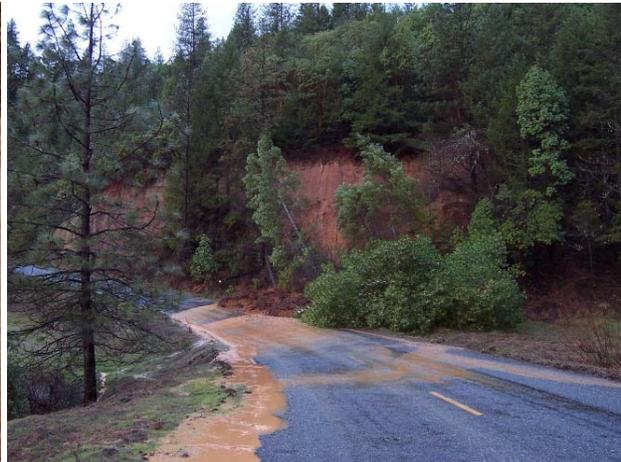
Two proposed treatment sites on Dutch Creek are related to fill failures (left) and slides (right). This project will include upgrading existing culverts and installing additional ones to dewater ditch segments at the base of active slides. Upslope of portions of the project area were burned in 2008.

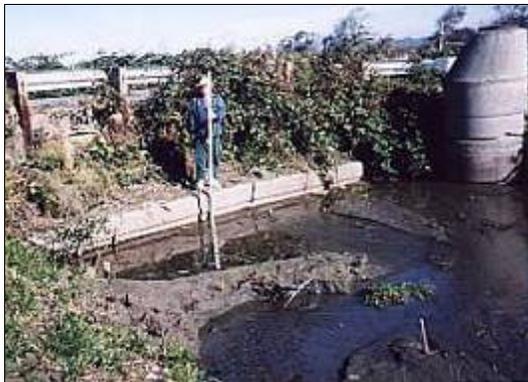
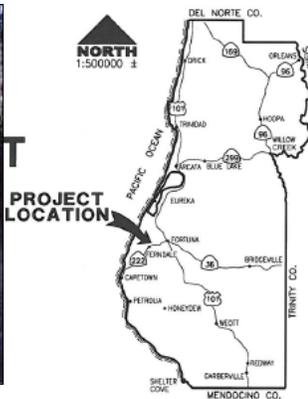
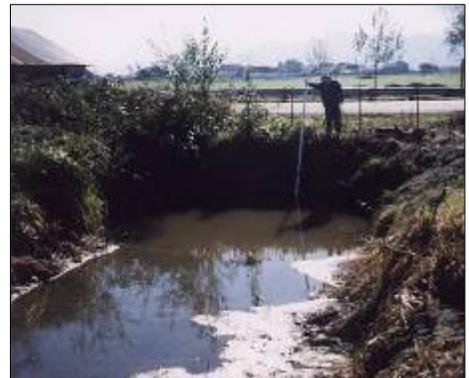
While the culvert at this crossing site seems adequate, it will be replaced. Due to extreme amount of sediment in the culvert, backlogging and overflowing are common occurrences. Note water level in photo taken in October prior to winter rains.

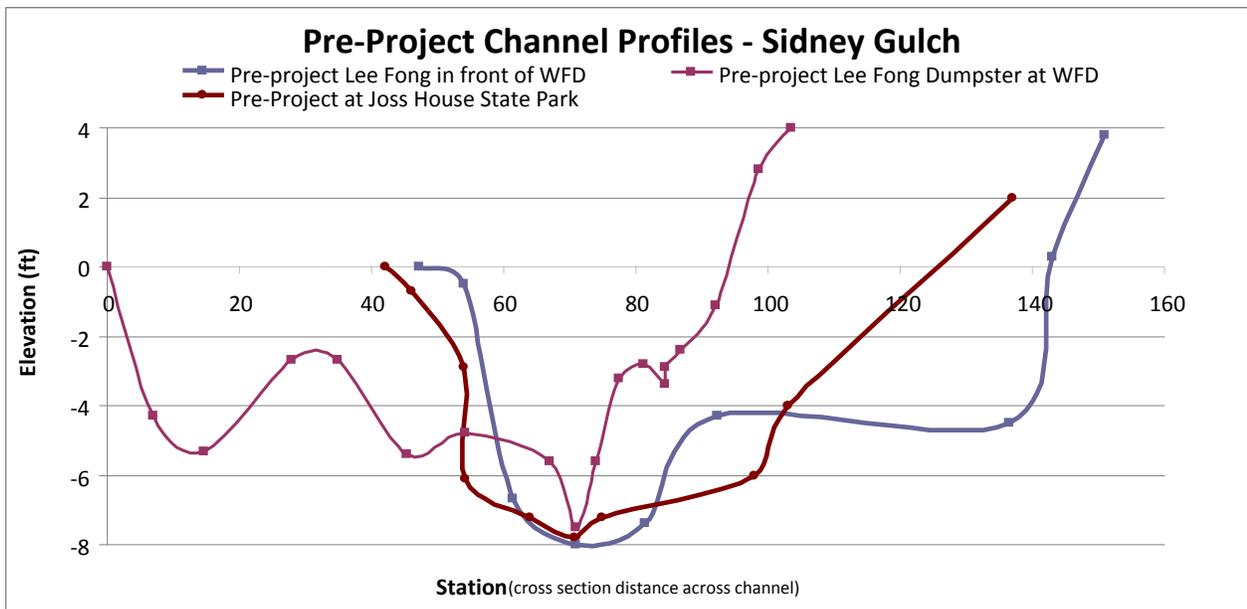
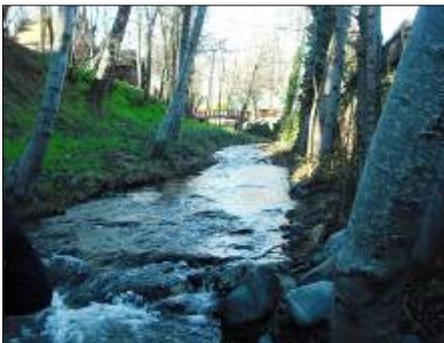
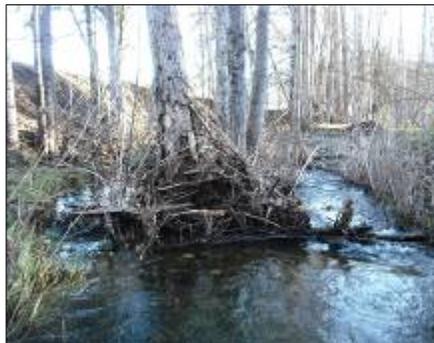
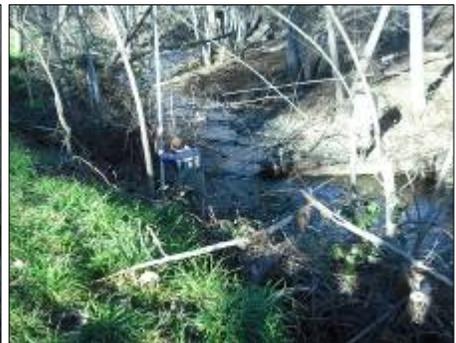
A habitat improvement project for Sidney Gulch (Trinity County) is in the planning stages. Sidney Gulch, a tributary to Weaver Creek, is identified as a priority watershed for coho recovery under the CA Coho Recovery Strategy because of year-over-year Coho populations. Sidney Gulch is an integral part of the Weaver Creek fish population matrix. There is potential to increase channel and habitat complexity to support larger populations of Coho, steelhead, and other aquatic species as well as increasing the stream's carrying capacity. As planning continues, channel profiles help assess the current state and extent of potential restoration in the Gulch (below).

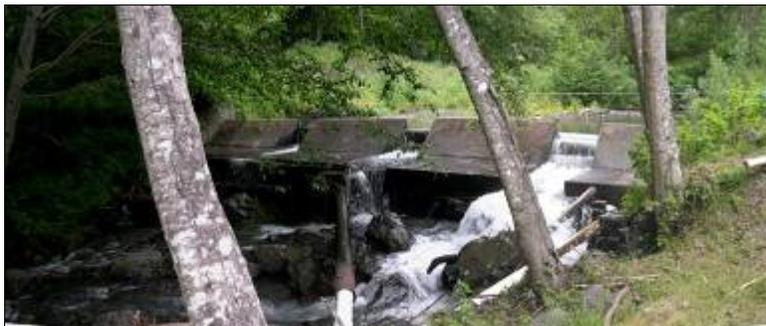
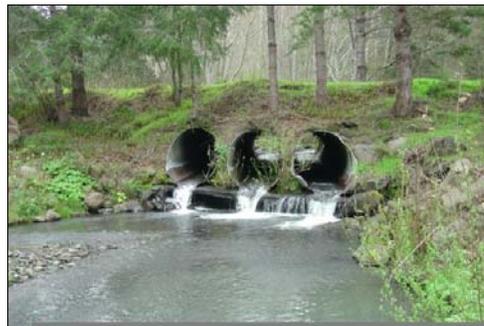
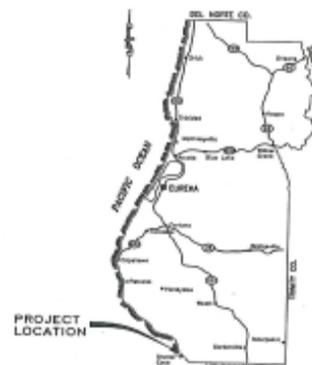
A concrete dam located approximately 1.1 miles upstream from the Pacific Ocean represents a partial barrier to adult fish during winter flows up to 30 cubic feet per second (cfs) and a total barrier to fish passage during the dry season due to low flows of 1.0 cfs. The dam has been in place for over 40 years and is used as part of a water treatment plant intake that provides the community of Shelter Cove with 99% of its potable water supply. The project goal is removal of the dam and triple culvert on Telegraph Creek to re-establish fish passage and open an additional 4,900 feet of stream habitat for adult and juvenile salmonids. Full removal of the dam is contingent upon the District securing an alternative water supply.

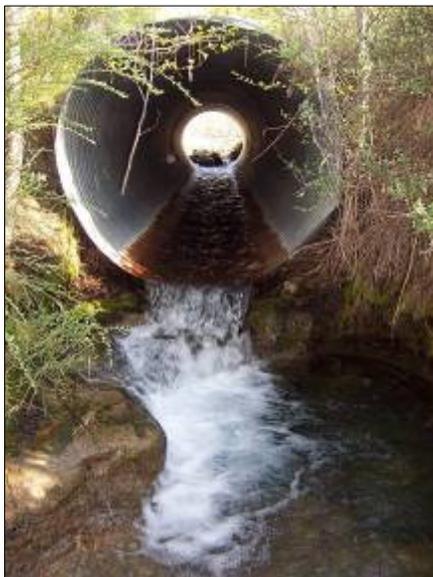
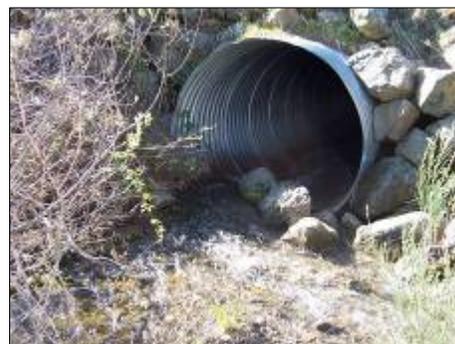
The existing structure is a circular corrugated metal pipe 7-foot diameter and 60-feet long set at 4.91%. The culvert is undersized for 100-year flows and estimated to overtop

aggrading. They subsequently determined that the culvert did not have to be embedded, assuming that it would embed itself naturally. This determination proved to be wrong and the outlet of the culvert remains above grade and has downcut significantly. This new project would improve fish passage and reduce sediment/bedload transport at the stream crossing by replacing one undersized culvert structure with a larger box culvert.

Above left – outlet jump into culvert. **Above Right** – inlet to culvert showing rock movement through the excessive gradient culvert

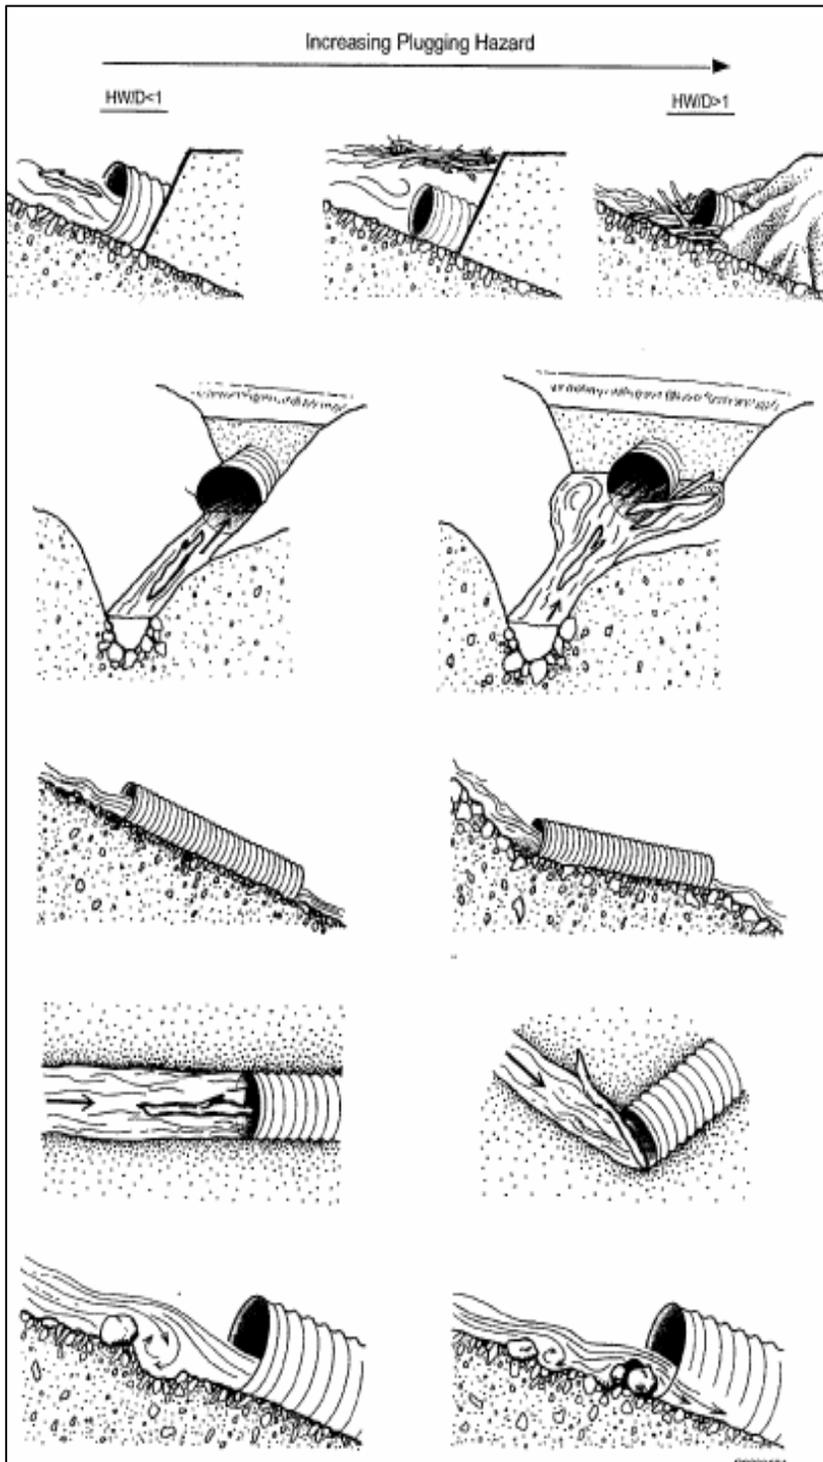
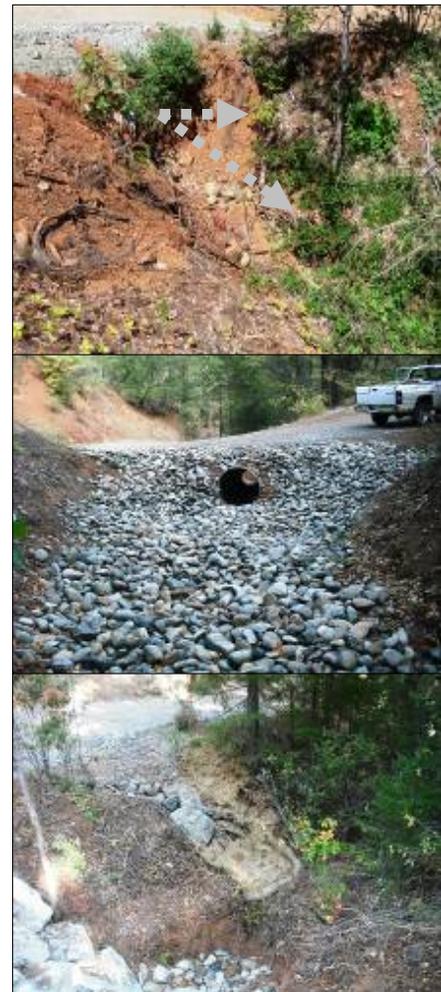
On China Gulch Road in Trinity County, (below right; solid white line in photo) misaligned and undersized culvert erodes bank and road and has high diversion potential down the road. Natural channel alignment is shown as dashed white line. A larger, properly aligned culvert with inlet rock apron erosion control and energy dissipater was installed (middle photo). An offset critical dip, energy dissipater, and erosion control (seed, mulch, and fiber roll) were installed as well.

CHAPTER 4. Culvert Improvement and Repair, BMP 4-B-2: *“Align culverts and other structures with the stream, with no abrupt changes in flow direction upstream or downstream of the crossing. This can often be accommodated by changes in road alignment or slight elongation of the culvert.”*

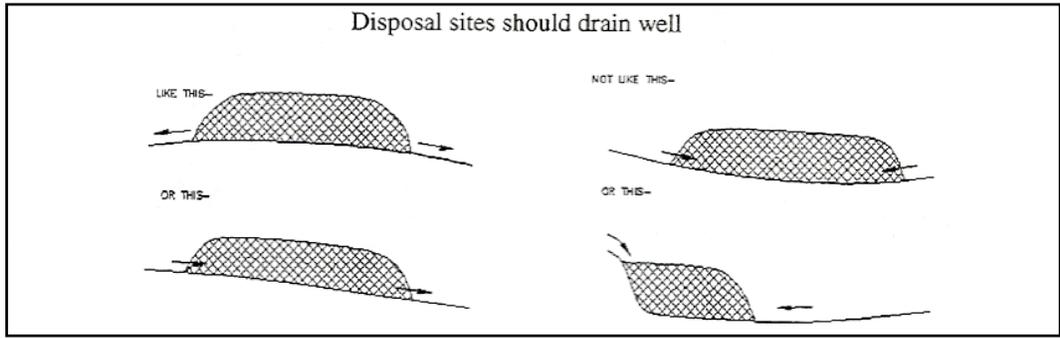
Source:
Choctawhatchee,
Pea & Yellow Rivers
Watershed
Management
Authority (2000)

CHAPTER 5, Stockpile Maintenance 5-B-1: *Stockpiled materials at approved disposal sites, even those stored for a short time, need to be maintained. Some sites, particularly of clean fill material such as gravel and crushed rock, may need only short-term maintenance as the spoil is usually reused for other projects. All stockpile sites need to be “storm-proofed” to prevent slumping or erosion of stored material into the stream system.*

Temporary disposal sites, or stockpiles, are useful when materials can be reused for other County maintenance or construction activities. Proper management of stockpiles on site eliminates or minimizes the discharge of pollutants to the storm water drainage system and watercourses. Temporary stockpiling of certain spoil, such as asphalt or fine-grained sediments, may necessitate stringent drainage-related controls during the wet season.

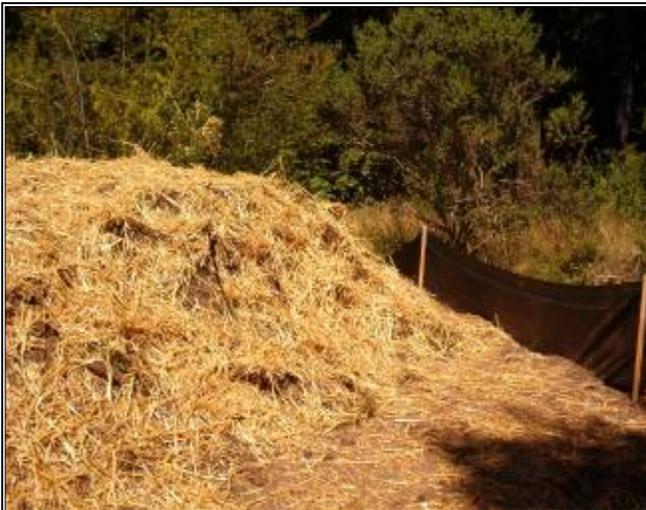
Stockpile - erosion and sediment control BMPs – straw and sediment fence protection from erosion.

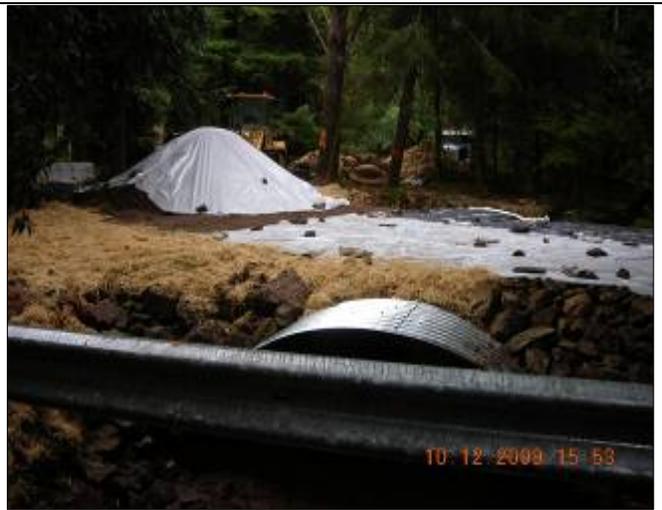
Ancestor Creek Migration Barrier Removal Project- Erosion and Sediment Control BMPs in response to forecast rain.
