TRINITY COUNTY

Final Project Report

Big Creek Road Sediment Reduction Project, 03-DG-11051400-053

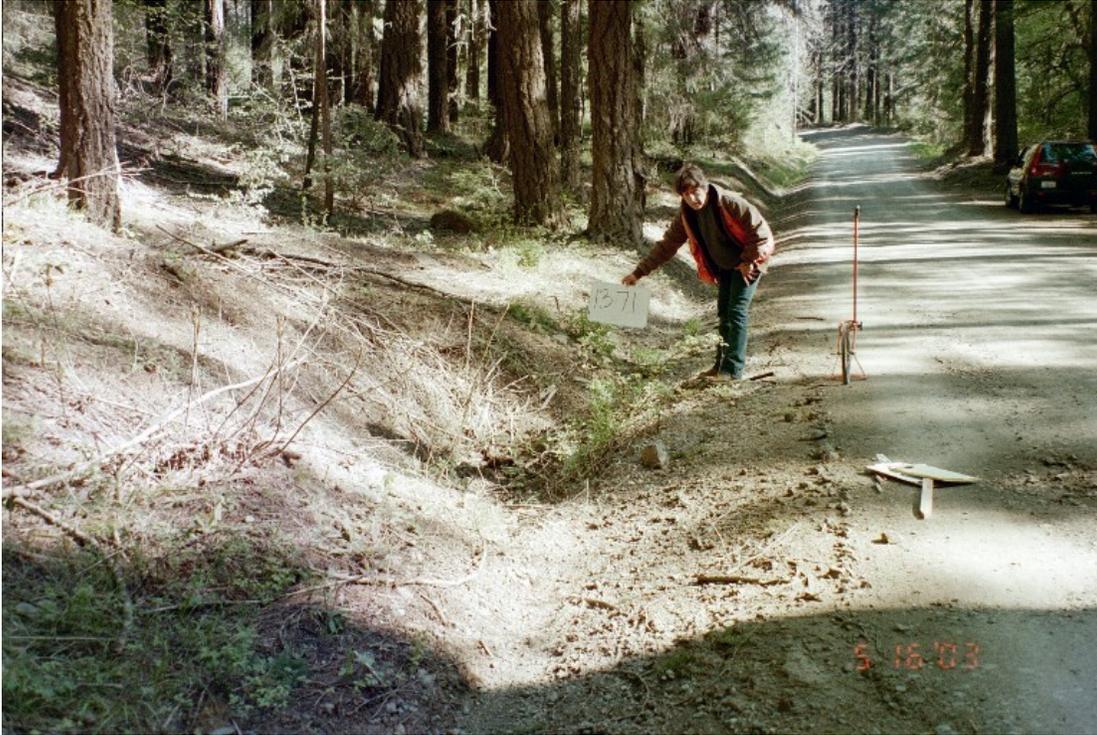
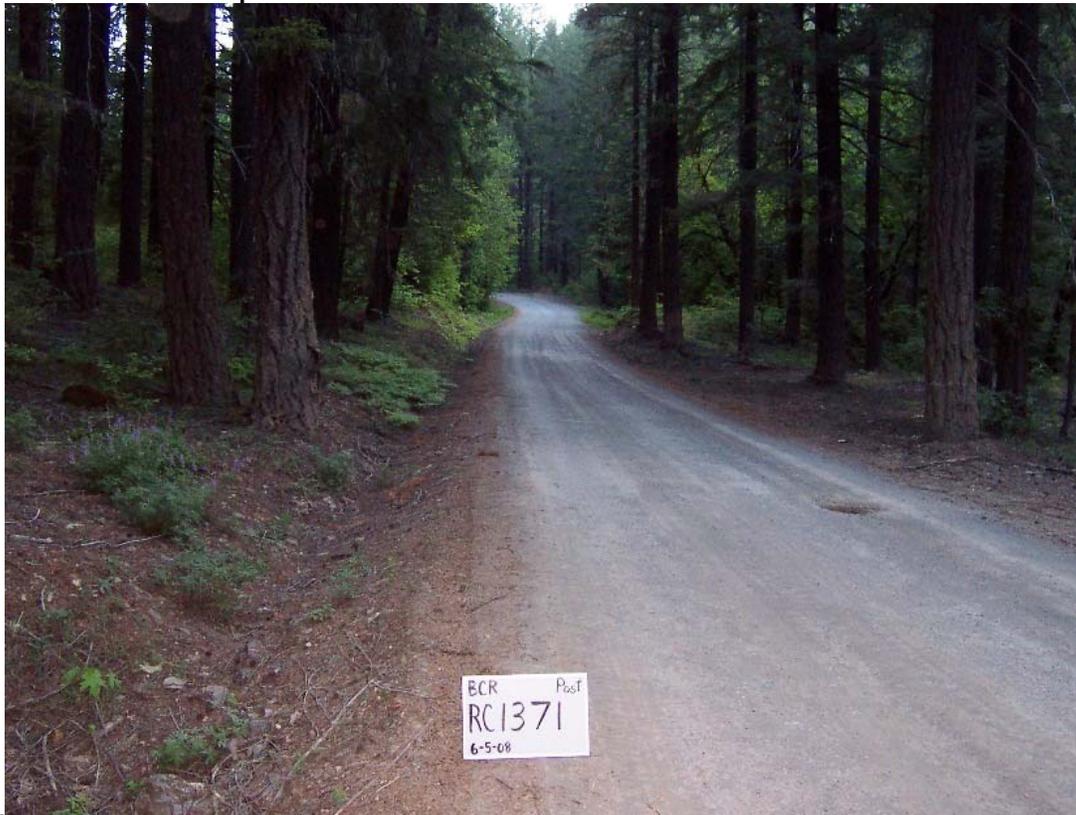
Photo1 (above). Site 1371 Showing in-sloped road draining to ditch and culvert. Photo 2 (below). Post treatment, road is outsloped to distribute road runoff into forest litter rather than into the ditch.

- Out-sloped 9,932' of road, including segments where the ditch was retained in order to dewater slopes and retain the integrity of road base (Photos 1-6);

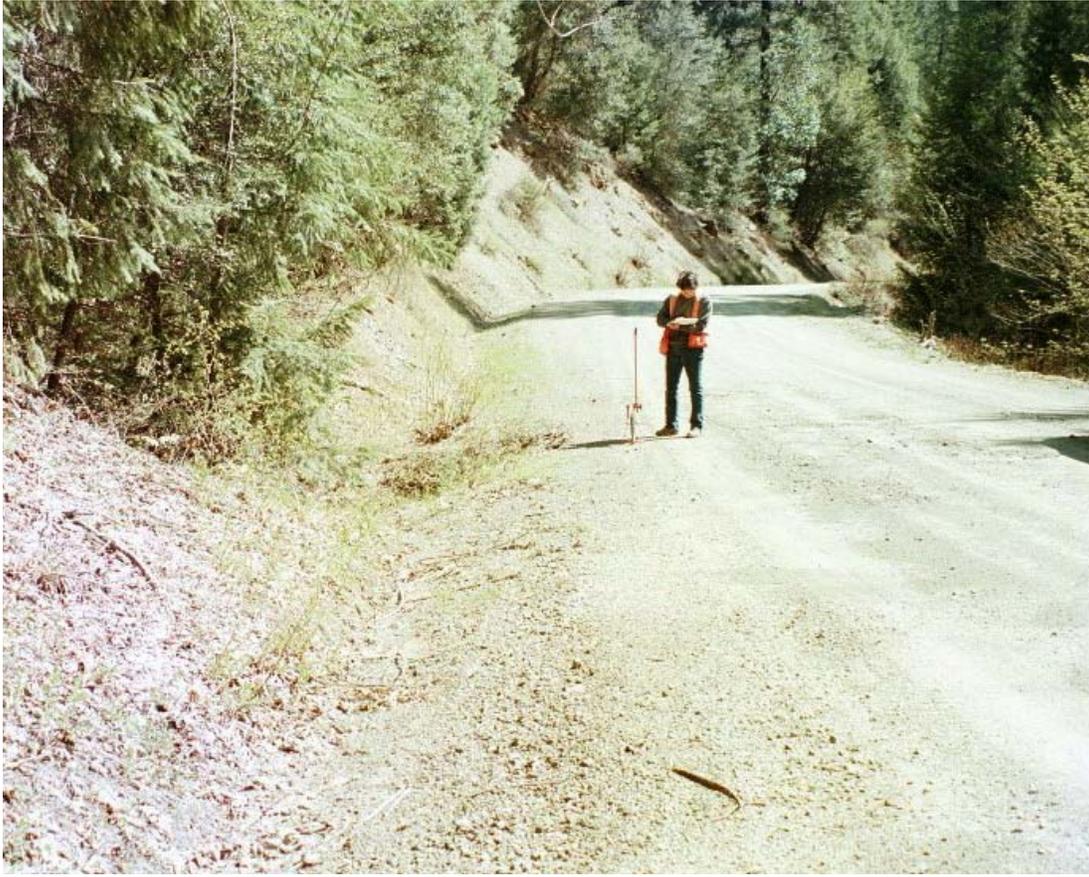
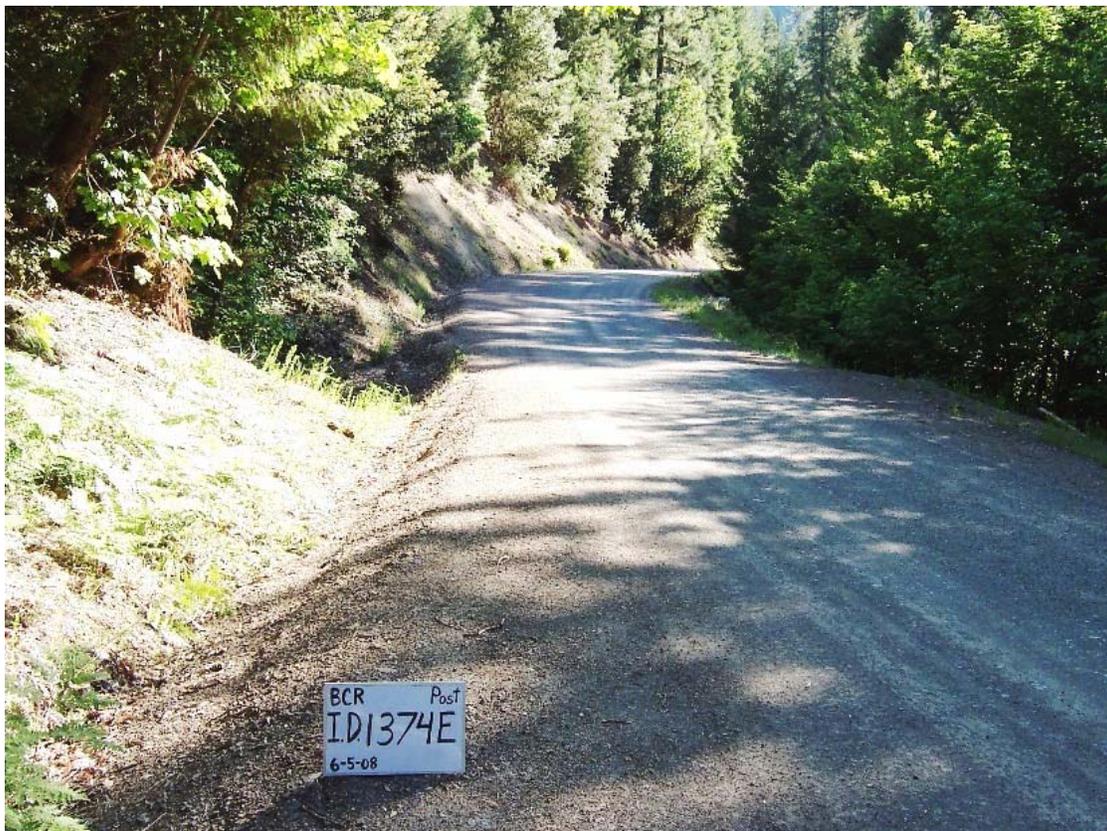
Photo 3 (above). Site 1374 (before project), showing segment of in-sloped road that was outsloped with retention of the ditch segment (Photo 4, below).

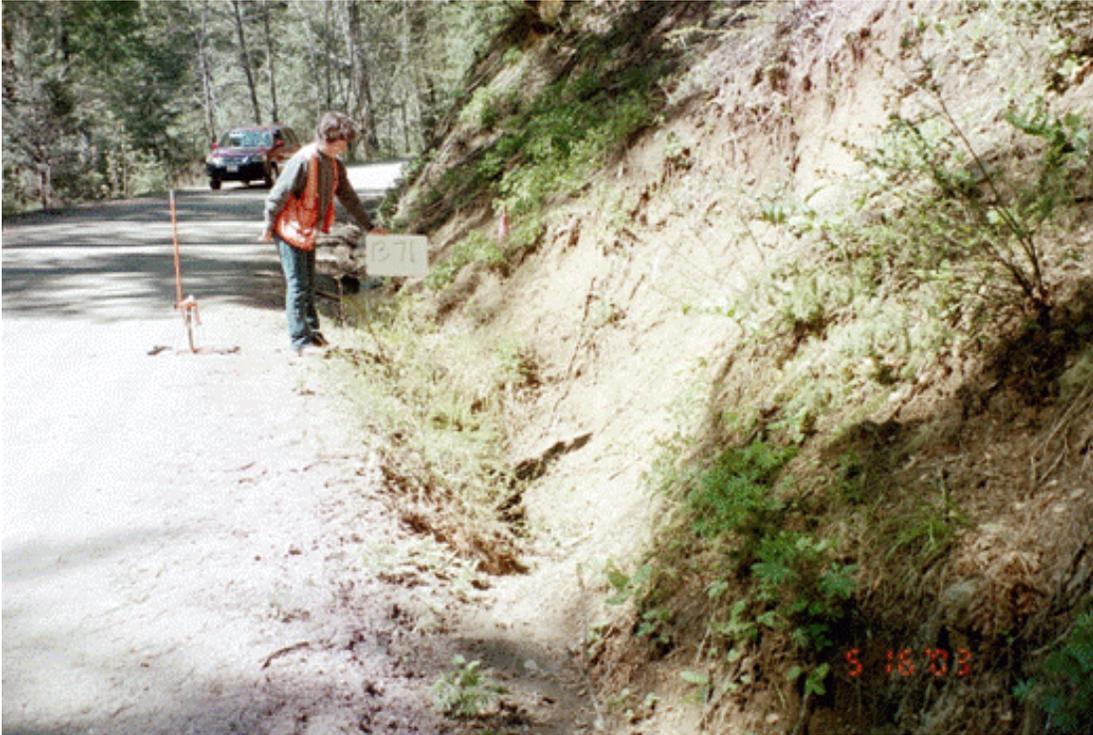
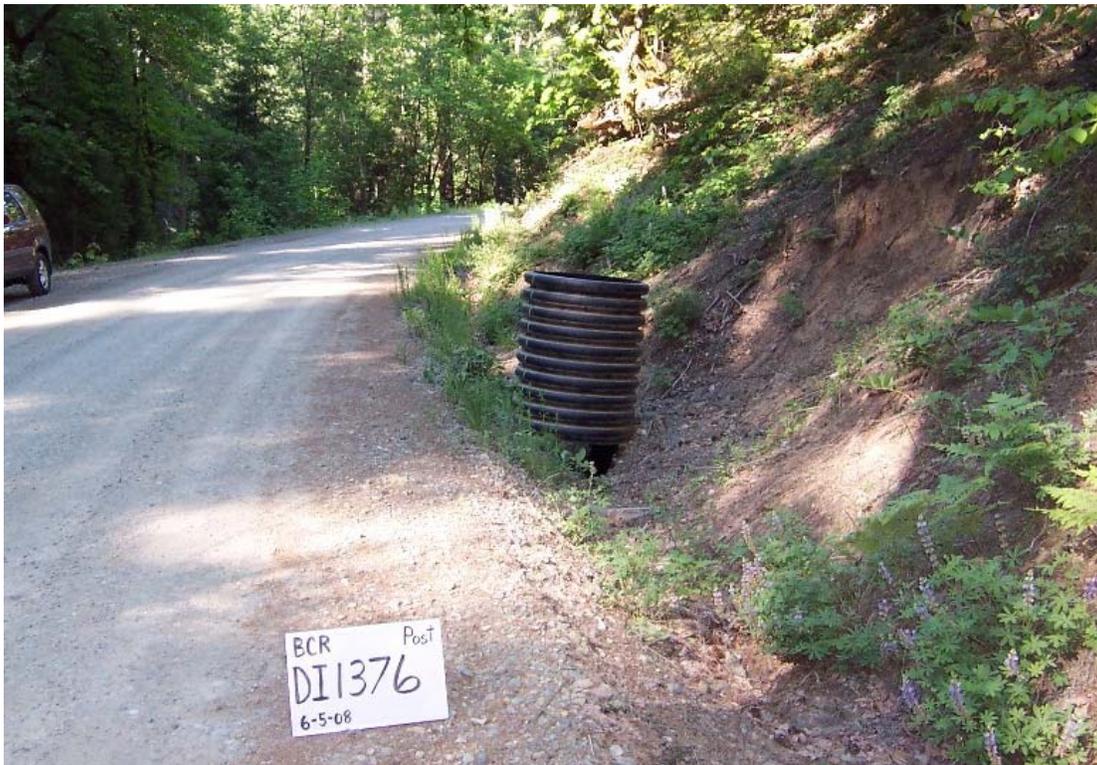
Photo 5 (above). Site 1376 consisted of 880' of ditch system delivering from both directions to an 18" ditch relief culvert (above). This culvert had a "shot gun" outlet. Photo 6 (below). The site treatment included installation of a drop inlet on the culvert to prevent plugging from cutbank sluff, outsloping the road, cutting the shot gun culvert and installing rock armor outlet.

- Rock armored four culvert outlets;
- Installed 1 36" culvert drop inlet (Photo 5-8);
- Cleaned 2 culverts;
- Installed 5 18" diameter ditch relief culverts (Photos 9 and 10);

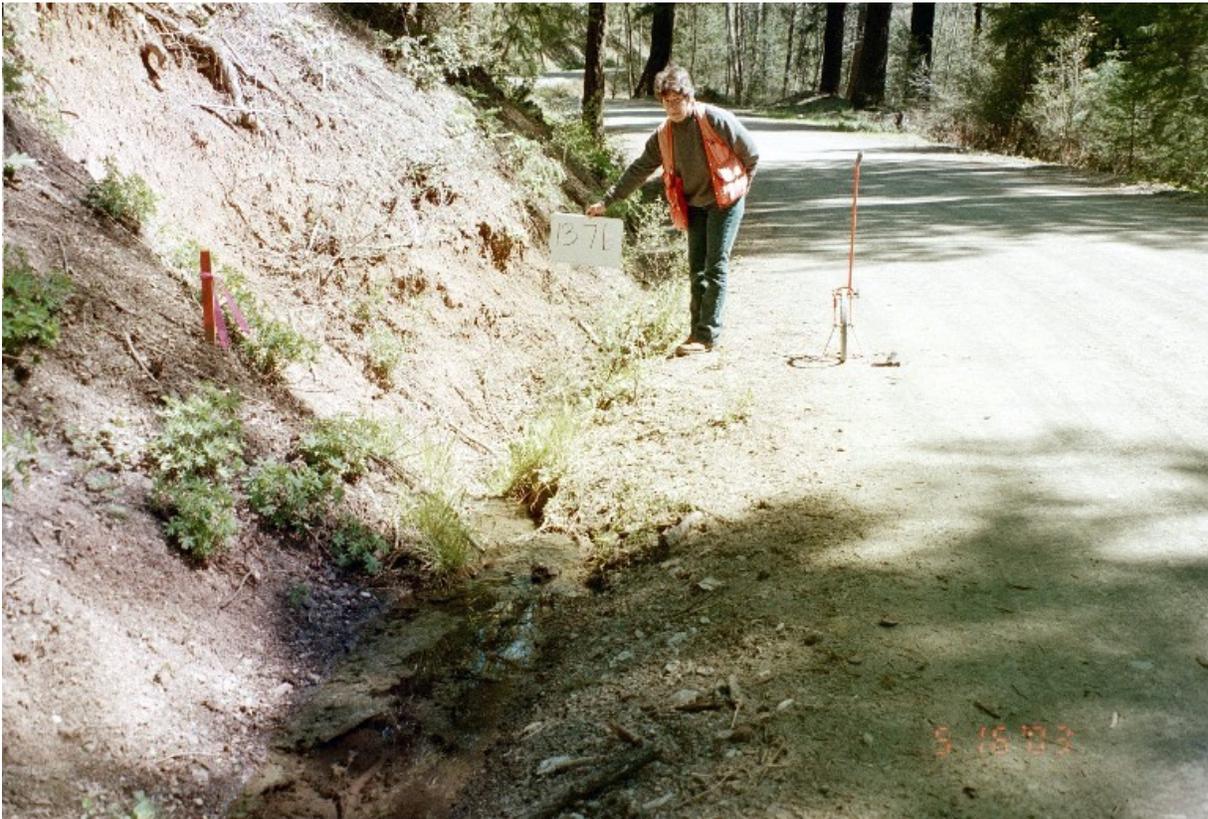
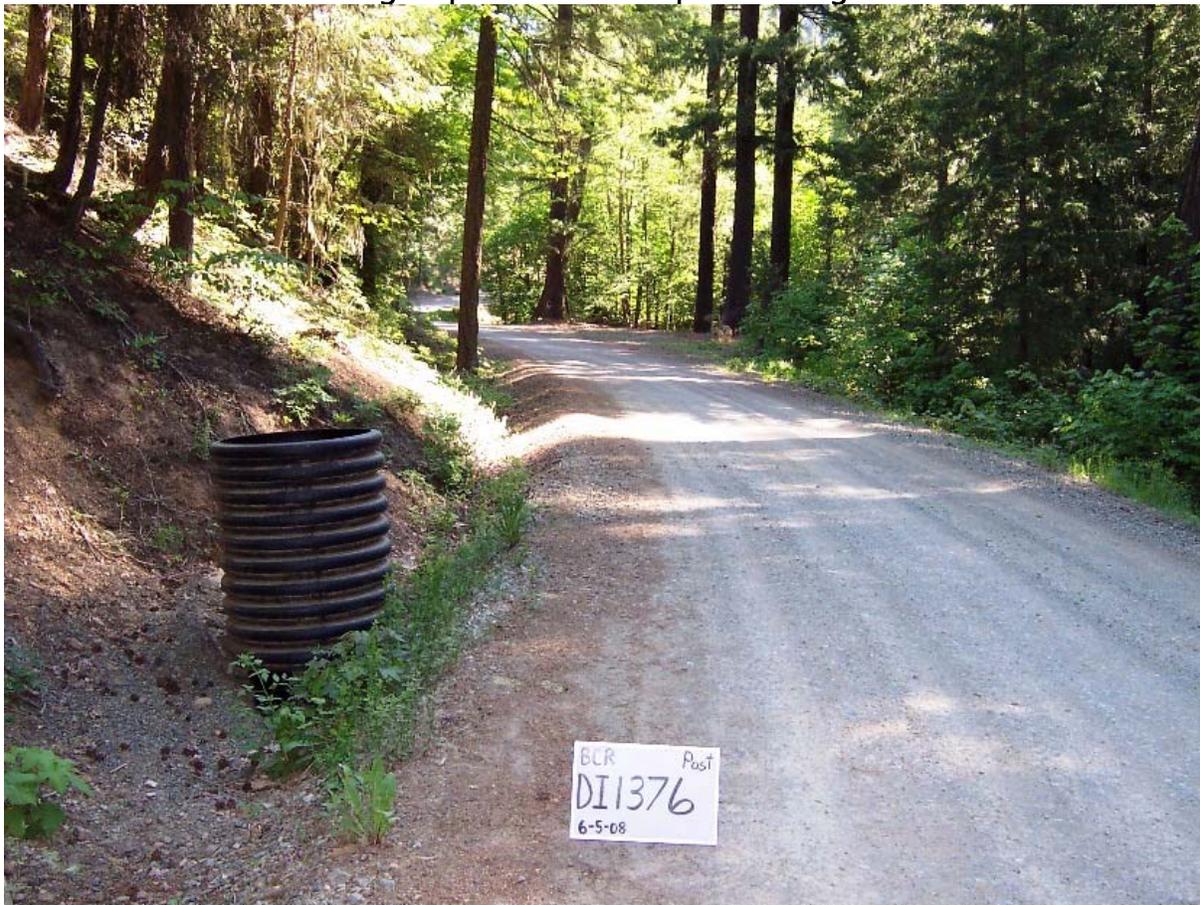
Photo 7 (above). Site 1376. Looking from the other side of the ditch from Photo 5, Photo 8 (below) showing drop inlet and outsploped road segment.

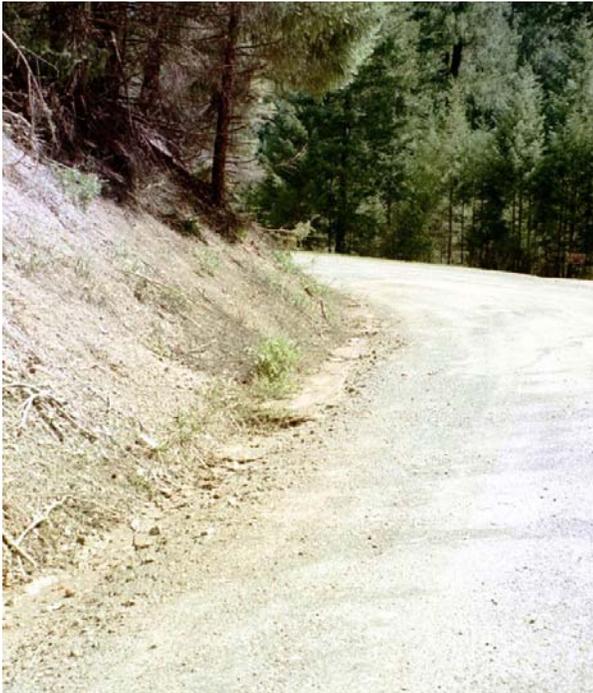
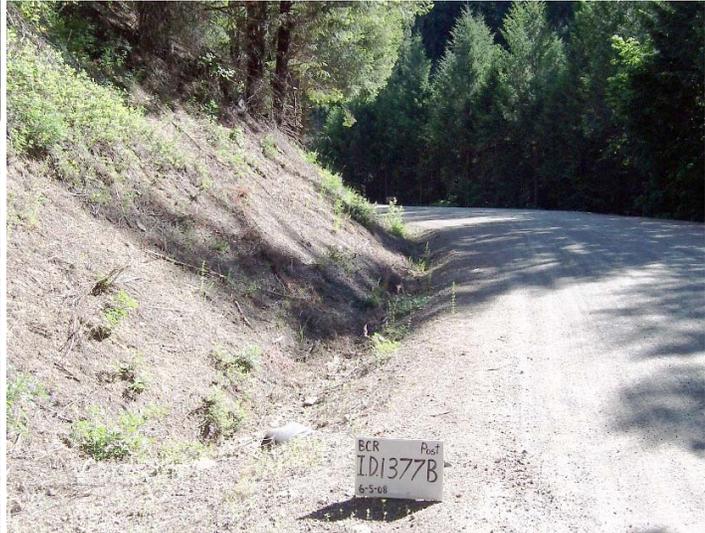
Photo 9 (above left). Site 1377B. This site had a 1,000' long ditch and insloped road concentrating water into the ditch and contributing to bank and ditch downcutting (left). The 1000' of ditch and cutbank area combined with road related sediment were estimated to deliver ~160 yd³ to Big Creek per decade from chronic erosion. The treatment included outsloping the road and installation of two ditch relief culverts (Photo 10, above right) to reduce water concentration and it's erosive and downcutting force.

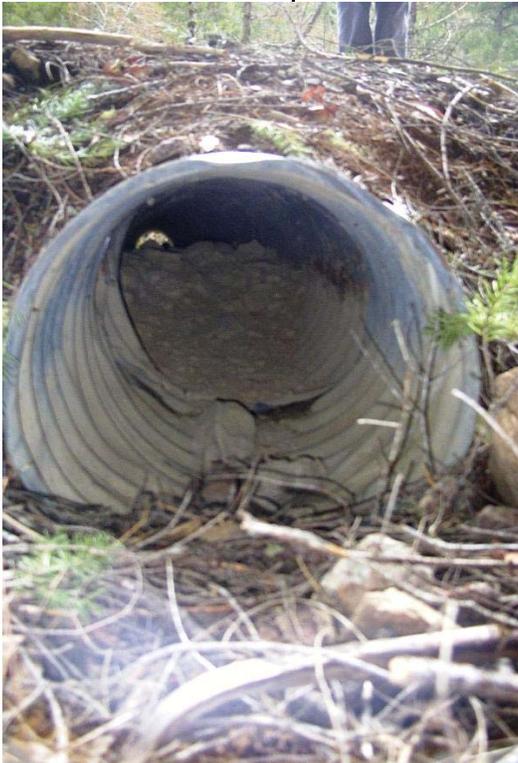
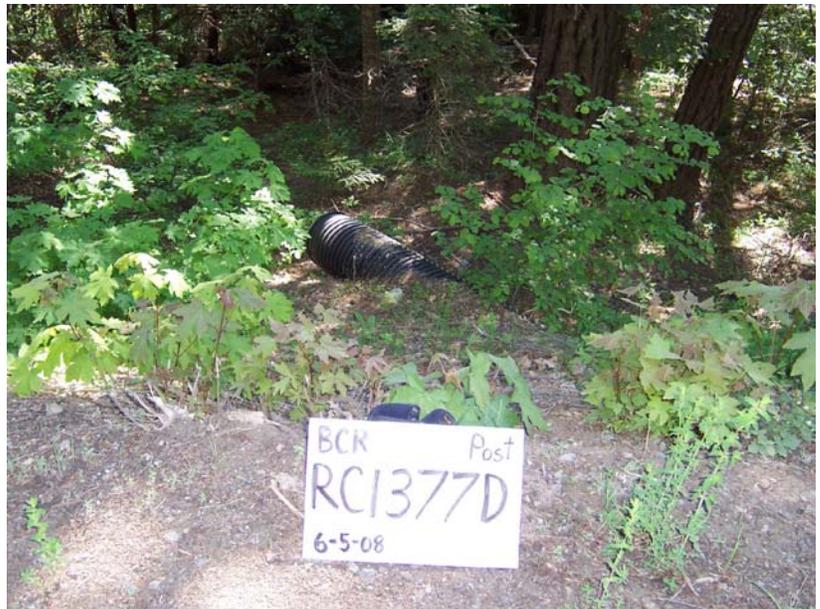
Photo 11 (below left) Site 1377D. A rusted, damaged and plugged ditch relief culvert that was replaced with an HDPE culvert (Photo 12 below right).

- Replaced 7 18" diameter ditch relief culverts (Photos 11-12);
- Installed 1 36" culvert
- Installed 1 rolling dip;
- Installed 1 critical dip;
- Removed berms and spoils at Sites 1370, 1383 (Photos 13 and 14) and in various small areas throughout the project site;

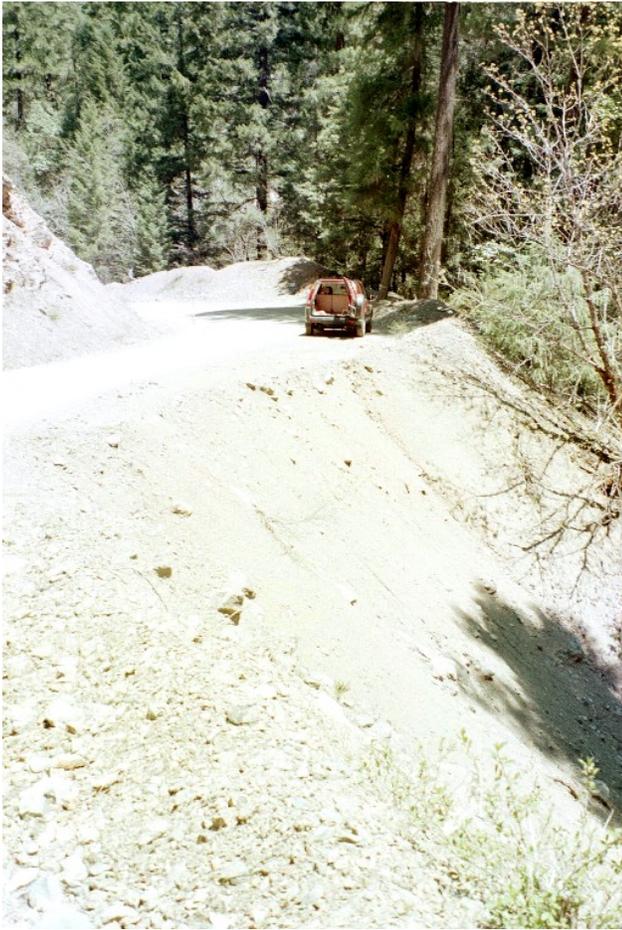
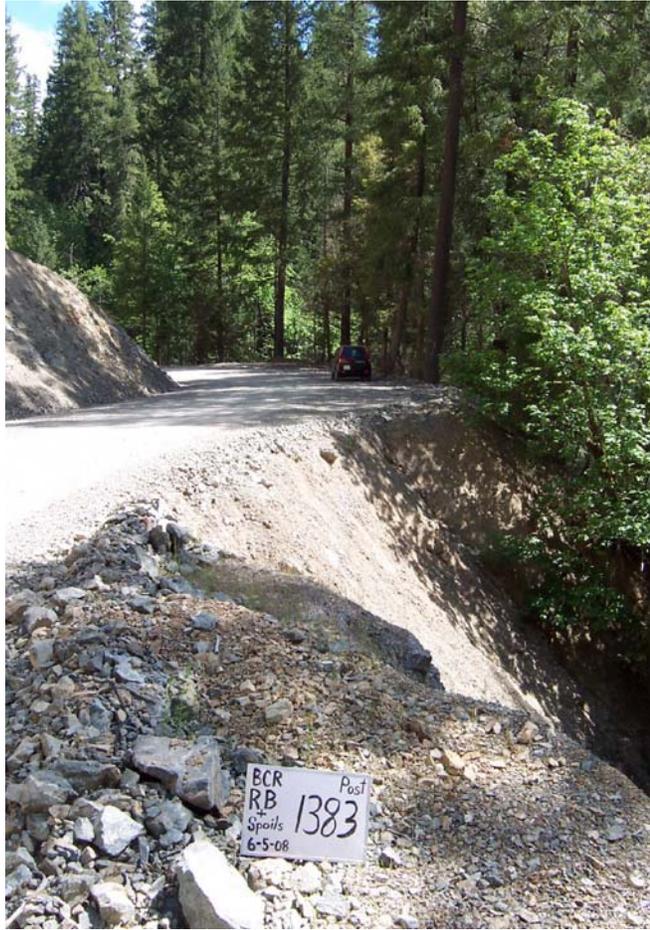
Photo 13 (above left). An extremely narrow road segment with a large berm and spoils area near Big Creek (Site 1383). Photo 14 (above right) shows the spoils removed. Photo 14 also shows the road improvement and widening which was done as a separate project.
