China Gulch Road Sediment Reduction Project Phase 2A

FINAL REPORT

Prepared By:
Five Counties Salmonid Conservation Program

December, 2010

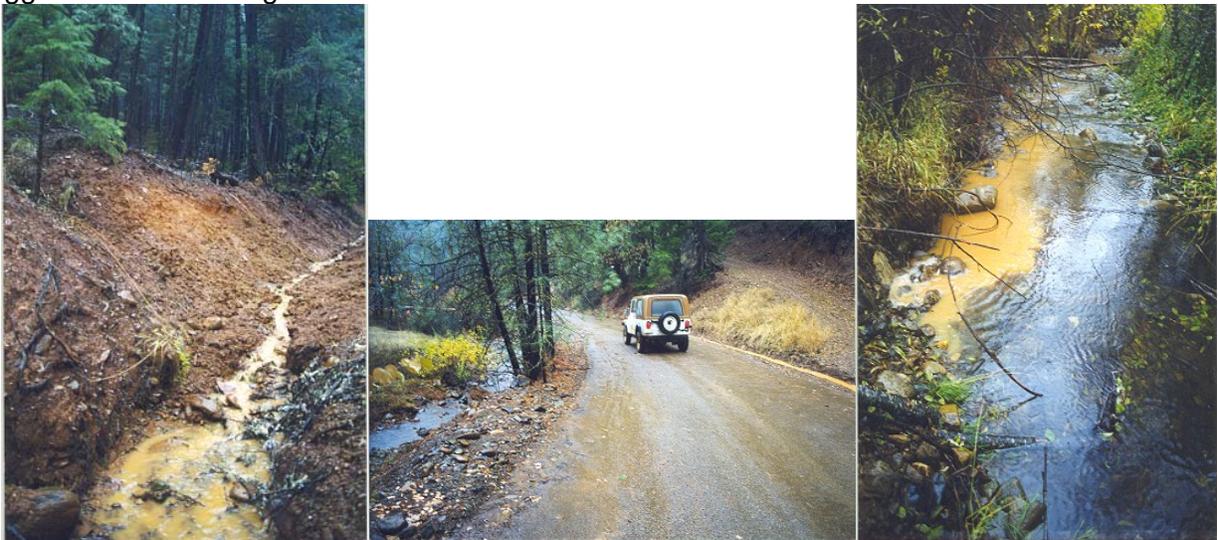
Above Left diverted Class III streams erode the ditch, road and hillslope. Turbid runoff from the road contrasts with the flow in China Gulch Creek stream (Middle) and the effect China Gulch Creek as it flows into Little Browns Creek (Right).

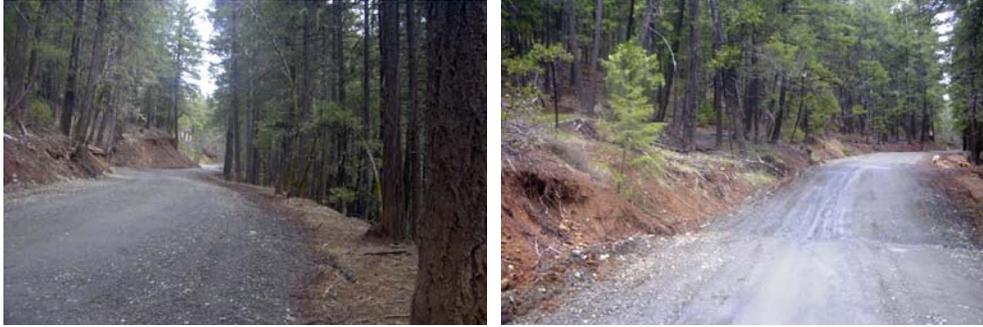
Outsloped segments of the south side of China Gulch Road repaired in 2001 reduced bank slides, ditch down cutting, road gullying and fill failures. There has been no maintenance on this road in the intervening nine years except for slide removal at Site 2464.1

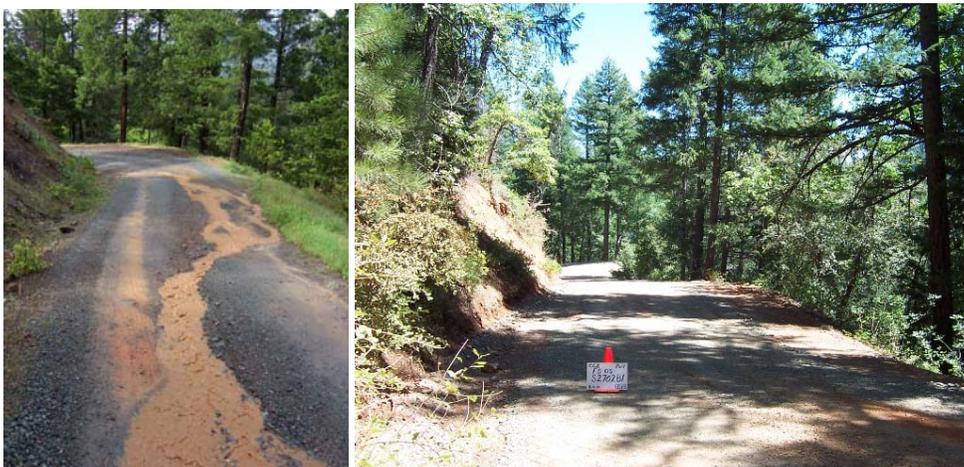
Above left pre-project ditch diversion down the road. Above right post project outcropping, ditch removal and rolling dips drain water across the road rather than down it. Below pre-project culvert misaligned and directed into bank was replaced with a proper aligned and larger culvert

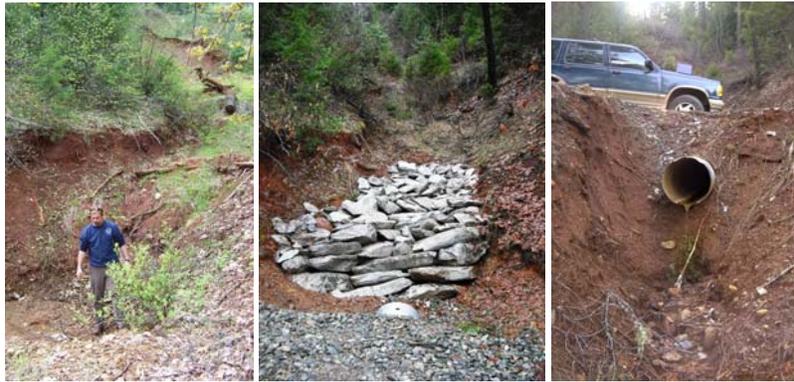
Site 2700a- Upslope partially gutted channel and culvert inlet before (left). Large RSP installed upstream of stream crossing (middle). Shallow, undersized 30' x 18" culvert with outlet scour creating a plunge site (right).

- Excavated ~ 130 yd3 (50' x 9' x 8') to remove and replace 18" CMP with 24" x 50' CMP set at 25% vertically alignment to near channel grade of 30%. Reinstalled approximately 90 yd3 of material back into site.
- Installed critical dip, including placement of ~60yd3 of large diameter RSP and filter fabric.

- Excavated material from upstream channel: 10' long x 12' wide x 4' deep (~17 cyds)
- Place & key 1½-ton RSP into excavated area (~20 cyds)
- Rock excavated channel area with 6" to 10" angular rock: 30' long x 12' wide

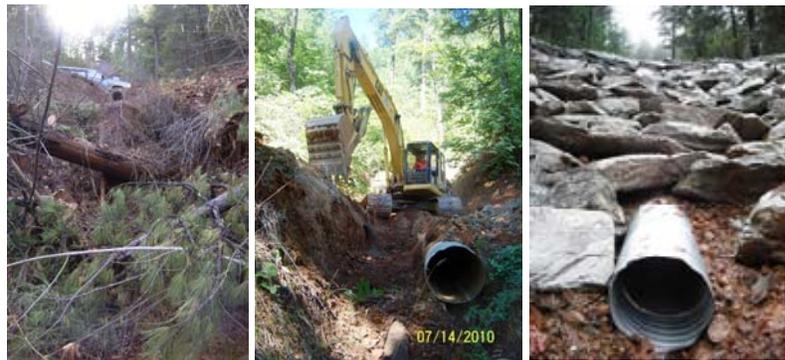
Buried wood in the outboard fill as well as accumulated surface wood (below left). Excavating to remove old culvert, woody debris and fill (middle). Installed 60' x 24" culvert set near channel gradient (~14' below road grade) with critical dip and RSP installed (right).

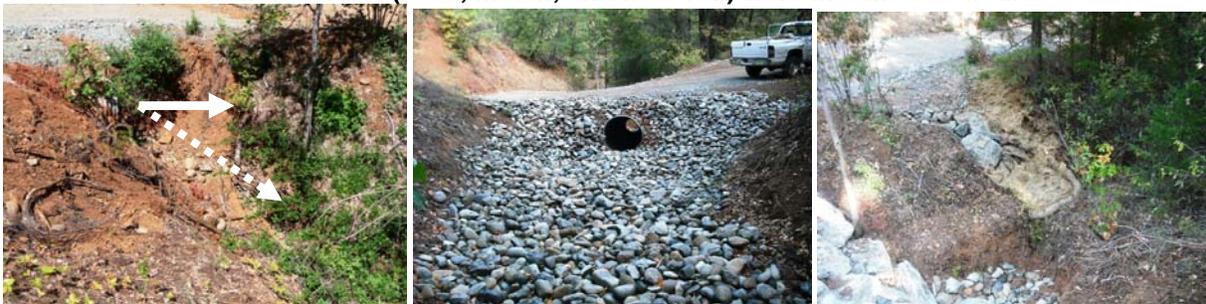
At Site 2703 (below left) misaligned (solid white line in photo) and undersized culvert erodes bank and road and has high diversion potential down road. Natural channel alignment is shown as dashed white line. A larger, properly aligned culvert with inlet rock apron erosion control and energy dissipater was installed (middle photo). An offset critical dip, energy dissipater, and erosion control (seed, mulch, and fiber roll) were installed as well.

- Replaced culvert with 36" x 60' CMP at channel grade of 20% & aligned
- Armored outlet area with ¼-ton rock: 10' l x 10' w (~ 7 cyds)
- Installed "C" Dip (with large rock & filter fabric) at the base of the skid trail to catch runoff

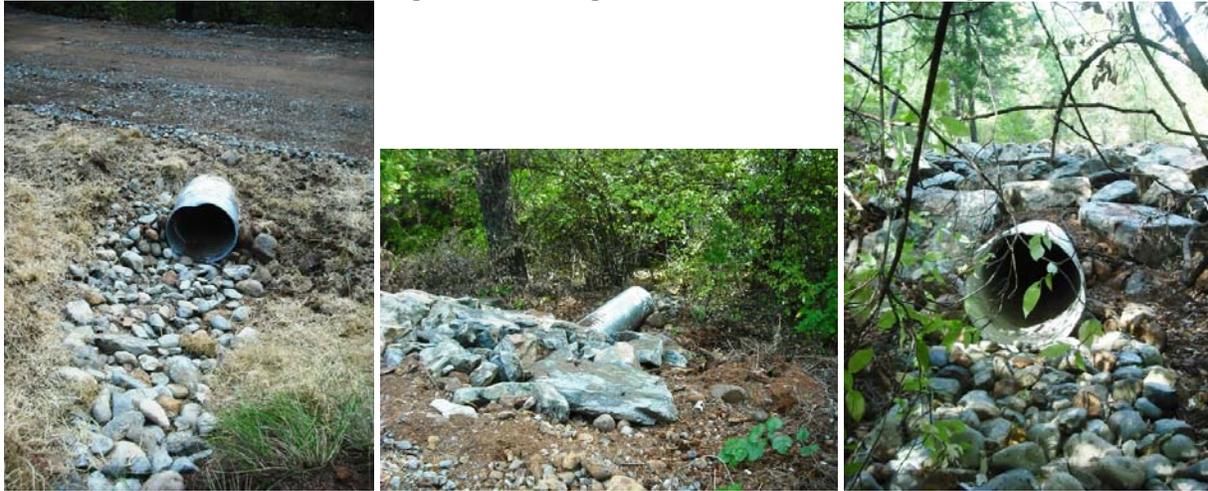
Site 2704 treatments (below) included culvert upsizing from 12" to 18", rock armoring the inlet/outlet, seeding and mulching disturbed soils and removing berm materials.

- Replaced existing 18" culvert with 24" x 50' CMP at channel grade of 43% & aligned
