# Connor Creek Mouth Feasibility Study Final Report

Five Counties Salmonid Conservation Program

Jan. 2014

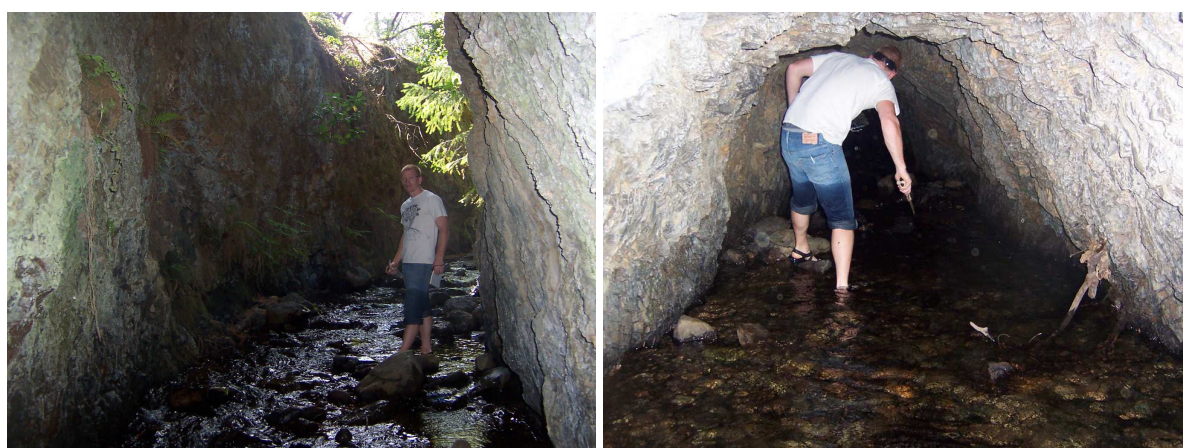
**Figure 1** – Cut through 18 ft. of schist parent material (Left) **Figure 2** – Tunnel under Quail Rd. (Right).

The current channel within the mined reach was cut through Salmon-Hornblende Schist bedrock parent material as part of the mining operations. The channel in this reach consists of step pools with vertical walls (Figure 1). The vertical walls provide shade over the channel and there is a sparse mix of alder and cottonwood trees growing within the canyon. The age of the trees in the canyon (approximately 17 years old) suggest that the canyon scours in response to large flow events such as the 1997 New Year's Day storm. Blackberry, ponderosa pine, grey pine and incense cedar grow on the banks above the channel.

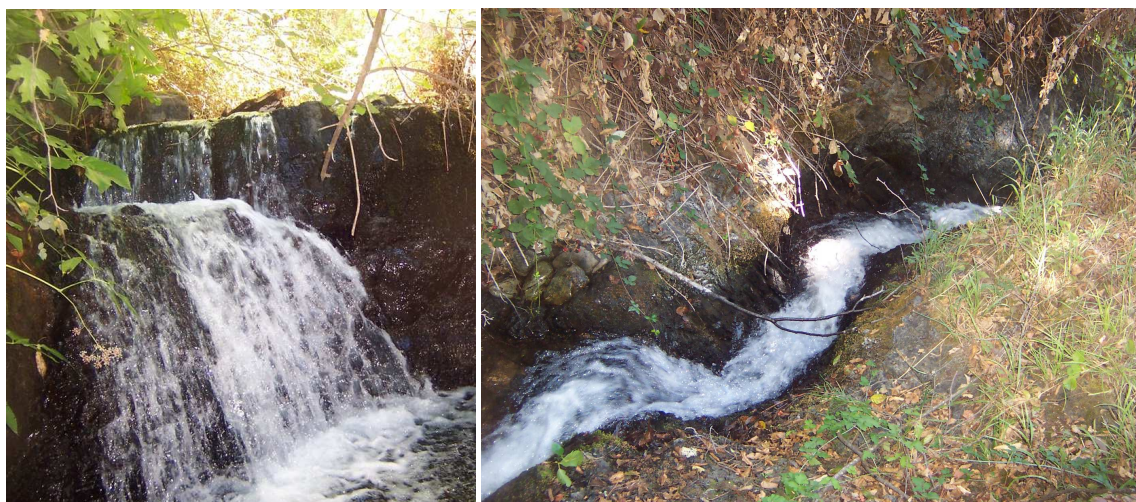
**Figure 4** – Downstream 6.3 ft. waterfall. **Figure 5** – Upstream chute barrier at 21.6% grade.

GMA Hydrology was contracted to conduct a fish passage assessment through the lower reach of Connor Creek which can be found in Attachment 2 – *Connor Creek FishXing Memo*. The assessment used FishXing software, the survey data collected by 5C, and flow data from USGS methods for determining magnitude and frequency of floods in California (Gotvaldt 2012). Key results include that all sites analyzed fail to meet passage requirements for juvenile salmonids. The downstream waterfall fails to meet CDFW passage criteria and moderate fish ability criteria, but meets criteria for maximum fish ability 79% of the time. The upstream chute fails to meet CDFW passage criteria and moderate fish ability criteria, but meets criteria for maximum fish ability 49% of the time. The tunnel under Quail Rd poses less of a threat, meeting CDFW criteria 5% of the time, moderate fish ability 35% of the time, and maximum fish ability 95% of the time. The assessment indicates that Connor Creek Mouth is “a rather difficult stretch of creek to navigate for the majority of fish at fish migration flows” (Matthews 2014).

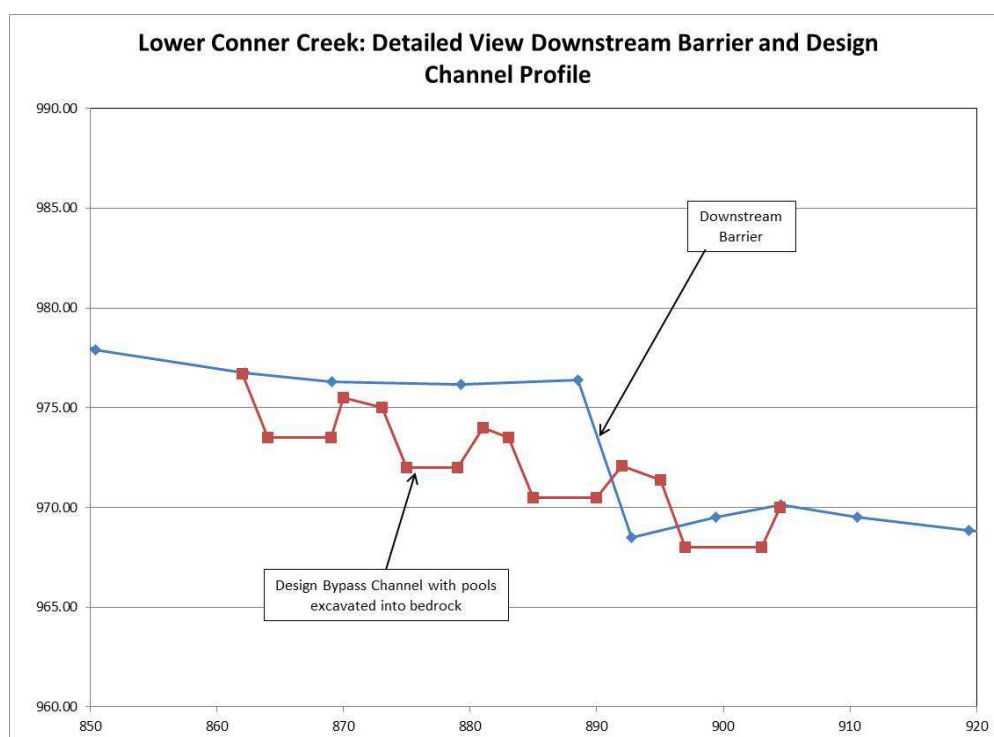
**Figure 7** – Alternative 1, downstream waterfall barrier, design channel profile.

Alternative 1 consists of jump structures placed at both the waterfall and chute migration barrier within the active channel. These structures would consist of a stepped channel excavated into the existing bedrock at each barrier as seen in **Error! Reference source not found.**7 and Figure 8. This would allow fish to more successfully overcome the waterfall and chute migration barriers by creating several smaller jump stages and pools to rest in. This design does not include the creation of a new channel nor tunnel modification.

Maximum jump heights, required pool depth, distance between pools, and other jump feature measurements are described in CFDW Fish Restoration Manual and preliminary step pool measurements are provided by GMA Hydrology (Attachment 6- *Connor Creek Conceptual Alternatives*). The preliminary design spreads the downstream waterfall 6.3 ft. jump over 43 ft. (Figure 7). Individual jumps are designed to be 1.5 ft. which is consistent with natural jump heights in the

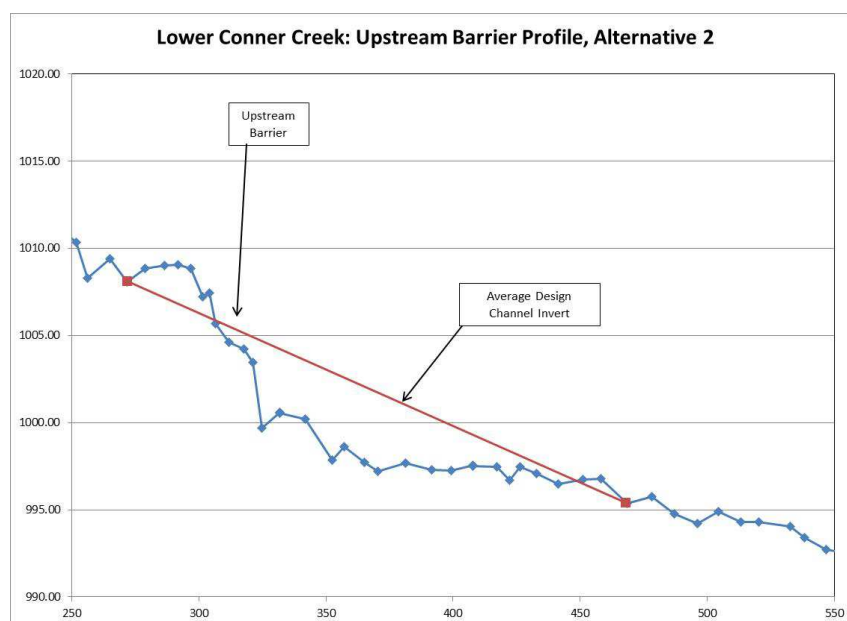
**Figure 9** – Alternative 2, upstream barrier, average profile of design channel.

A partial channel reroute and boulder jump structure is the second alternative considered. A partial channel reroute involves creating a new channel around the upstream chute barrier at a gradient of approximately 5.1% (Figure 9). This channel would then return to the existing channel prior to the tunnel entrance. “This would also eliminate any passage issues that might arise in the slot channel upstream of the tunnel at certain flows, due to potential high velocities in that extremely confined section which has very few velocity refugia” (Matthews 2014). This alternative would utilize the same boulder jump structure at the lower waterfall as previously discussed in Alternative 1. GMA Hydrology’s Alternative 2 alignment can be seen in Figure 10. This design does not include tunnel modification.

fish would be required to swim at a 5.1% gradient for 255 ft. (however, rest pools and features would be implemented). Creating a new channel could allow active flow or subsurface flow to be split into either channel.

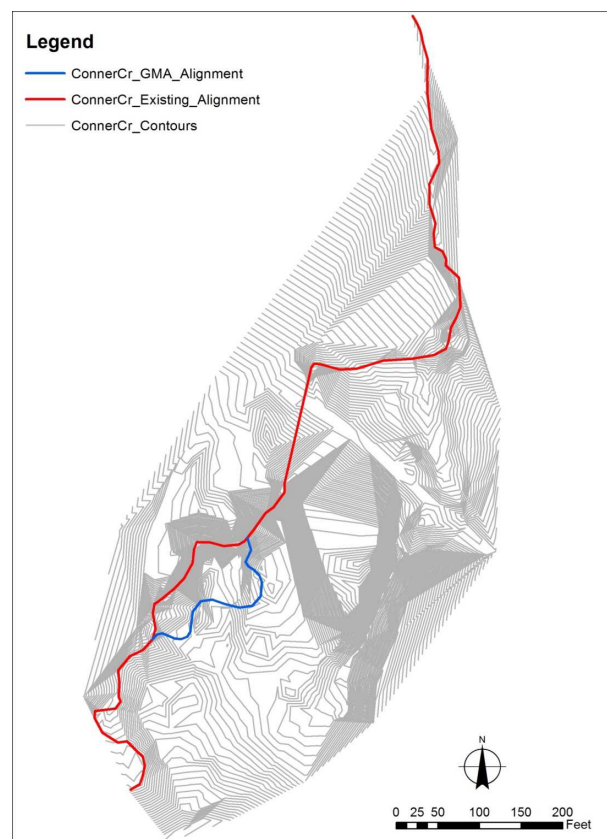
**Figure 10** - Alternative 2 alignment. Existing alignment is indicated in red and the Alternative 2 alignment is indicated in blue.
