**Finley Gulch Fish Passage Improvement and Sediment Reduction Project  
FINAL REPORT**

**United States Fish and Wildlife Service – Fish Passage Program  
Grant No. 813318J068  
July 16, 2010**

Christine Jordan and Mark Lancaster, Five Counties Salmonid Conservation Program  
on behalf of the Trinity County Natural Resources Division, Weaverville, CA 96093

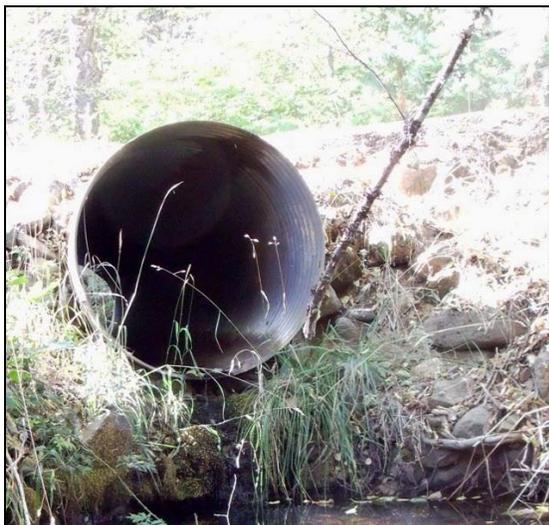
Pre-project photo of perched 42-inch culvert

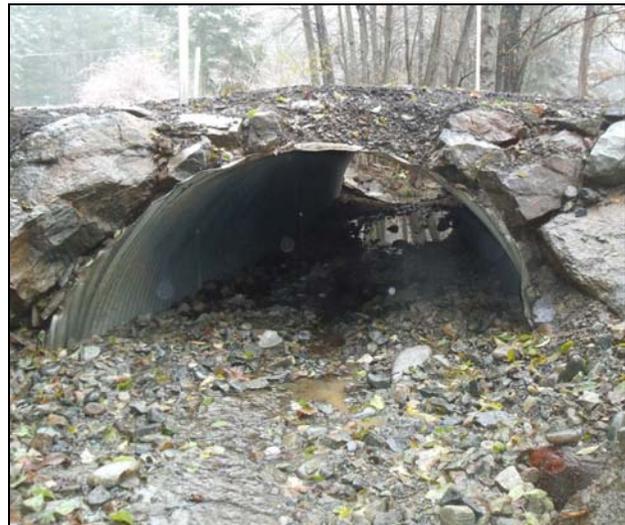
Post-project natural bottom streambed condition

The new 84-inch diameter, 34-foot long corrugated metal pipe was installed at a 4.5% grade. The culvert inlet was beveled to increase flow and debris capacity. The culvert was backfilled with D5-D84 sized streambed material; the inlet was embedded approximately

3.75 feet and the outlet was embedded approximately 2.75 feet. A ¼"-thick metal sheet "V" notch plate structure was welded to the outlet in order to provide scour and maintain an outlet pool while still meeting the jump height requirements for juvenile steelhead. The V-notch also contains the interstitial flow within the culvert, allowing for saturation of the streambed material and increasing the surface flow levels in the crossing, thereby extending the period that fish can move up or downstream. This condition will result in surface flows within the crossing being similar to the natural condition encountered upstream of the crossing. Three inches of 3 inch minus rock was placed over the jetted streambed material with the intent of it moving into the culvert during the first high flow period. 1/4-ton to 1-ton angular boulders were placed at the inlet and in the outlet pool to maintain grade and reduce the potential for upstream headcutting.

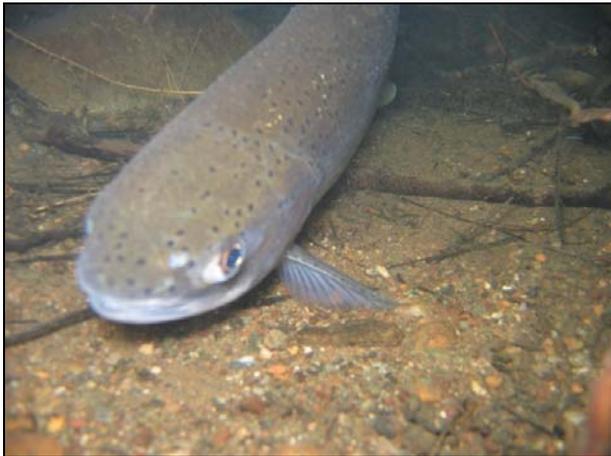
Adult steelhead in Little Browns Creek, July, 2007

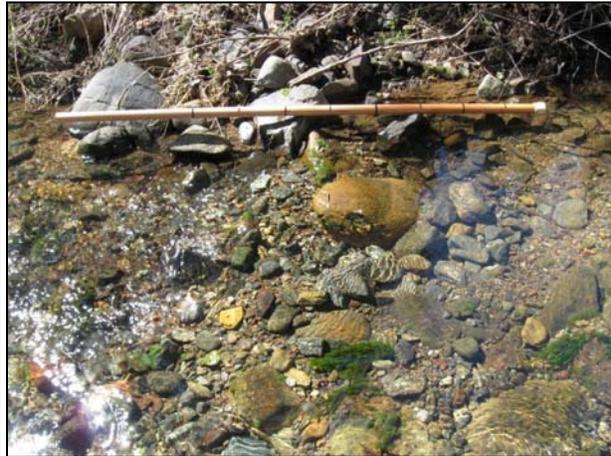
Steelhead redd, March 2009 near the confluence of Little Browns Creek & Finley Gulch

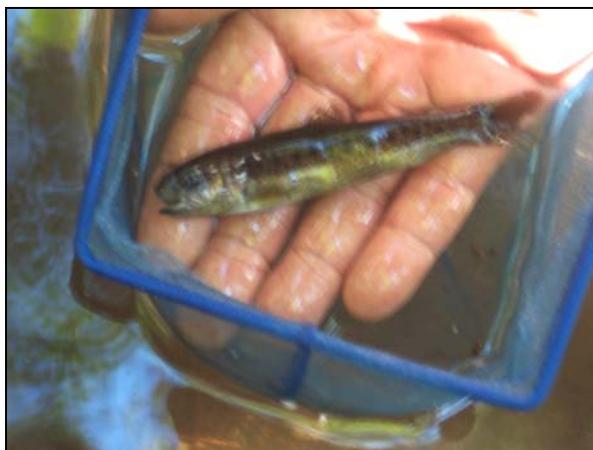
Young of the year steelhead captured upstream during monitoring (Sept 2008)

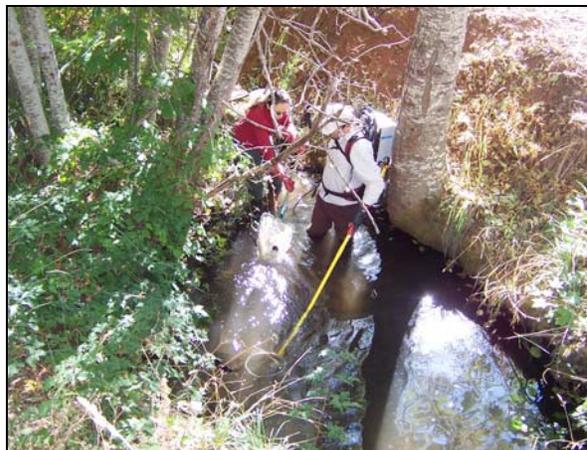
Fish relocation in the culvert outlet pool (2009)

At the time of relocation, the outlet pool had a depth of two feet at its deepest point. The water temperature in the pool was 46.5° F at 1030 hours and 50.0°F at 1430 hours. There was minimal surface flow downstream of the outlet pool and there was one pool upstream of Roundy Road within the project area. Several pools were located upstream of the project construction area that were suitable for releasing captured fish and amphibians. Fish exclusion fences were placed above and below the project construction area. The upper screen (hardware cloth supported by several 24" lengths of rebar) was placed 20' upstream of the upper end of the project area. The lower screen was placed at the riffle crest of the outlet pool.

A Smith-Root, model LR-20 electro-fisher was utilized with an initial setting of DC/200 volts. Two passes were made through the outlet pool, but because of the extensive undercut banks the pool was gradually lowered using a small gas powered Homelite pump (1,900 gallons/hr capacity). Once the outlet pool level dropped, several additional passes were made to capture the remaining fish. During most of the passes, 200 volts was used and on the final passes it was increased to 250 and 300 volts. All captured fish and amphibians were temporarily held in 5-gallon buckets with battery-powered aerators attached, Table 2 below summarizes the results of the relocation effort.

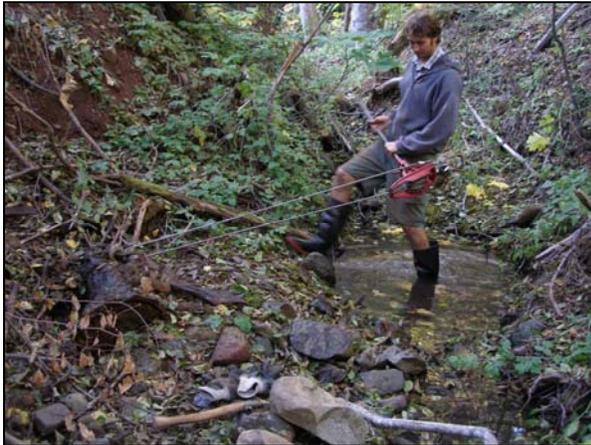
Danny McKnight (AmeriCorps) uses a come along winch to pull a transmission housing partially buried in the stream channel

On October 23, 2009, AmeriCorps members with the Trinity County Resource Conservation District and 5C staff members conducted a stream clean-up of approximately 800 feet of stream channel upstream of the project site. The site had been a mining claim and cabin site from the late 1890's to the 1980's and materials from those uses were concentrated in or near the stream. Over 1,000 pounds of metal, plastic, rubber and other debris was removed from the streambed and bank during this effort. Materials removed included: an

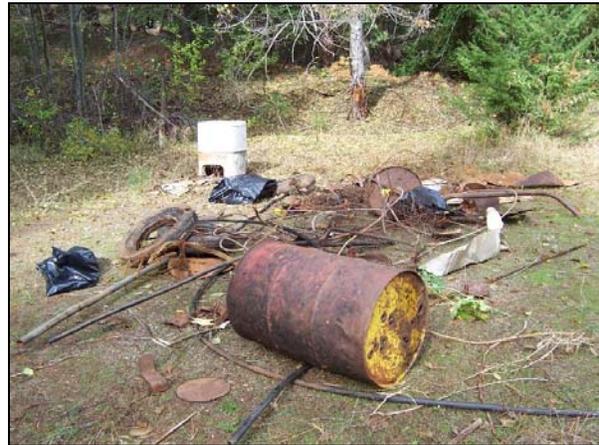
Debris removed from the stream and riparian areas

engine transmission, vehicle body parts, a 55-gallon drum, a washing machine, tires and wheels, aluminum and metal wire, rope, aluminum siding, chicken wire fencing, a toilet, tin cans, plastic and metal pipes, and lumber.

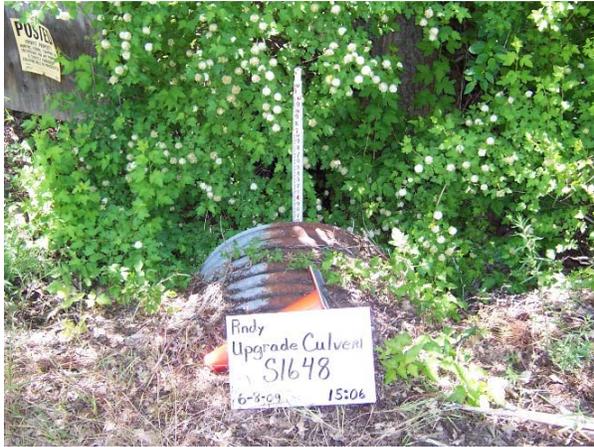
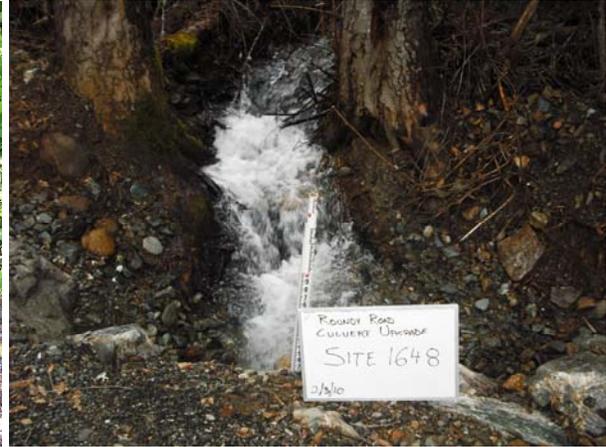
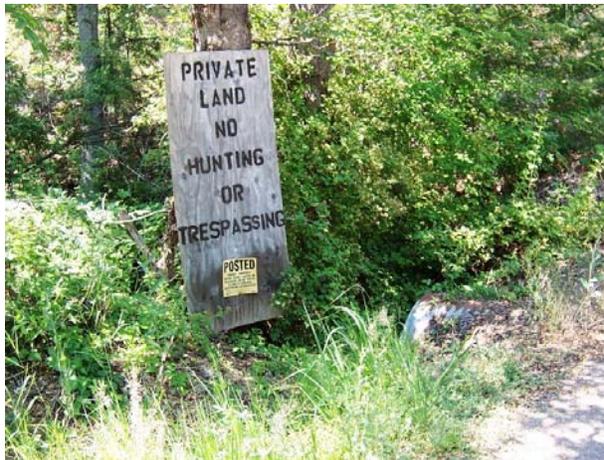
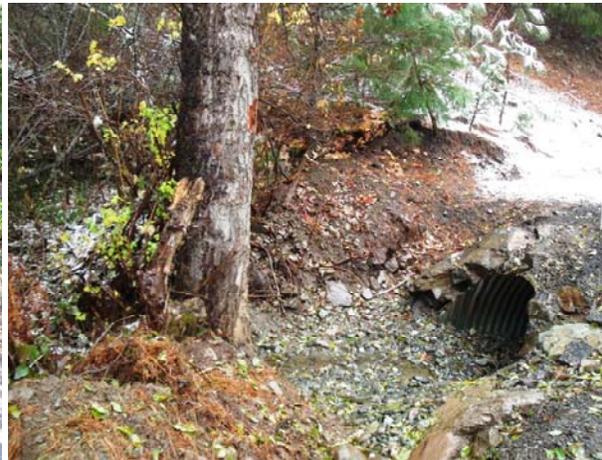
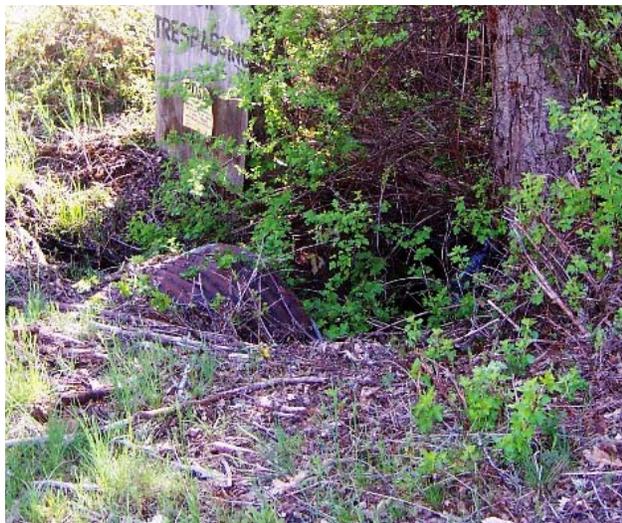
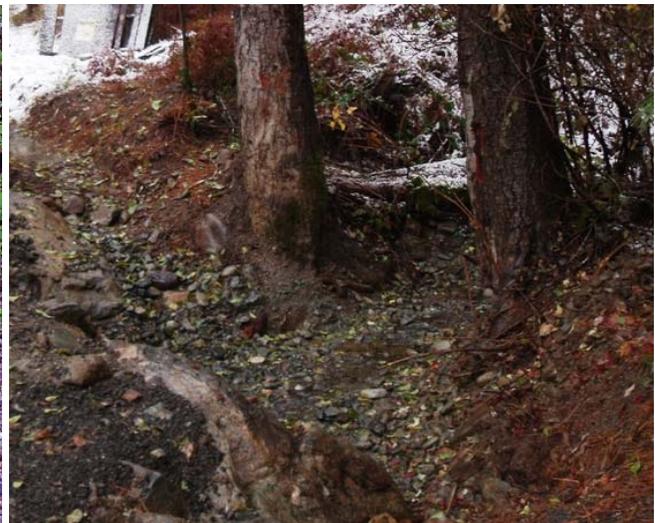
Upper Left - Inlet view before and after (right). Middle Left- View of inlet from channel right before and after (November 4, 2009) Bottom Left- Inlet view (channel left) before and after (right photo)

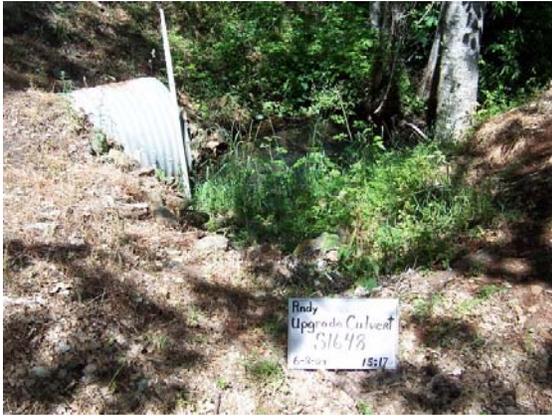
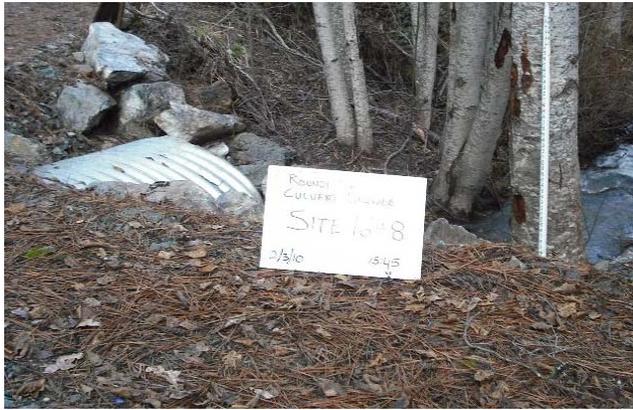
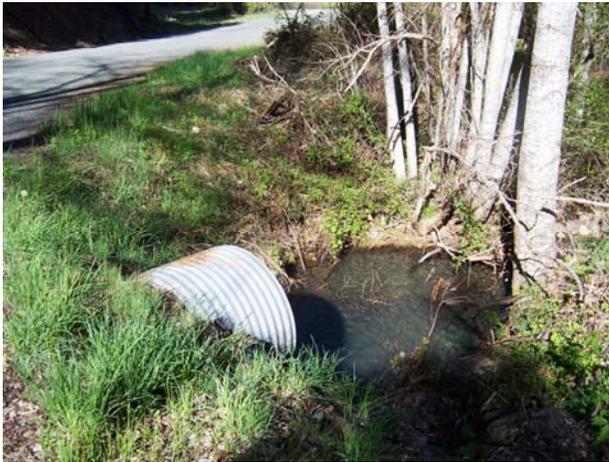
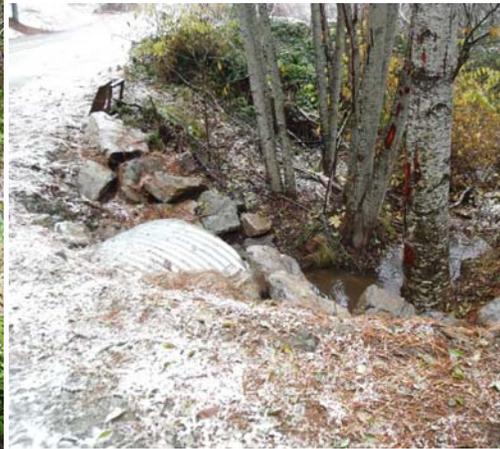
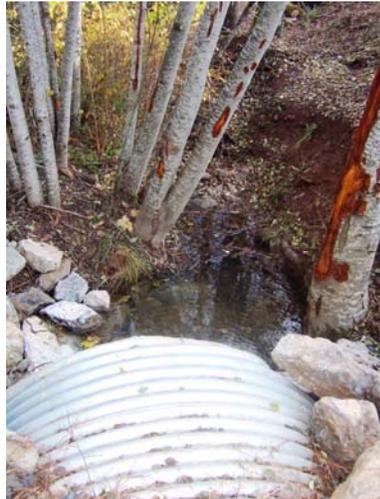
**Top Left - Pre-project view of outlet pool and top right post project (February 3, 2010). Middle Row Left - Outlet pool before project from right bank and after (12/12/2009) (Right). Lower Left- Outlet before. Lower Right - after (11/4/2009).**

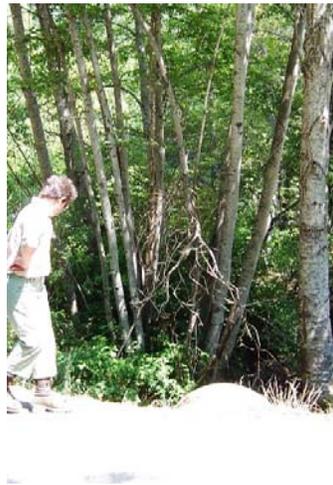
**Photo Series 1: Before (upper left), during construction (upper middle and right and lower left photos) and after (lower right photo)**

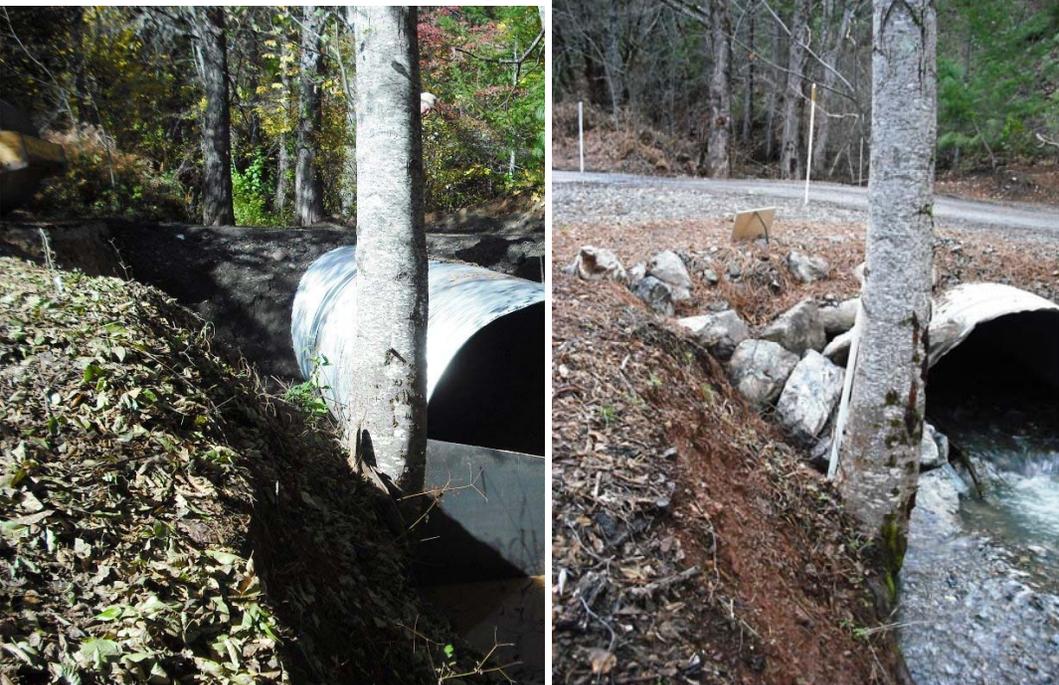
**Photo Series 2 (Pictures 1-6): Before and during construction of Finley Crossing including before( upper left); excavating out the 42” CMP (upper middle and right); preparing the bed for the new CMP (lower left) and placing the first segment and band (Lower middle and right). All photos taken October 27, 2009)**

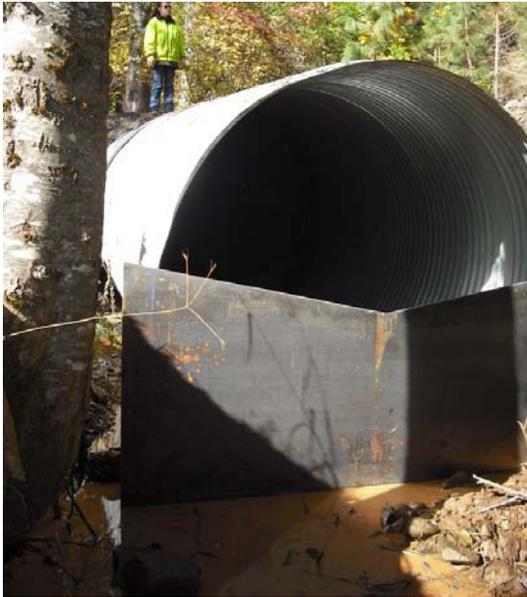
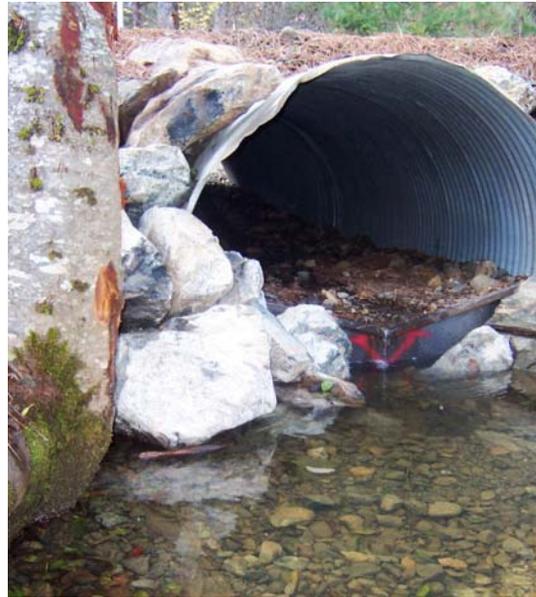
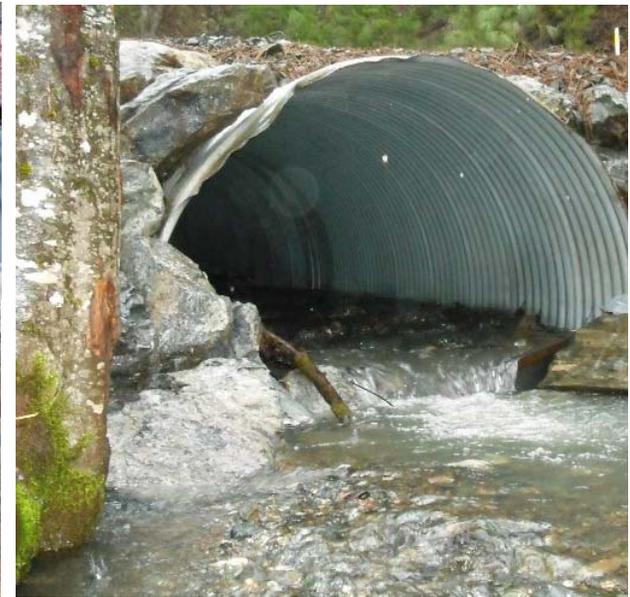
**Photo Series 2 (Pictures 7-9): Left: Outlet showing the steel plate during jetting and placement of bedload material (November 1, 2009). Middle: Outlet after bedload material has been placed and jetted and rock slope boulder placed (November 3, 2009). Right: Outlet flow during the receding end of a winter storm (February 2, 2010)**

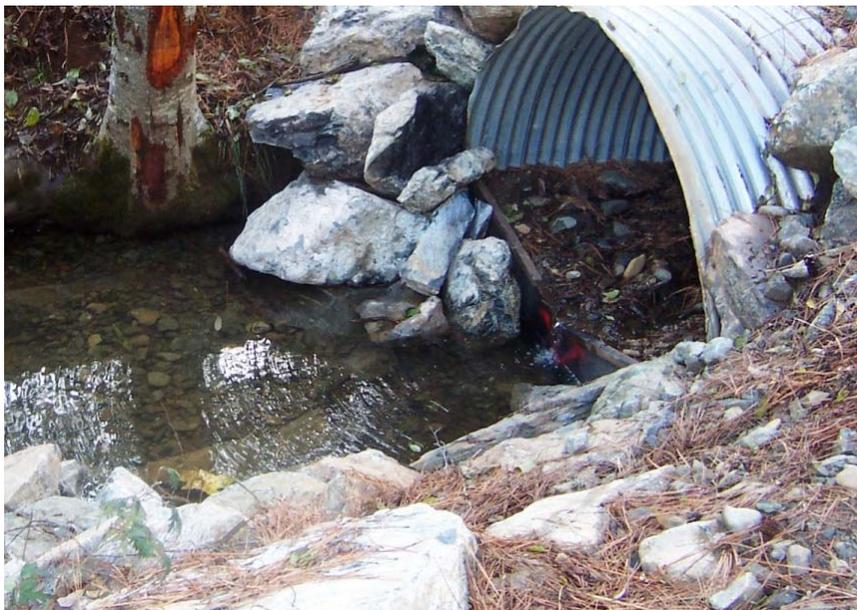
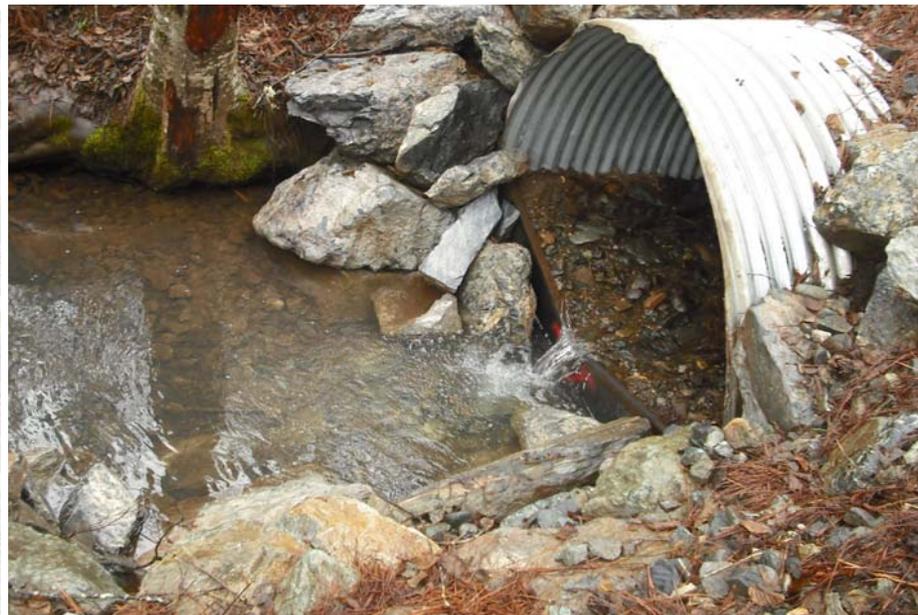
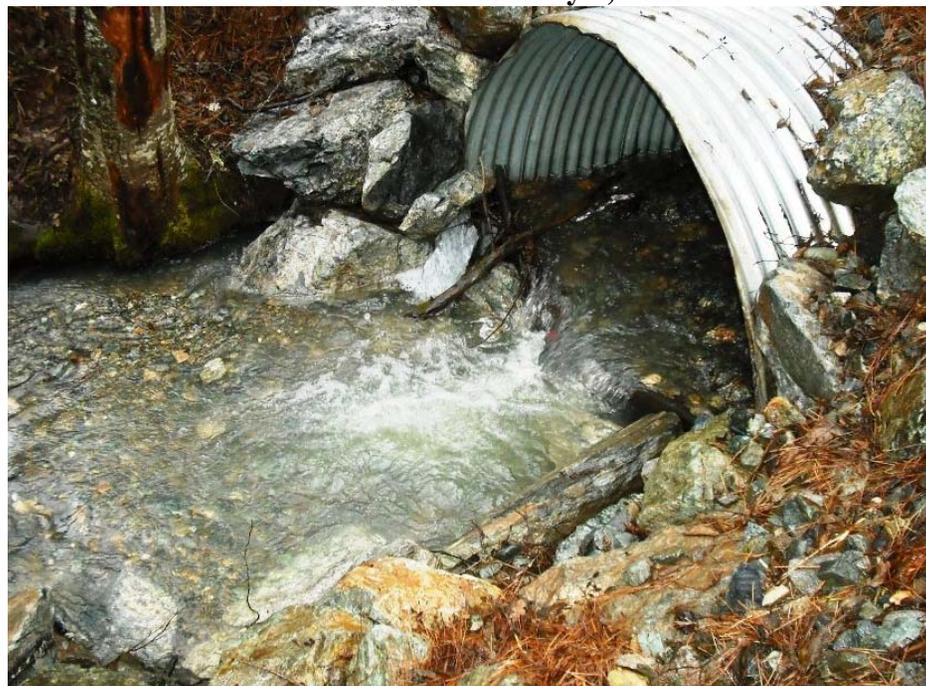
**Photo Series 3: Post Project Outlet and Pool Monitoring. Upper left Photo (November 4, 2009); Upper right: December 3, 2009. Lower Photo: February 2, 2010.**

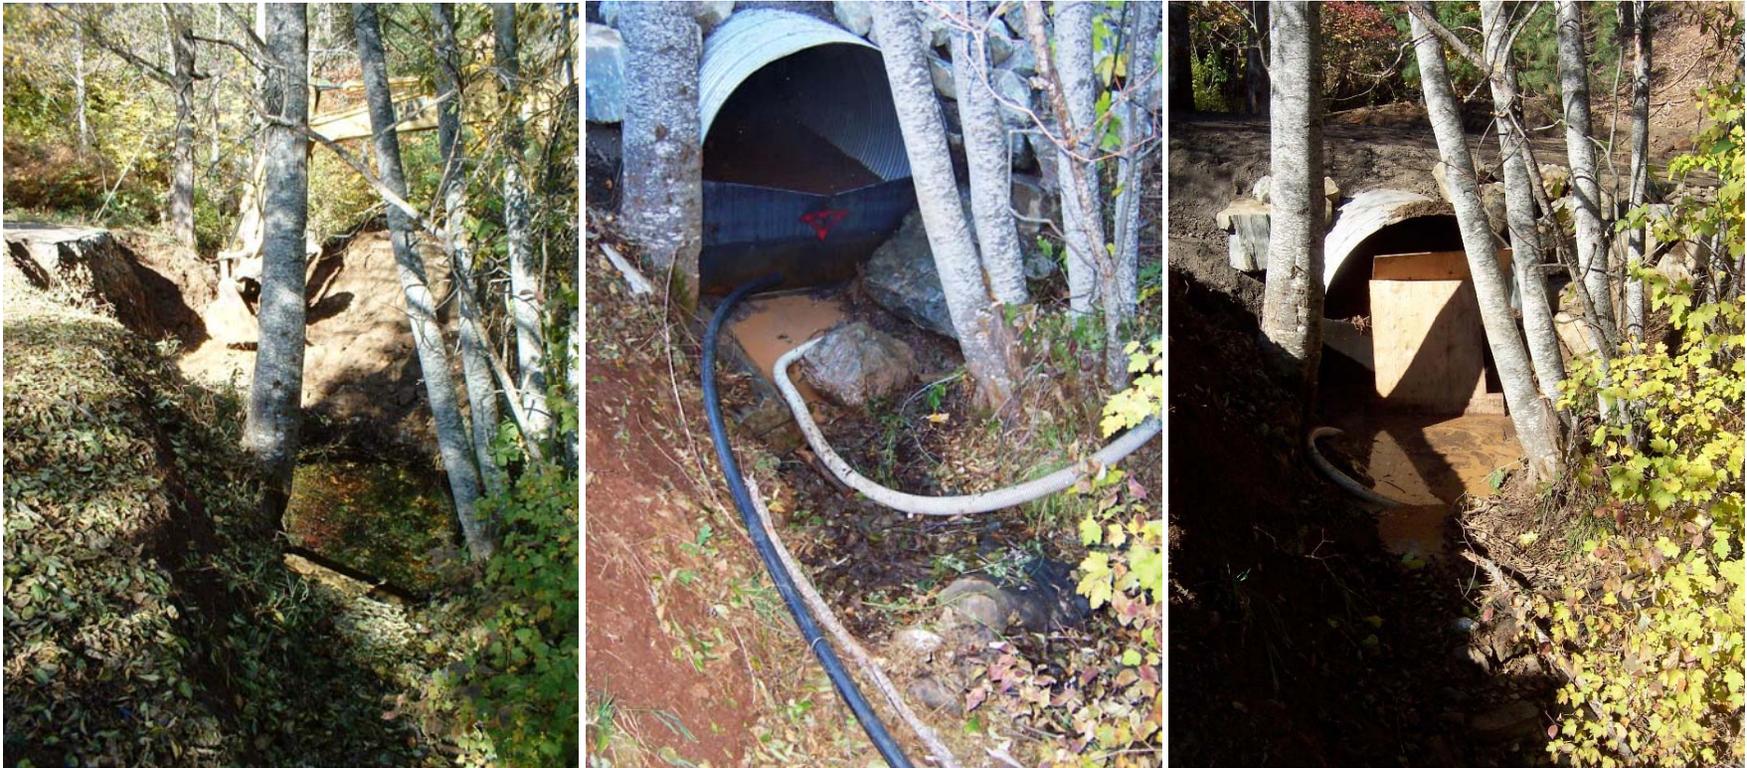
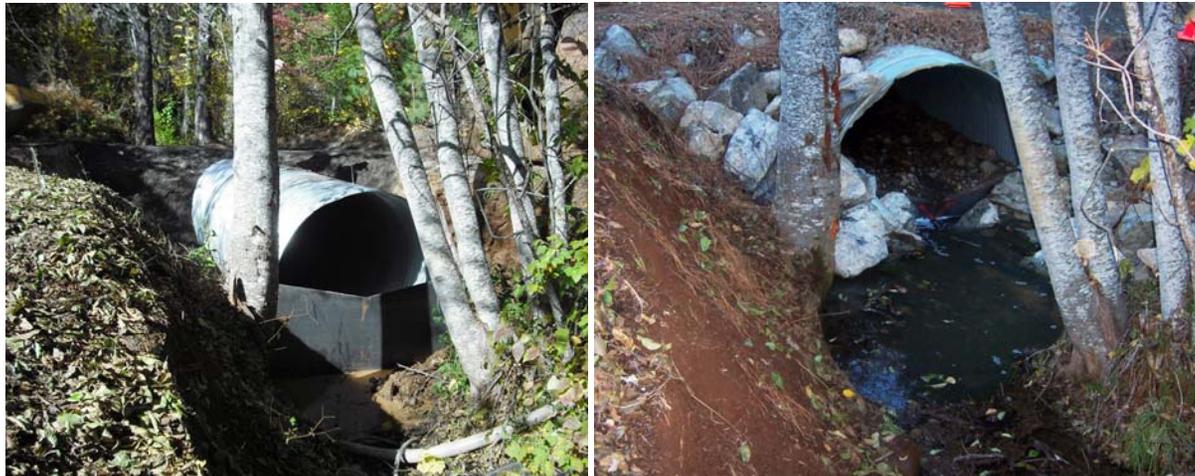
**Photo Series 4: Water Quality Monitoring:** There was minimal surface water flow during the project. Surface flow was routed around the site in a 2" HDPE pipe. Upper left Photo the outlet pool was protected during construction by retaining a 4' wide portion of the pre-project perched streambed forming a barrier between the work area and any water (not the pool in the lower 1/3 of the photo). Upper middle and right photos and lower left photo- during jetting of streambed material all water was pumped out of the pool. Lower right photo- Once jetting was completed the pool was washed with a low pressure hose to remove all sediment before flow was routed back into stream.

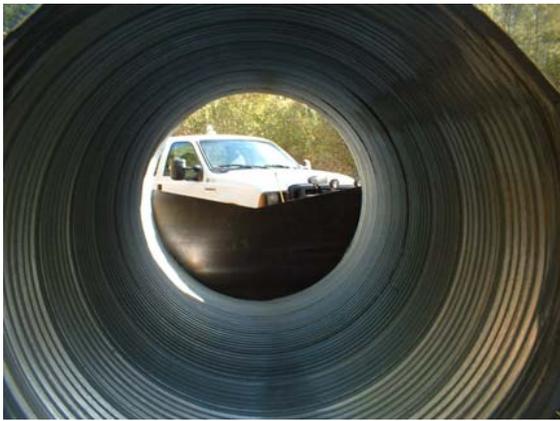
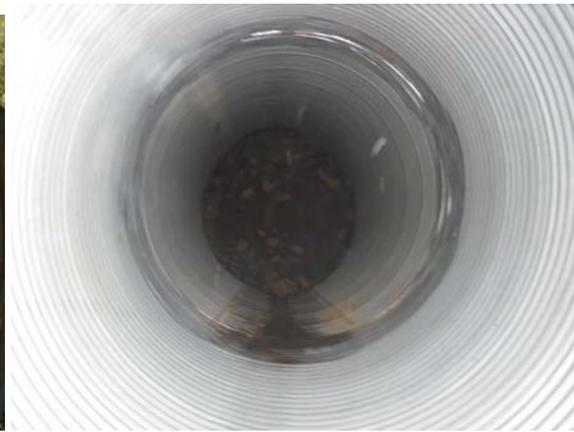
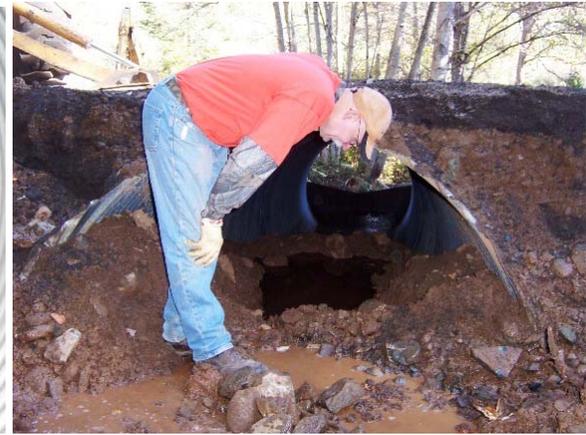
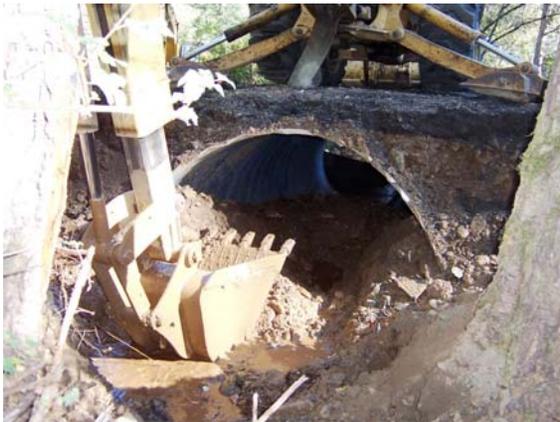
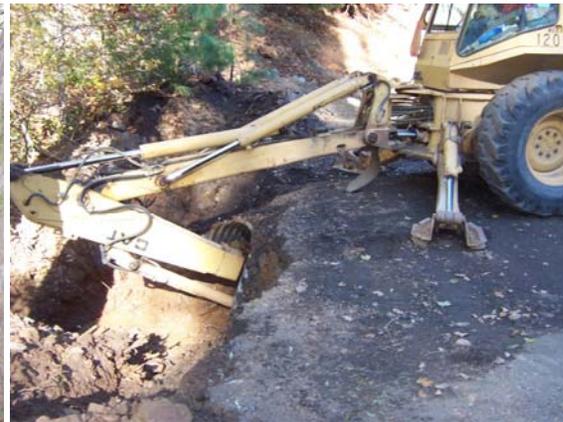
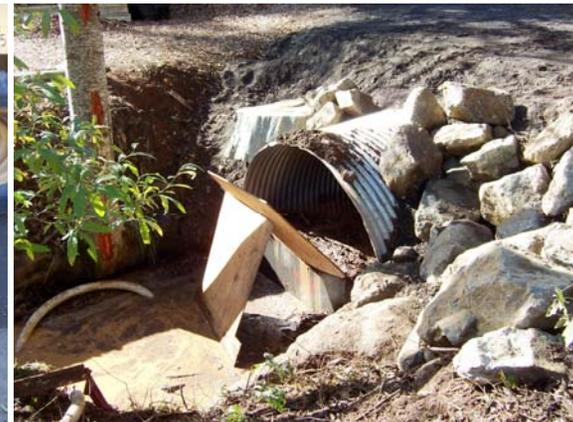
**Photo Series 5: Installing streambed Mix: Upper left- CMP w/plate ready to install; Upper middle- the inlet is filled with mix. Upper right- inlet mix beginning to be fed into CMP. Middle left and center photos- feeding streambed mix into culvert. Middle right photo- ramp to feed mix into outlet end of CMP. Lower left and right photos- distributing mix. Lower middle- pressure washing mix in culvert.**

Streambed material ranging in particle size from silt to boulders (16" diameter class) was placed in the culvert using a backhoe. At the inlet, streambed material was placed with an excavator and then pushed into the culvert with the backhoe bucket and extended hoe. At the outlet, a plywood chute was used to feed material into the pipe. The material was distributed and placed using a Toro walk behind tracked loader, manual placement, and jetting with water. A water truck with a high pressure pump and 1½" hose was used to jet the streambed mix at the rate of ~90 gallons per minute at ~150 psi. The welded metal V-notch at the outlet retained most of the turbid water associated with jetting and a 3-inch diameter trash pump was used to pump the turbid water into a vegetated swale. Discharge was monitored constantly to assure no delivery to Finley Gulch. At the peak of jetting activity, minimal turbidity was observed in three pools just downstream of the confluence with Little Browns Creek but no deposited sediment was observed in the pools during subsequent inspection. At the completion of the jetting process, the outlet pool was washed with low pressure hoses and water was continuously pumped to remove any accumulated sediment within the pool. Washing was done until the water in the pool was clear and no sediment was visible on the rocks and stream flow was permanently returned through the crossing at that time. Monitoring of the pool and water quality was conducted both as the outlet pool refilled and after the first several rainstorms, during which time, no turbidity or visible sediment transport was observed in the stream.

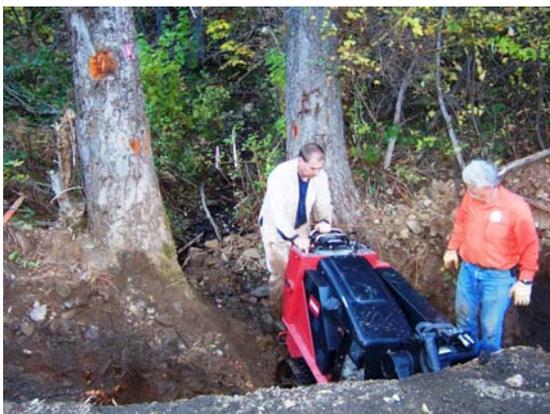
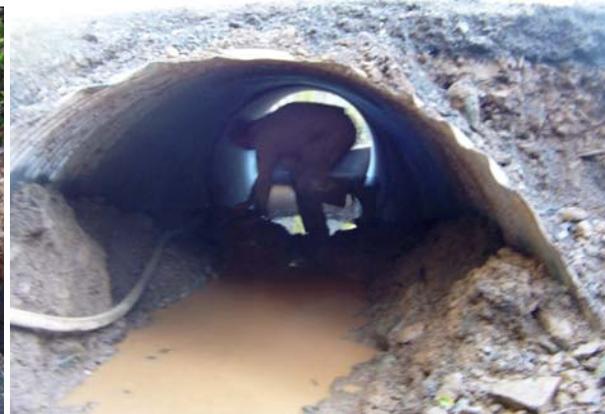
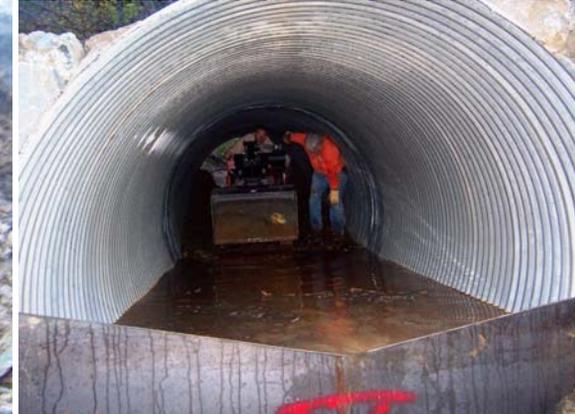
**Photo Series 6: Placing streambed mix (Upper left). Mix immediately after completion of jetting on November 3<sup>rd</sup>, 2009 (upper right). Mix after first high flows February 3<sup>rd</sup>, 2010 (lower)**

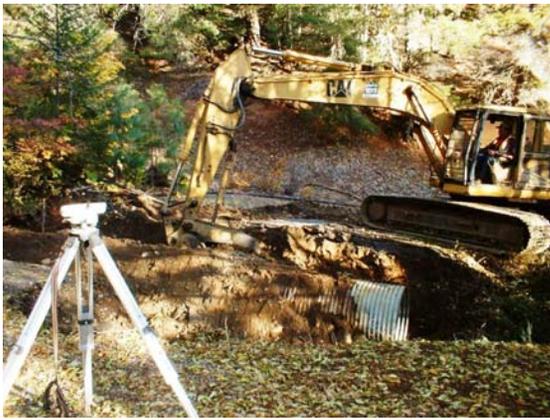
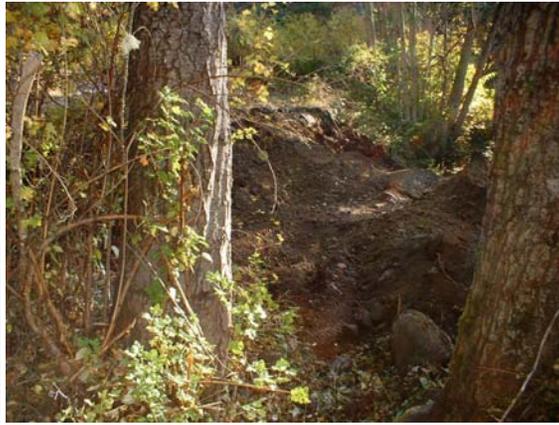
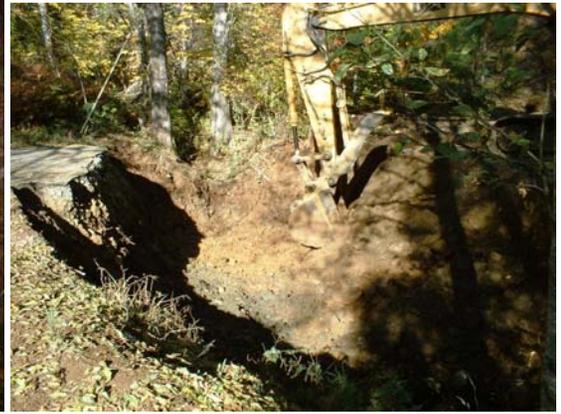
**Photo Series 7: Miscellaneous construction photos**

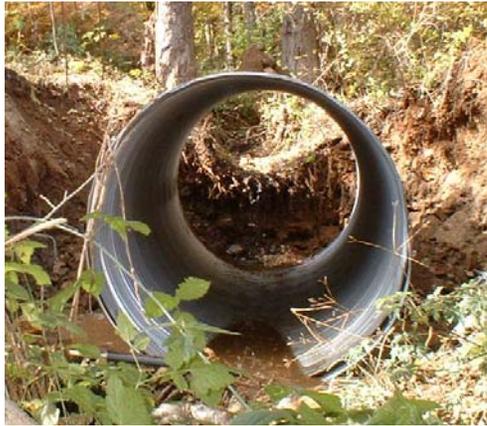
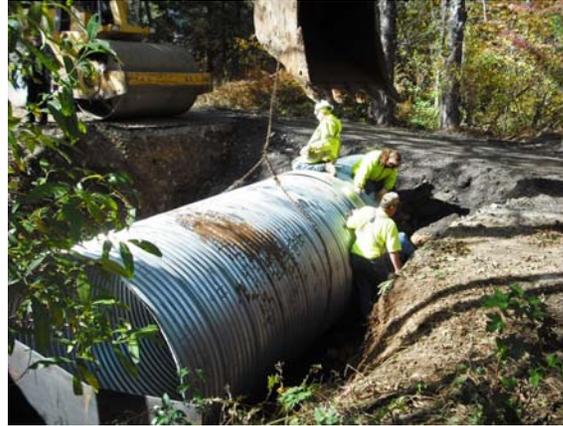
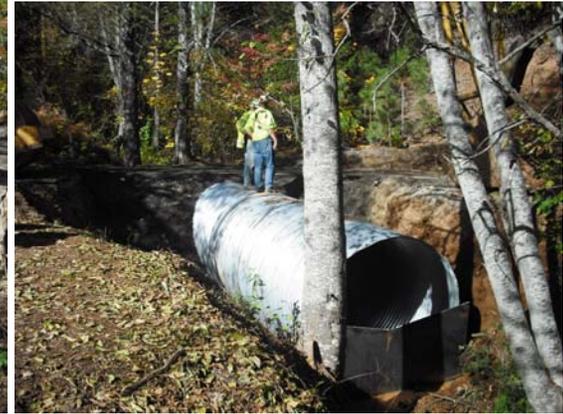
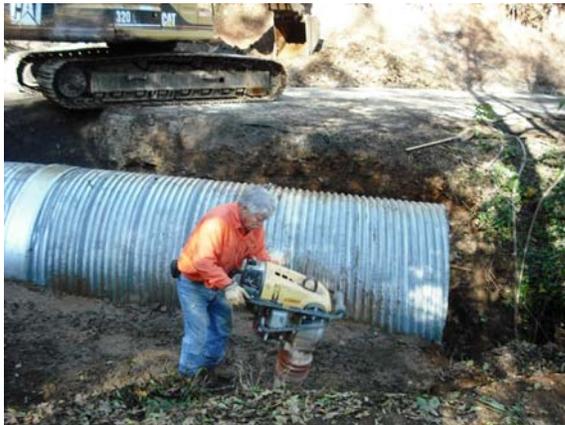
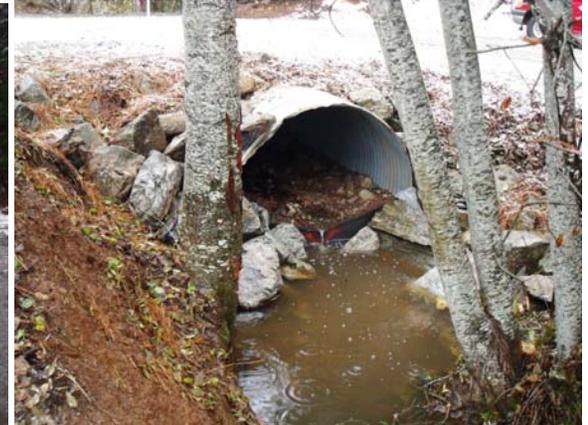
**Photo Series 8: View of outlet: Before and during showing upstream channel & culvert and plate in place but no flow or rock slope protection in place. Lower Right is following winter storm flows of January & early February 2010**

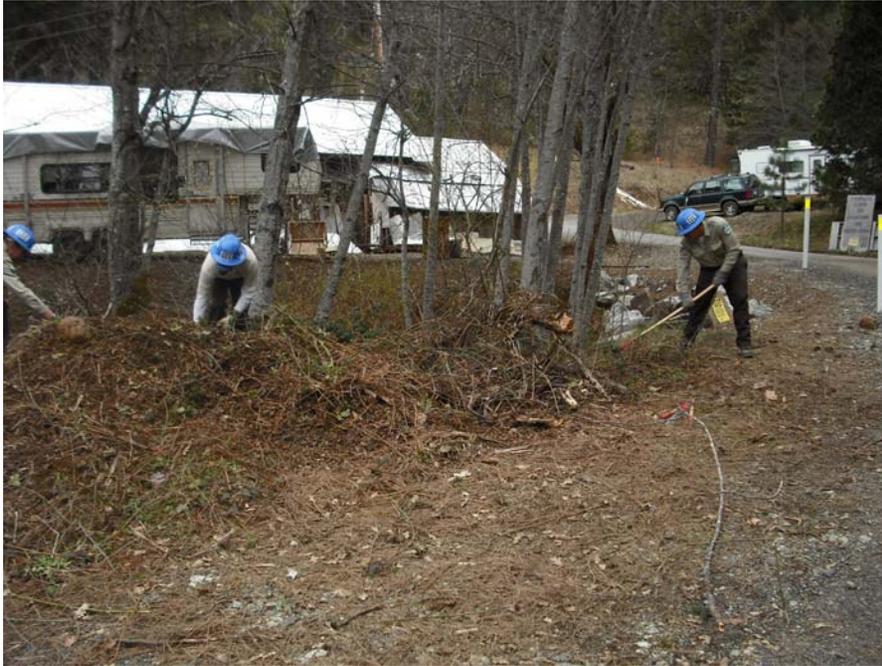
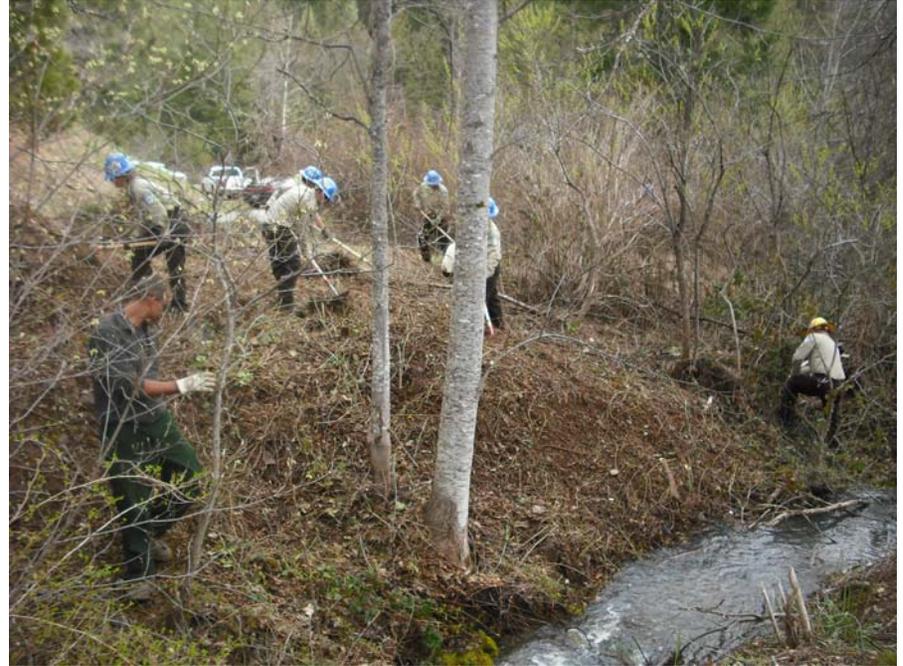
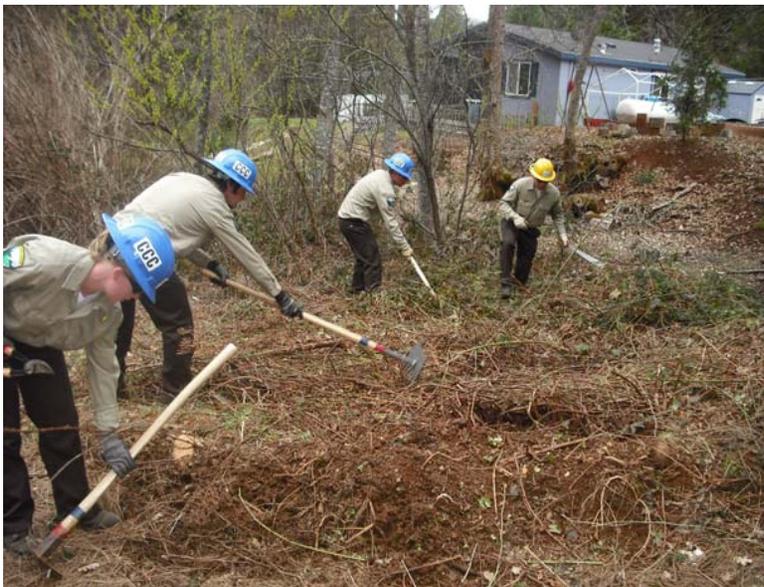
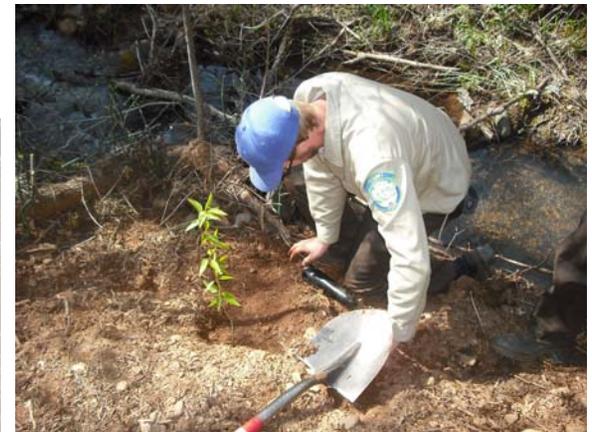
**Photo Series 9: Removal of non-native cut-leaf blackberry and revegetation with grasses and riparian tree species with assistance from the California Conservation Corps:**

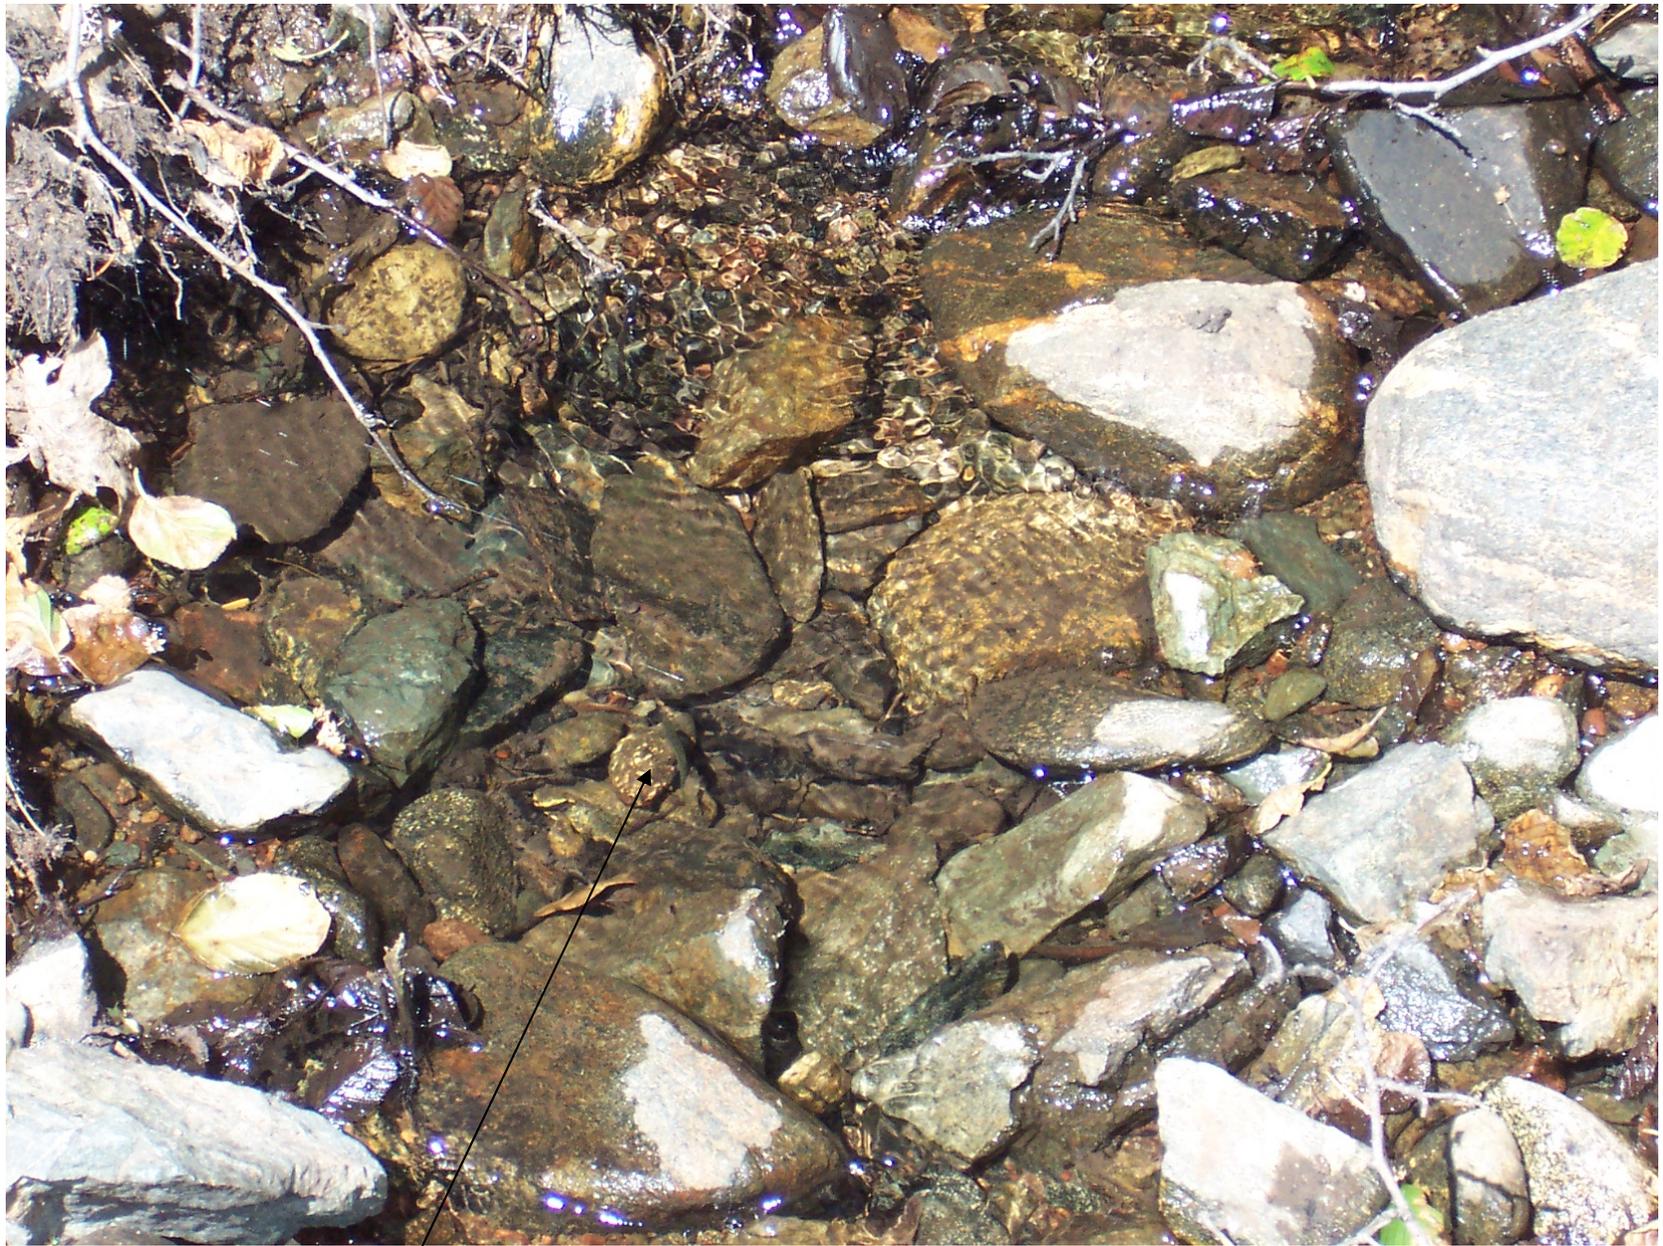
**YOY class Steelhead just upstream of the Culvert inlet (July 13, 2010)**
