**Rocky Gulch at Old Arcata Road
Channel and Floodplain Modification: Conceptual Design
Grant Agreement #205300**

FINAL REPORT

August 7, 2006

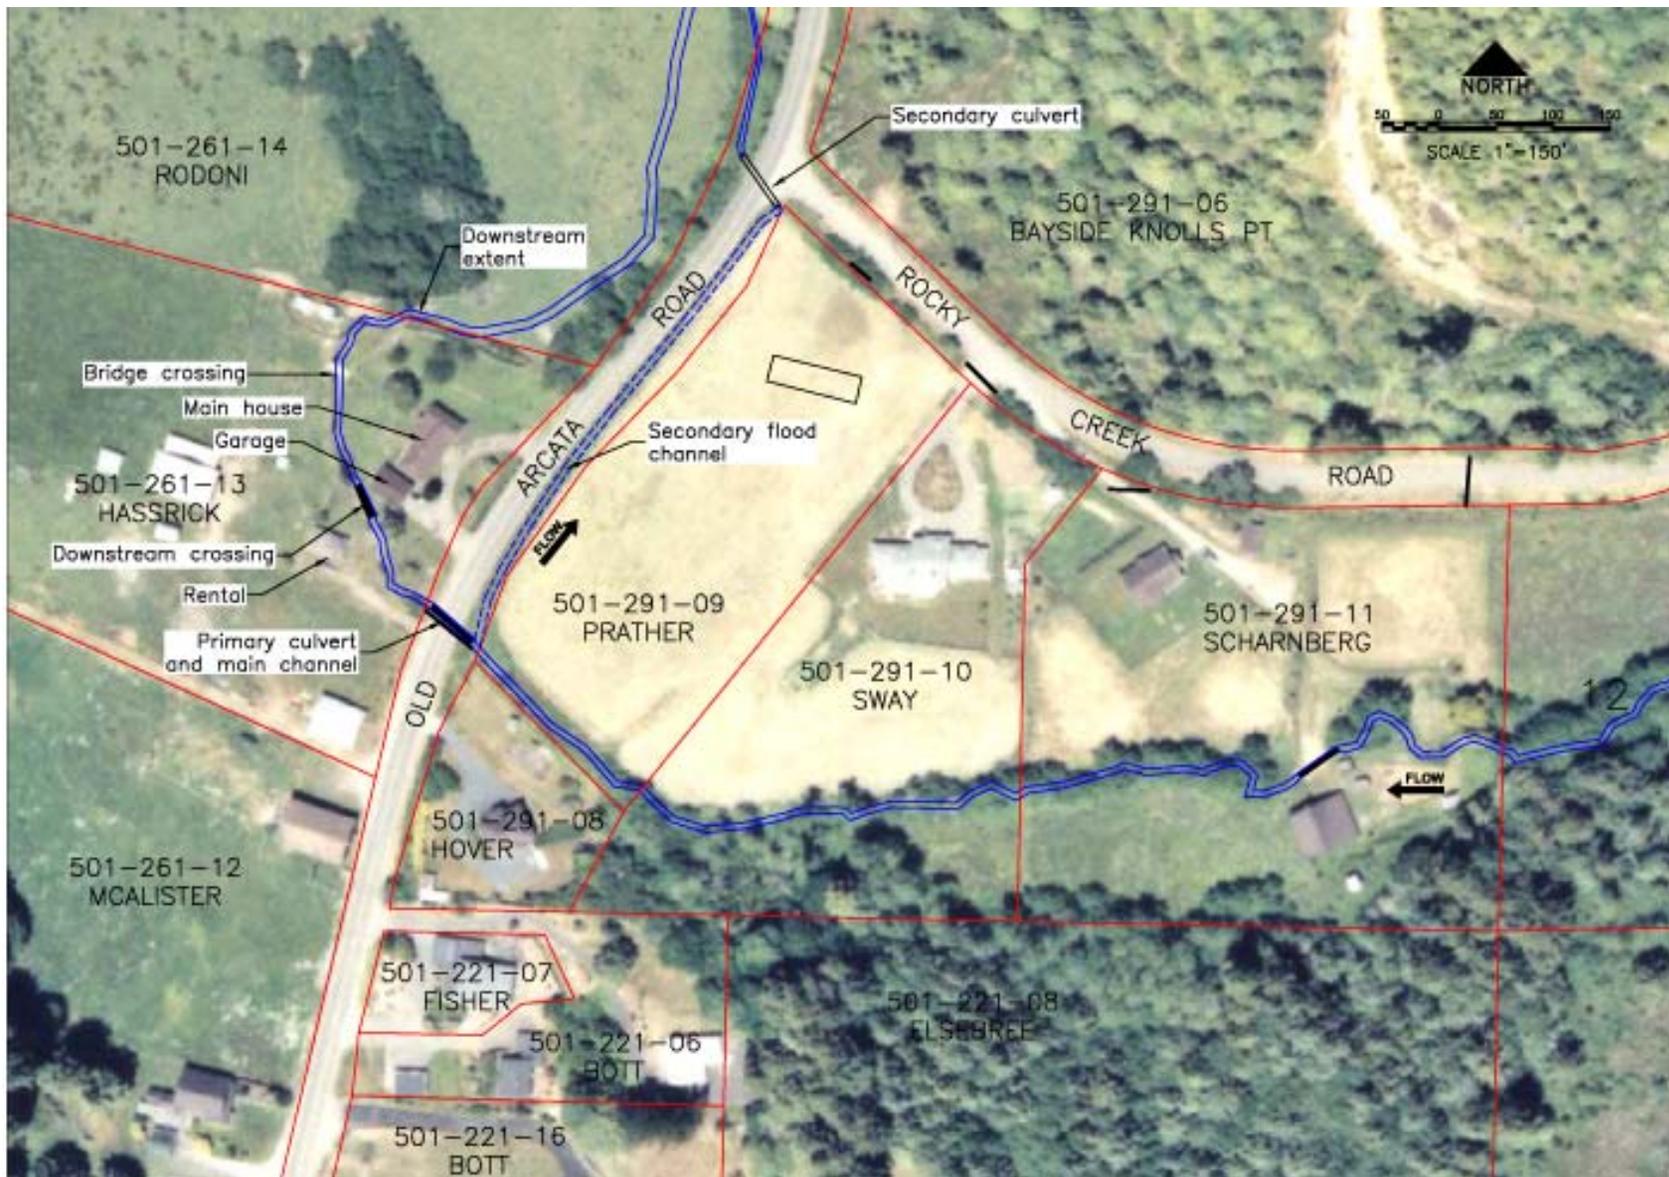
Figure 3. Residential parcels along Old Arcata Road surrounding the project area.

The properties surrounding the culvert are small (3-5 acre) privately owned parcels zoned for residential use (Figure 3). McBain and Trush and Jeff Anderson met with landowners Ginni Hassrick and Nathan Prather several times to discuss design alternatives. The failing retaining wall structure on the left bank upstream of the culvert was also discussed with landowner Lee Hover. This design memorandum presents design alternatives considered, presents our hydraulic modeling results, and then recommends a design that best balances landowner concerns, flood risks and impacts, and salmonid habitat issues.

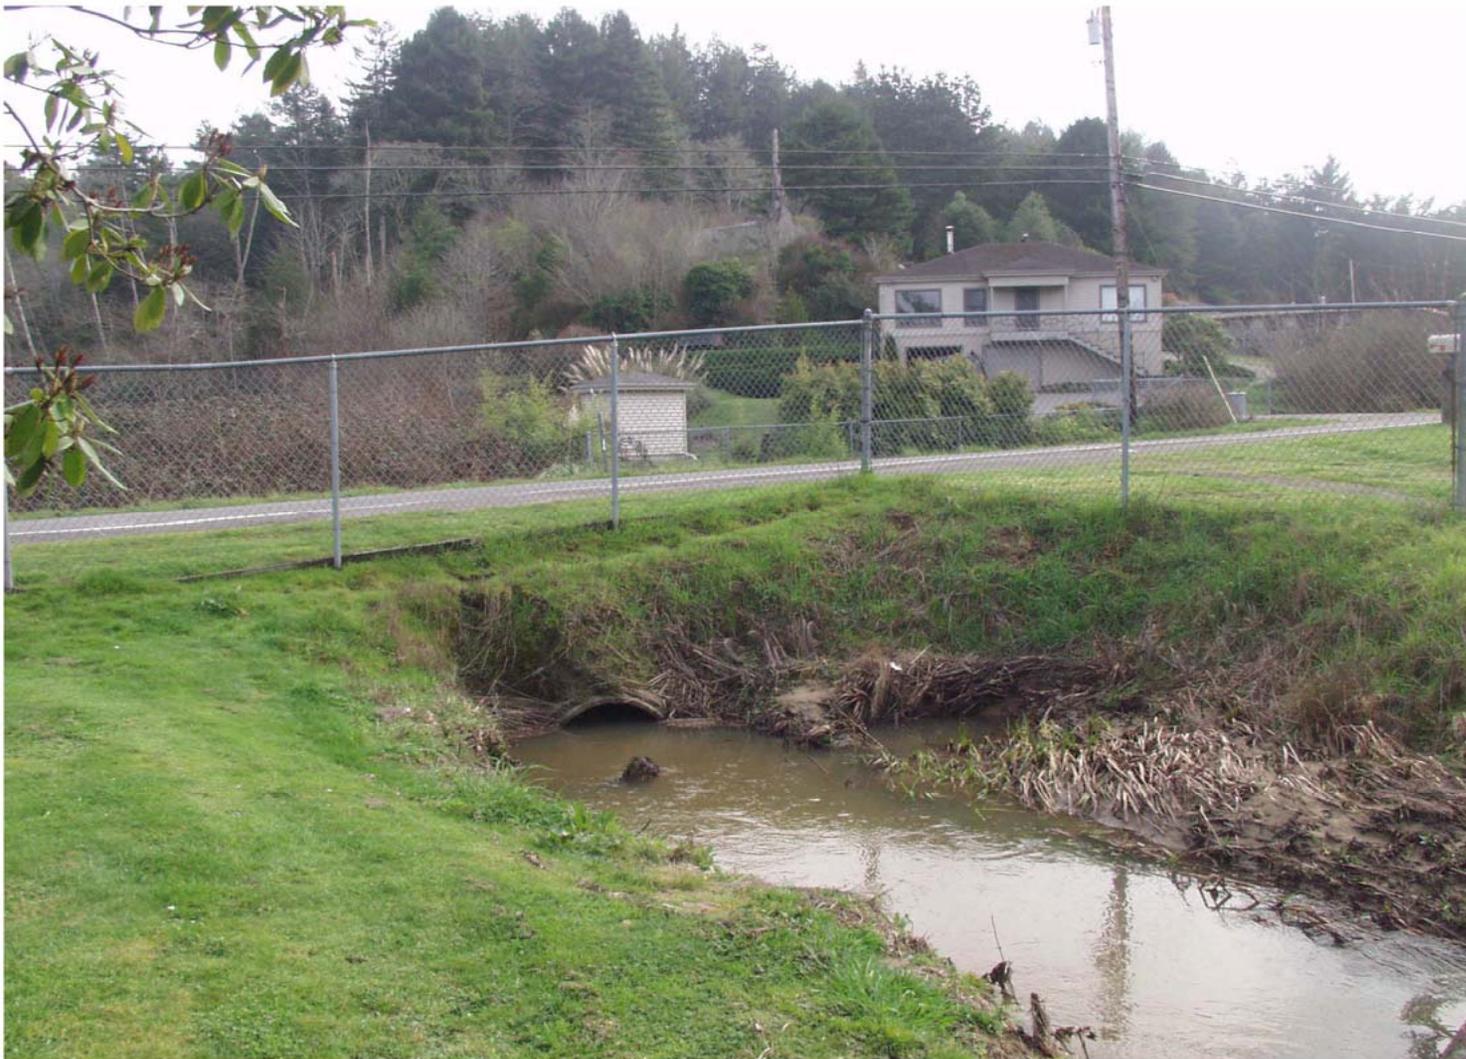
Figure 4. Downstream view of main channel and twin culverts passing under Old Arcata Road. The second culvert is underwater in this photo.

Overall condition: Poor, one culvert is overgrown and completely plugged with fine sediment. Entire channel flows through one 3' pipe (nearly full at low summer flow).

Sizing: Extremely undersized, especially with one pipe completely overgrown. Floods Old Arcata Road on a regular basis.

Barrier Status: Yes, excessive velocities occur in pipe at a moderate range of expected migration flows.

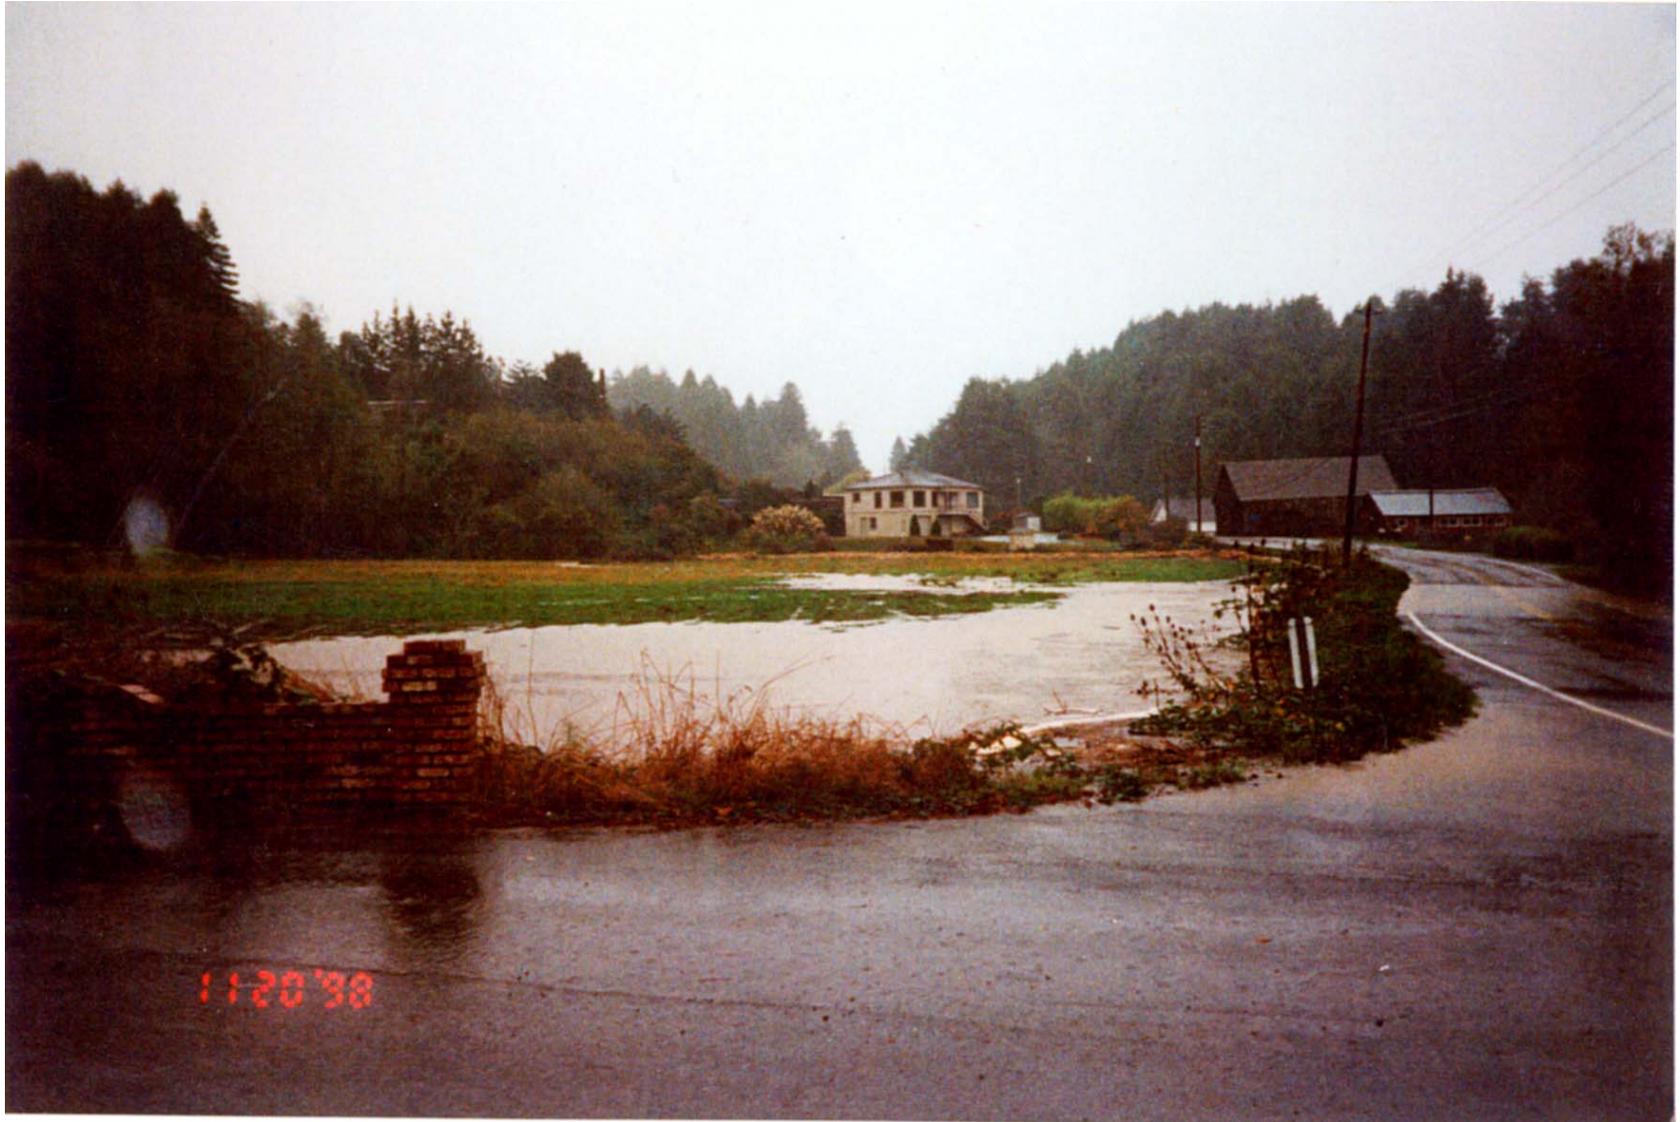
Figure 5. Floodwaters overtopping Old Arcata Road during the November 1998 flood. Photograph taken at the foot of Rocky Creek Road looking south. The main channel is in the distance; the secondary culvert entrance is in the foreground.

culvert at the foot of Rocky Creek Road before rejoining Rocky Gulch. Floods exceeding approximately a 5-yr recurrence interval overwhelm the ditch and secondary culvert capacity and flow overtops the road (Figure 5). A previous landowner constructed a berm along the right bank of the main channel for approximately 150 ft upstream of the culvert, in an attempt to route flood flow to the OAR culvert. This effort has been unsuccessful, primarily due to the undersized OAR culvert and the sloped topography.

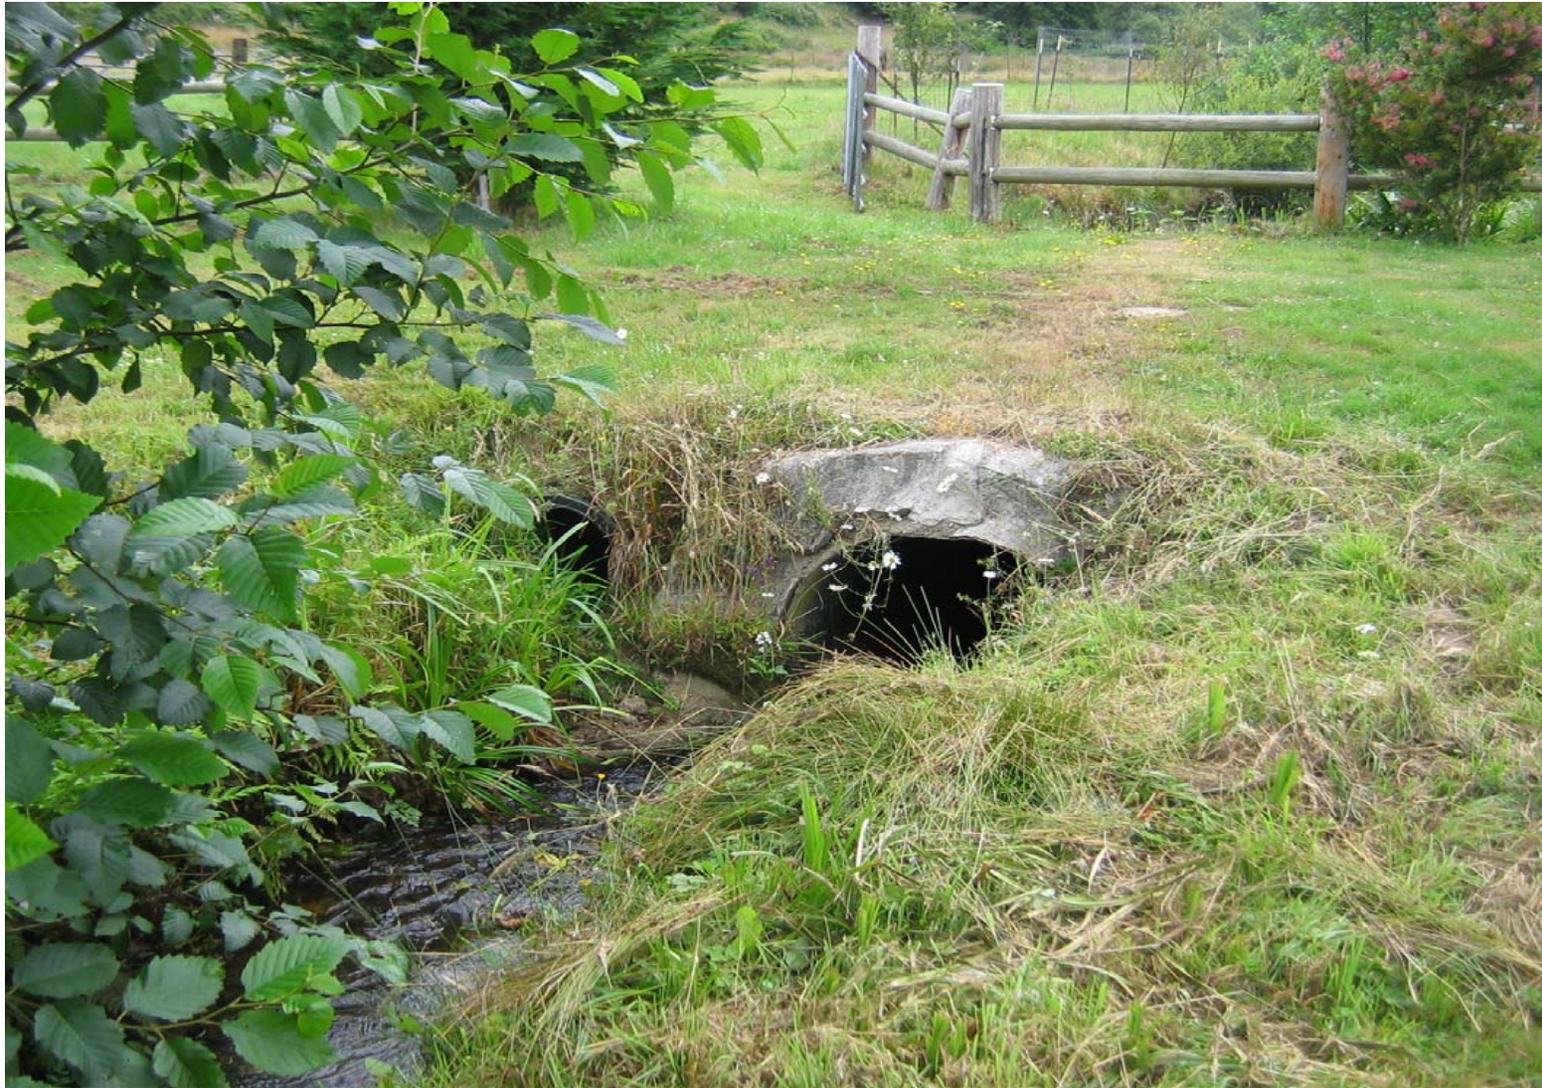
Figure 6. The downstream crossing culverts on Ginni Hassrick's property. The culverts were installed by a previous landowner, and are too small to convey large floods.

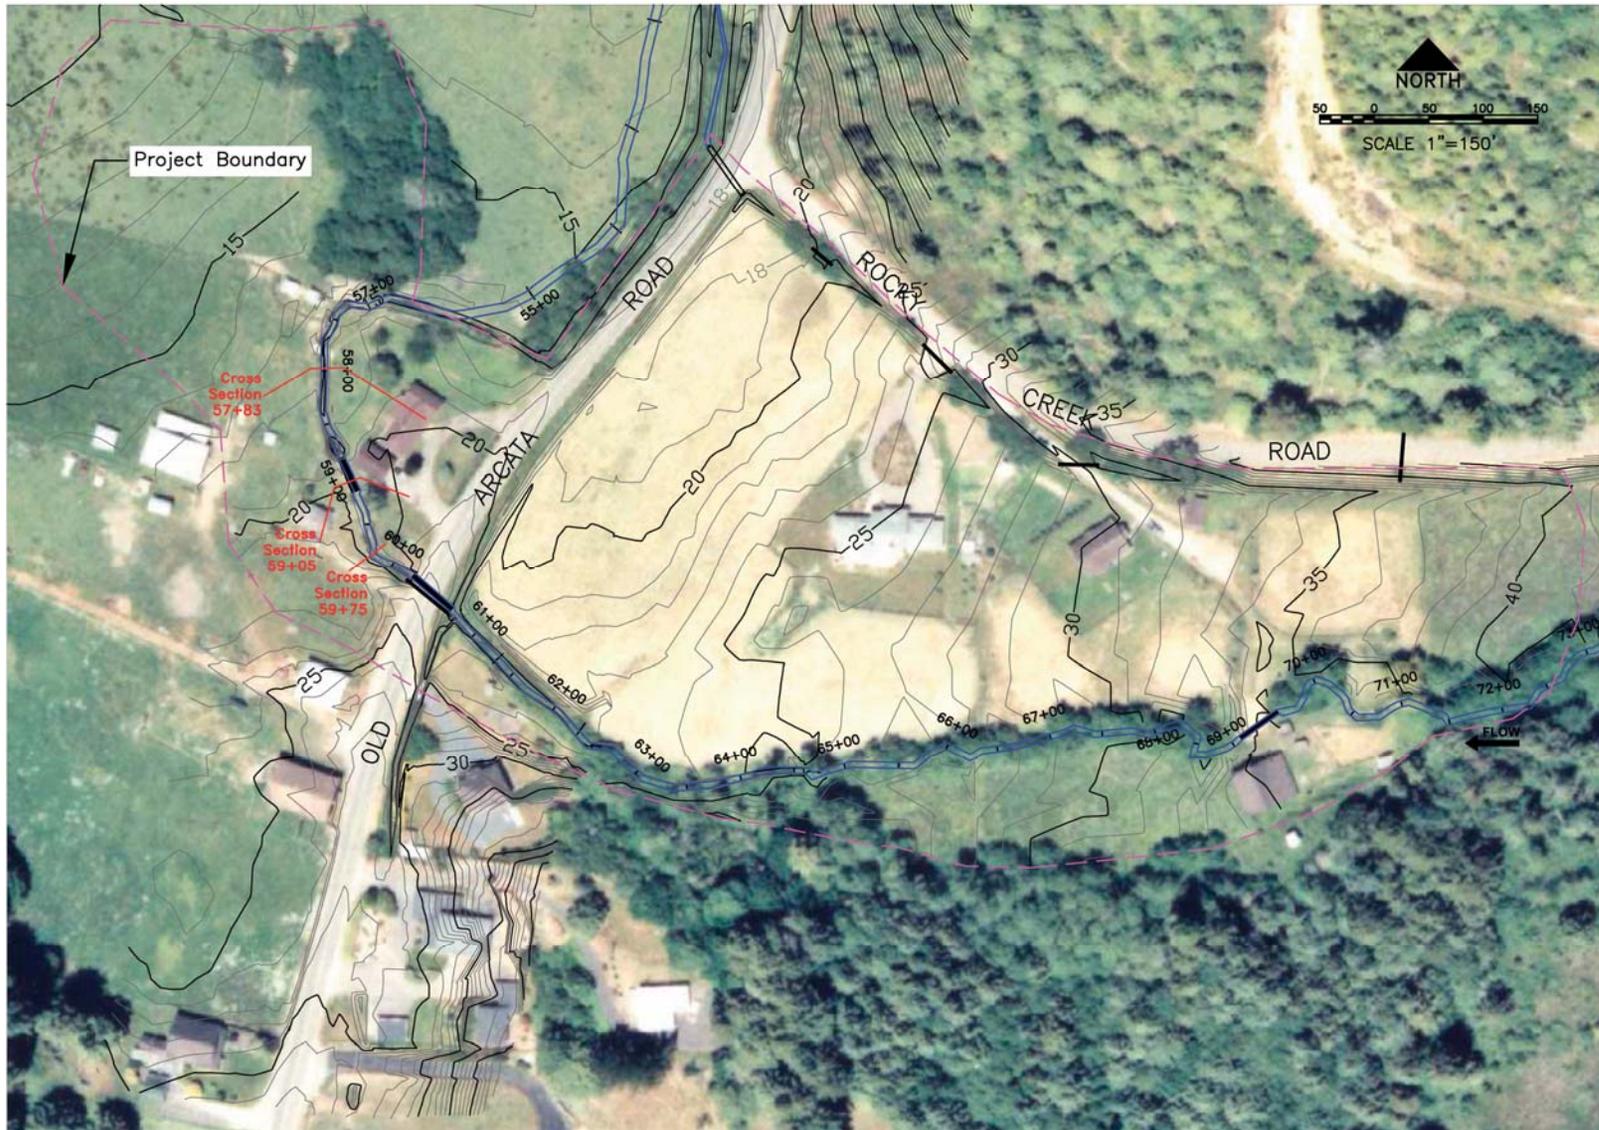
Figure 10. Contour map showing the project boundaries and extent of topographic surveys conducted for the project conceptual design and hydraulic modeling.

Portions of the land within the project area had been surveyed in prior projects, but additional surveys were required. The Humboldt County Public Works (HCPW) Department collected topographic surveys on parcels adjacent to the culvert, and M&T crews collected topography, channel profile, and cross section data upstream to station 69+00 and downstream to the Rodoni property. The resulting topographic surface provided the basis for hydraulic modeling and conceptual designs (Figure 10). We also obtained and orthorectified the 2001 aerial photographs from the Humboldt Bay Harbor, Recreation, and Conservation District for use as a basemap (Figure 10).
