Ryan Creek Migration Barrier Replacement Project

California Department of Fish and Wildlife Grant Award #P0910515

**FINAL REPORT
October 15, 2013**

David Colbeck and Mark Lancaster
Five Counties Salmonid Conservation Program
Northwest California Resource Conservation and Development Council
Weaverville, CA 96093

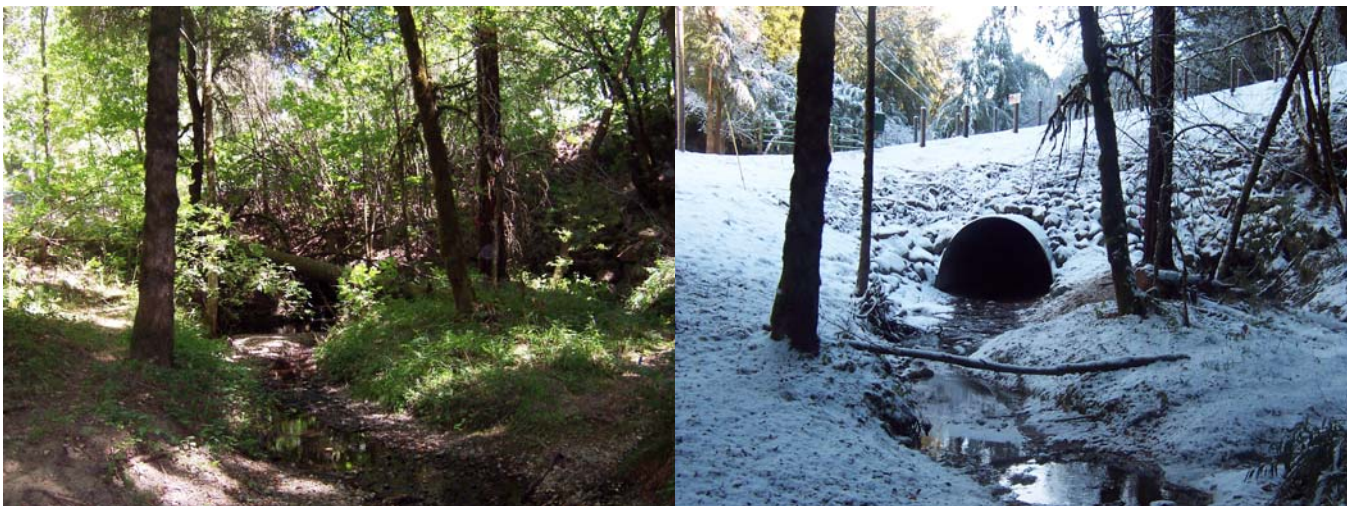
Rhine Driveway Project before with 5' corrugate metal culvert looking upstream (left) and restored channel with 14' wide multi-plate arch culvert (right).

Commencing August 12th, the 5’ diameter corrugated metal pipe (CMP) culvert was removed and replaced with an 100 foot long 14-foot span corrugated metal multi-plate arch, implementing a full stream simulation design through the road crossing. The old culvert created a 1.5’ jump at the outlet that did not allow for full fish passage. Both existing culverts were partially rusted through and had begun to collapse in several places. Also, the undersized crossing reduced passage of bedload and debris associated with the high flows. The full stream simulation design complies with the *NMFS Guidelines for Salmonid Passage at Stream Crossings* (September 2001 as amended), allowing for the 100-year flood flows and associated bedload and debris to pass safely through replacement structures. This treatment minimized the potential for future culvert failures in larger storms (<100 year storms). The pre-existing culvert at the Rhine Driveway overtopped on relatively small storms, due in part to a backwatering effect caused by the State Highway 101 crossing immediately downstream, with a significant loss of hydraulic efficiency (creek flows are above the culvert inlet and half-way up the upstream fill face) at the 10-year flow. The new crossings reduce potential maintenance costs associated with storm flows and culvert plugging, and eliminate the potential for delivery of approximately 3,600 cubic yards of road fill material into the downstream reaches of Outlet Creek and the Eel River.

The existing northerly culvert was replaced with a 13-foot 10-inch wide x 12-foot 2-inch tall, 100-foot long embedded multi-plate arch structure, following the stream simulation design. The southerly culvert was left in place and sealed. This design will allow for improved fish passage of all life stages for coho, Chinook, steelhead and Pacific lamprey.

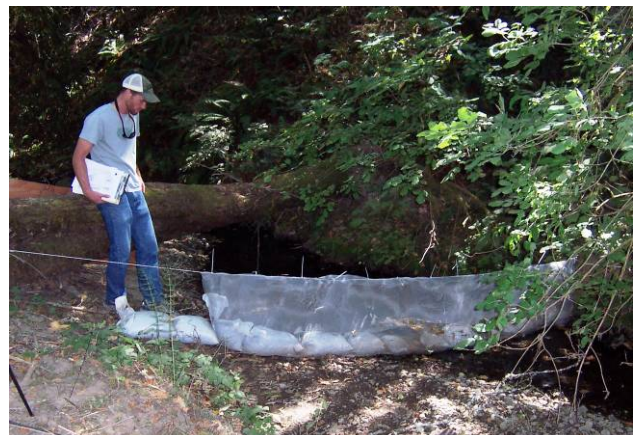
On August 13th RTA conducted pre-project depletion estimates in channel reaches downstream and upstream of the perched culvert. The objective was to determine if there were differences in fish numbers above and below this suspected partial migration barrier. In each reach, two electrofishing passes were made, with fish from the first-pass held until the second-pass was completed. The upper reach was located between the culvert inlet and the exclusion fencing erected for the pre-project fish relocation. The lower reach was located downstream of the lower exclusion fence and was only bounded by the exclusion fence on its upstream end. The upstream reach was 75 feet long, the downstream reach was 82 feet long, and both reaches had three small pools where most of the fish were captured during the electrofishing depletions. The differences in population estimates for the channel reaches downstream and upstream strongly suggest that the private culvert is at least a partial barrier to adult salmon and steelhead, and a complete barrier to juvenile salmonids².

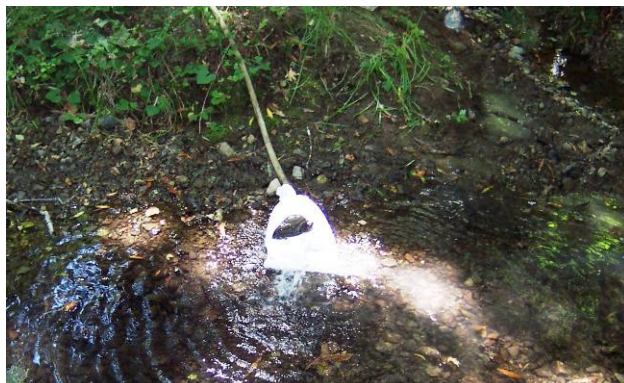
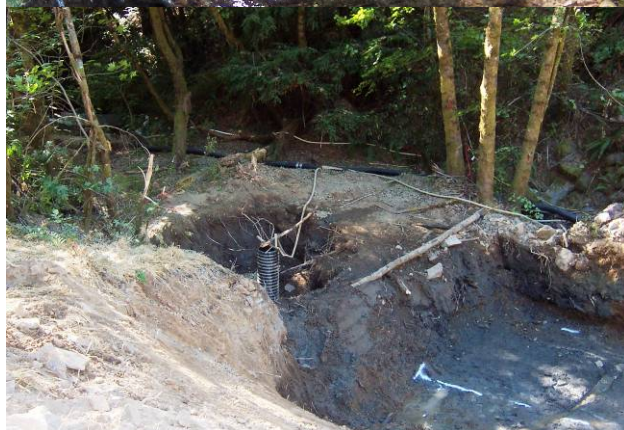
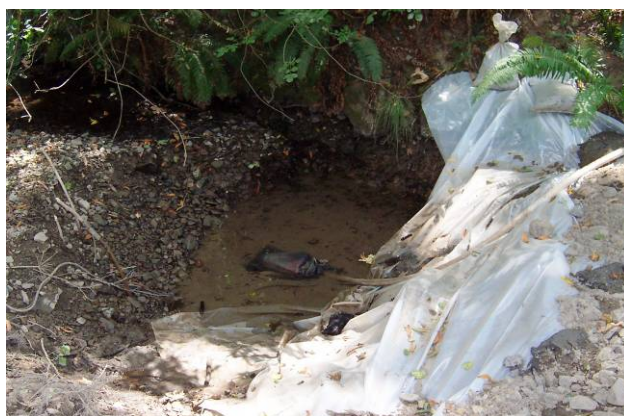
A sump hole was dug in the creek at the bottom of the project site to facilitate removal of turbid water with a submersible pump controlled by a float valve to the downstream flood plain. A second sump hole was

dug in the creek bed at the top of the project to remove as much interstitial flow from the excavation site as possible. Turbid water caused by construction activities and interstitial creek flow was collected at the bottom of the construction area and pumped onto the hillside downstream. This water was discharged to the ground in a vegetated flat area approximately 80 feet from the top of the bank. The discharge pipe was relocated periodically (twice a week) to prevent saturation of the ground and potential surface flow returns to the creek. A perforated HDPE flexible pipe was affixed to the end of the discharge pipe to facilitate the dispersal of water across a large area.

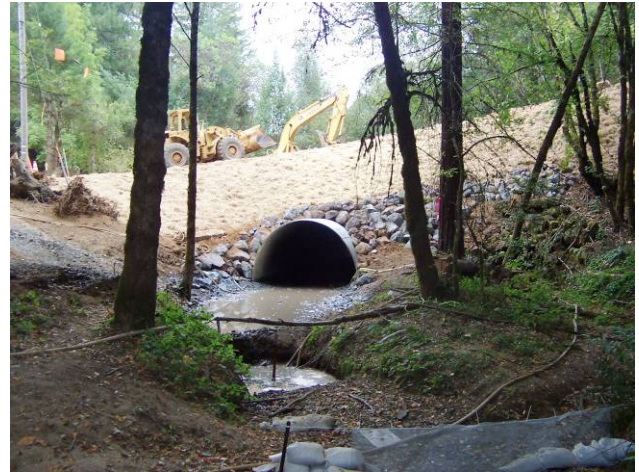
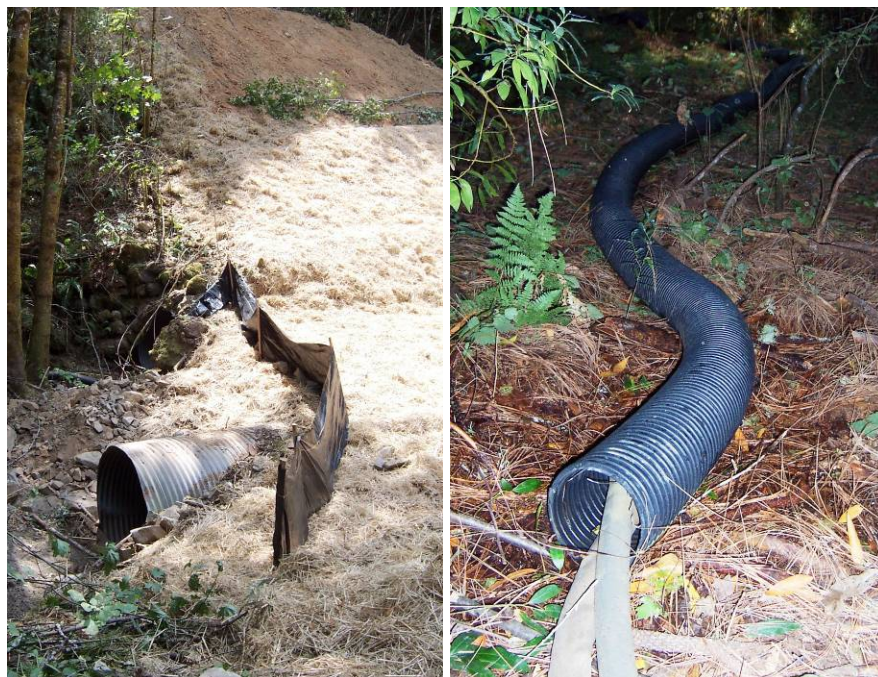
Left - Straw mulch and silt fencing was used during extended shut down periods to prevent erosion and delivery of sediment from the excavation site. Right – use of perforated pipe to distribute turbid discharge across the floodplain.

The spoils site was located in a clearing 50' Rhine Driveway from the construction site. Silt fencing was installed at the down slope side of the spoils site to prevent surface runoff and sediment transport in the case of summer storms. Additional sediment control materials, including tarps and silt fencing, were kept on hand should weather (wind or rain) conditions change. During work stoppages, including weekends, construction crewmembers monitored the works site to assure creek flows were maintained through the project and that the spoils site was stable. Straw and silt fencing was installed above the existing culvert at the upstream and downstream edge of the excavation area in order to prevent sediment traveling to the creek during the work stoppage, see below.

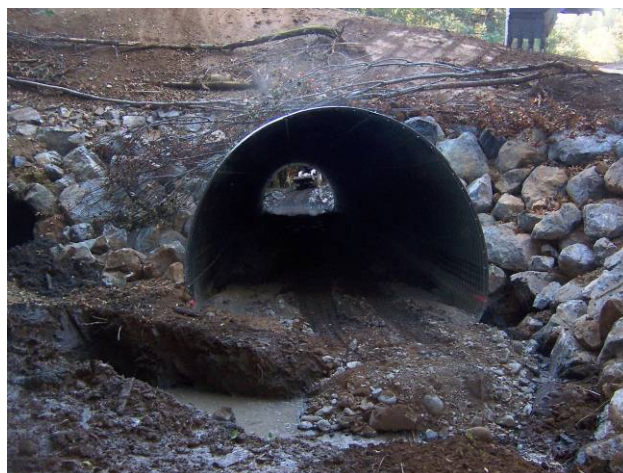
Between September 7th and September 15th road fill was placed in lifts. MDOT conducted compaction testing concurrent with fill placement. Fill compaction exceeded 90% in the fill face and 95% on the road surface as per design requirements. Concurrent with fill construction, large wood was placed in the channel (utilizing both small diameter material stockpiled after grubbing activities and rootwads unburied during excavation of the fill) and the streambed material was installed into the channel. Streambed materials consisted of river-run rock that required minimal amendments to achieve the desired streambed mixture. The streambed was installed using a small bulldozer and rented, tracked skid-steer. Jetting

occurred over one day using a water truck and re-circulated runoff. Half-ton rock-slope protection was installed upstream and downstream of the new culvert to prevent any scour and increase fill stability. The downstream portion of the channel was re-contoured to reduce the potential for scour on the right bank. The existing overflow culvert was plugged using large rock intermixed with streambed mix. During the entire construction period diversion pumps and fish exclusion netting were checked and maintained as necessary.

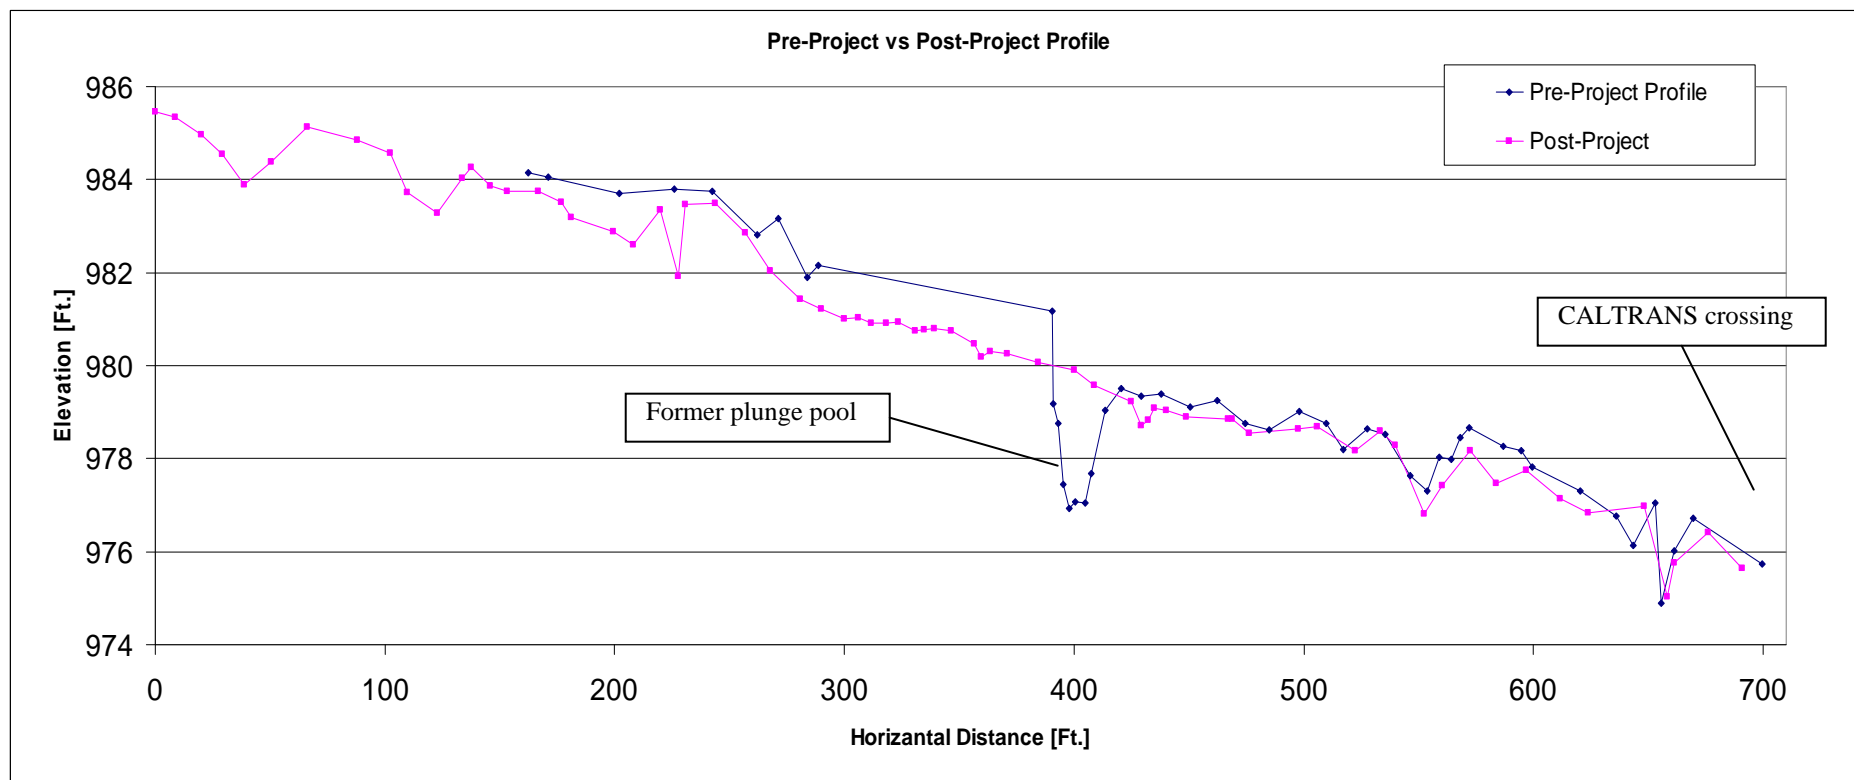
LONGITUDINAL PROFILE/THALWEG MONITORING

Note: Variations in the pre and post-project are caused, in part, by slight channel adjusted due to trees falling in the creek and associated root wads creating new pools. This tree fall was not caused by project construction as they were located outside of the area of any activity. Also, slight discrepancy exists between the pre-project survey and the post-project survey –specifically with the location of the CalTrans Highway 101 crossing located at the bottom right of the graph. This difference is caused by the horizontal distance between data points varying between each survey. Normally, this is correctable by stretching one graph to correspond to another by matching data points (non-moving, exactly known physical points). However, the post-project survey was completed in the winter under snowy conditions and an inadequate number of matching points were collectable. Because the surveys are of a relatively short distance, this discrepancy is small.

Longitudinal Profile/Thalweg Monitoring: Pre-project longitudinal and thalweg surveys have been completed. A Post-project longitudinal profile survey was completed following construction. Similar monitoring will be conducted at the County Road Ryan Creek project site and will tie in to this project's survey.
