# Ryan Creek Migration Barrier Replacement Project

California Department of Fish and Wildlife Grant Award #P0910515

## PHOTO LOG

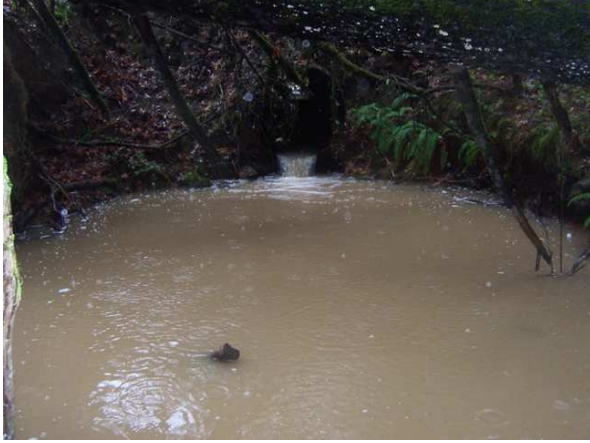
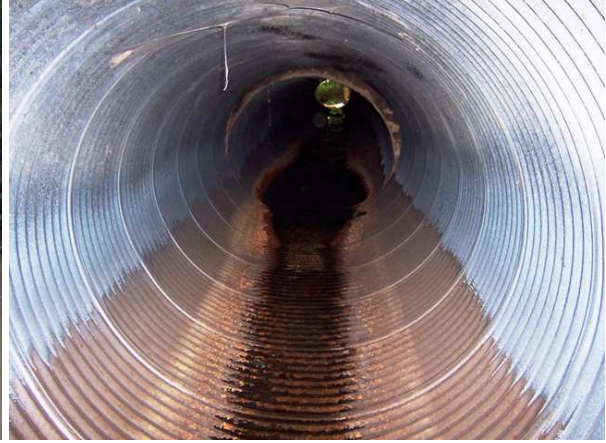
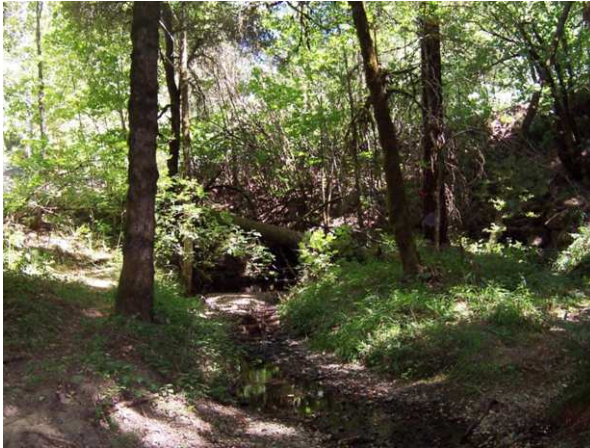
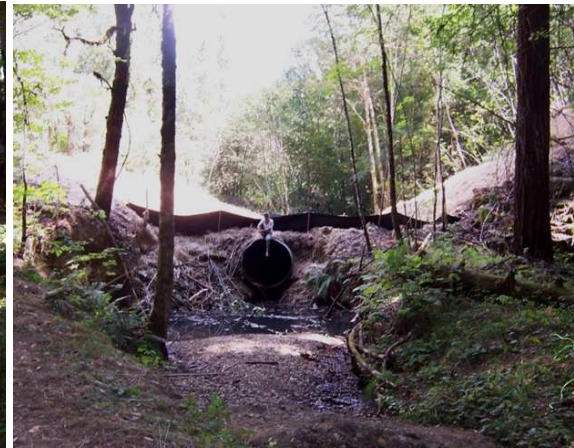
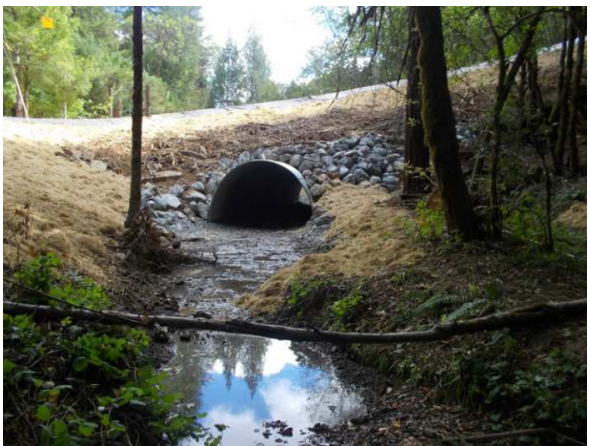
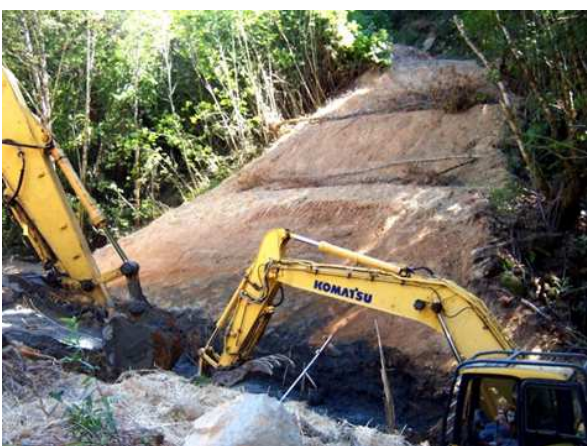
Upper Left Outlet of 5' diameter culvert before project. Upper Right- Inside old culvert showing disconnected segments and rotted bottom. Middle Left- Looking upstream pre-project. Middle Right Fill excavated to culvert depth. Bottom Left- New 14' x 12' (with 3' embedded) arch in place. Bottom Right- 40' deep cut to get new culvert in place.

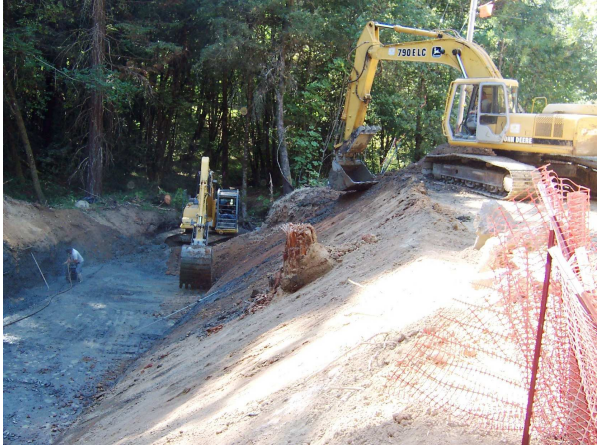
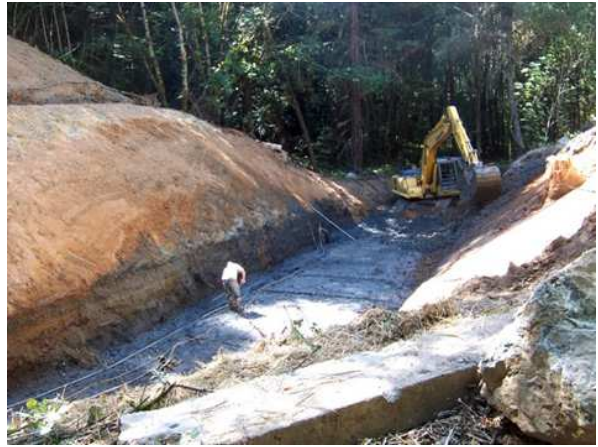
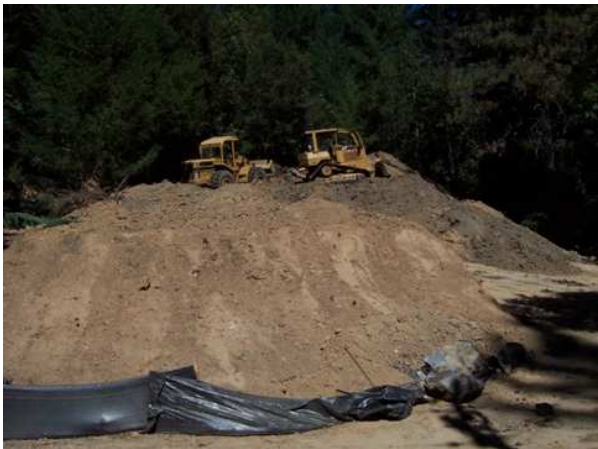
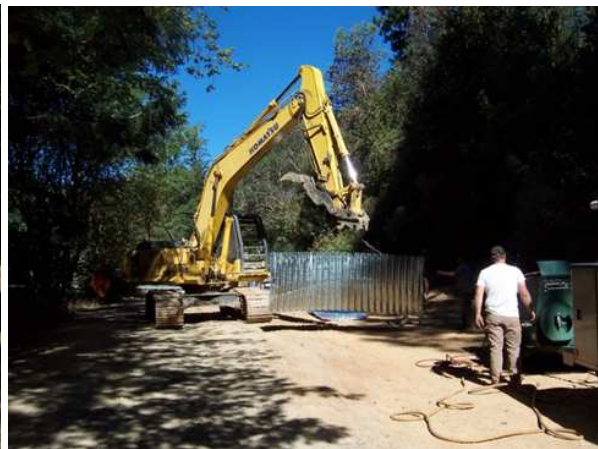
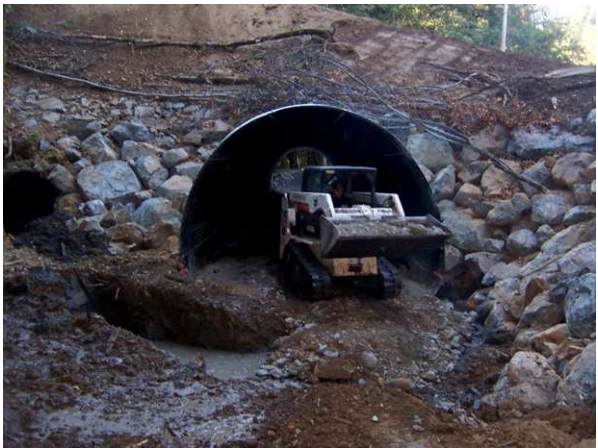
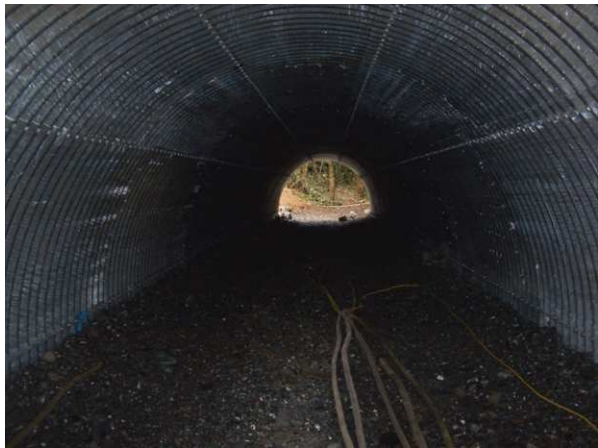
Upper Left- Digging below stream grade to set arch. Upper Right- The creek bed was dewatered and culvert alignment and grade set. Middle Left- Managing the spoils pile. Middle Right- Unloading the arch pieces. Bottom Left- Filling the stream bottom with material. Bottom Right- Streambed in place.

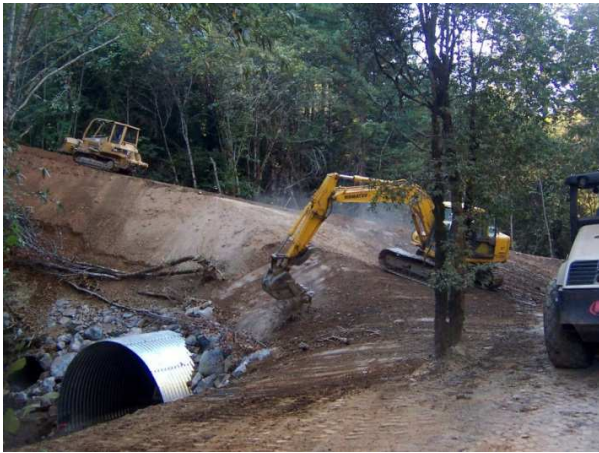
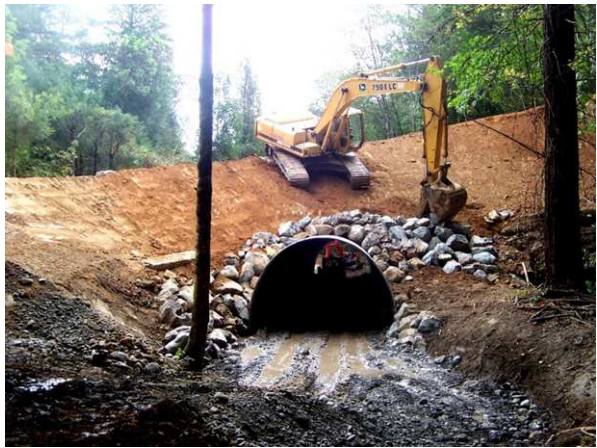
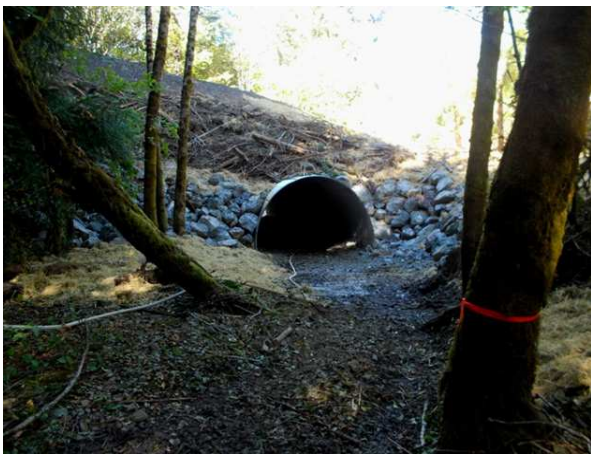
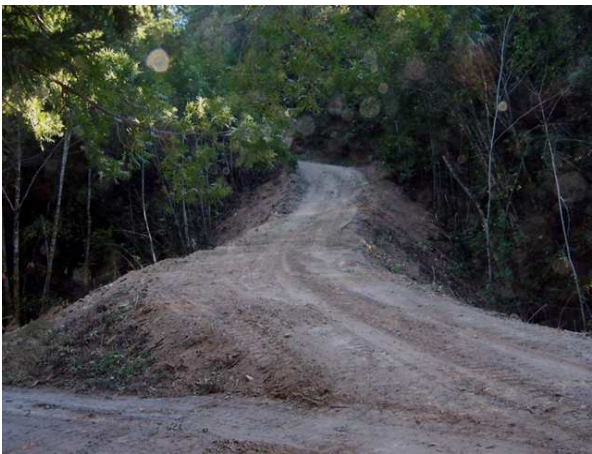
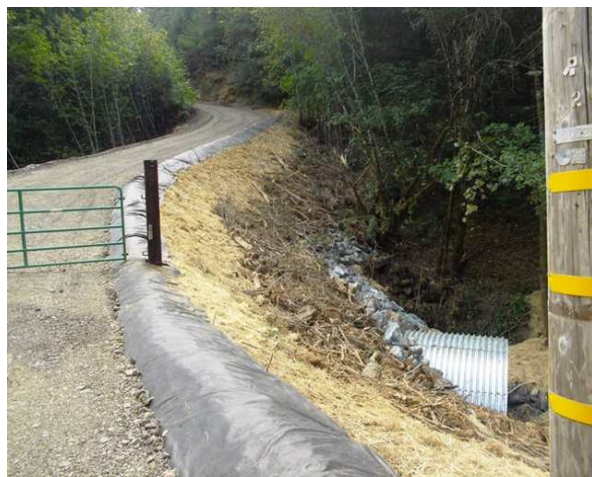
Upper Left- Replacing the road fill. Upper Right- Placing rock slope protection while rebuilding road. Middle Left- Upstream of inlet. Middle Right- Road roughed in. Bottom Left- Road roughed in. Bottom Right- Road in place with only "guard rails" remaining to be installed.

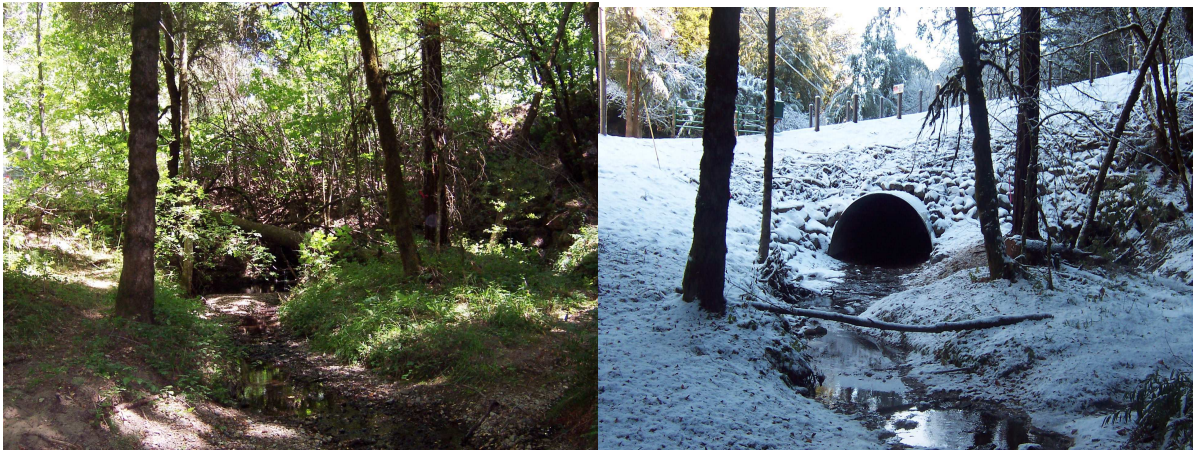
Rhine Driveway Project before with 5' corrugate metal culvert looking upstream (left) and restored channel with 14' wide multi-plate arch culvert (right).
