# Sidney Gulch at Weaver Bally Loop Road Migration Barrier Removal Project

Final Report For  
California Coastal Conservancy  
(Agreement 15-011)

**Prepared By:**  
Five Counties Salmonid Conservation Program  
Northwest CA Resource Conservation and Development Council

January, 2016

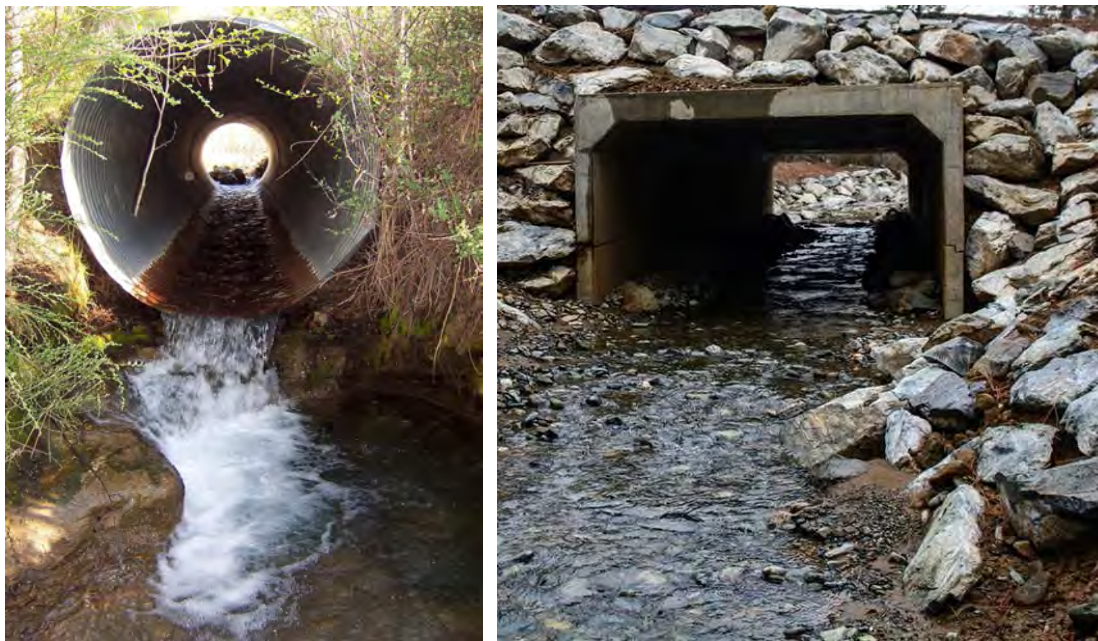
Figures 1 and 2: Pre-project jump and 5% channel gradient in the 7' diameter metal culvert made it impassible to fish migrating upstream. Above left the 12' x 9' box culvert was imbedded 3' and allows for migration on all fish flows.

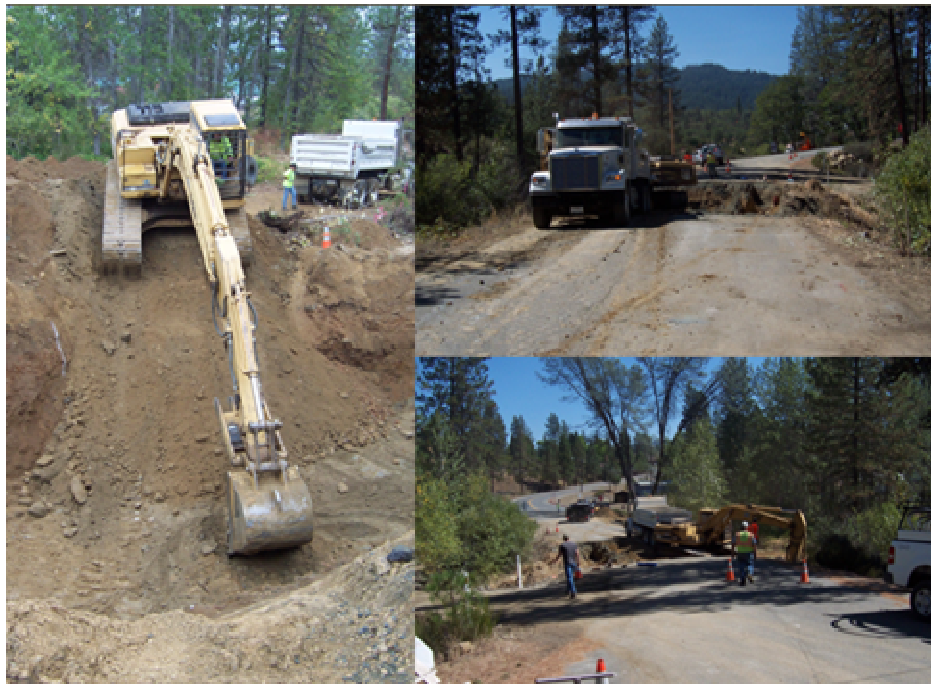
**Figures 3-5. Excavating the road fill and preparing the bottom for placement of box culvert segments (Above left). The road excavation (Right)**

Once the detour road was open, the Bally Road fill was excavated down to the depth of the Weaverville Community Services District water main, the Weaverville Sanitary District sewer main, and the buried power, phone and cable conduit. All pipes and conduit were cut and removed with temporary pipes routed around the work area. Once utilities were removed the fill was excavated to a depth of ~12' on the outlet end and 15' on the inlet end. Spoils were end hauled to the staging area. A bed of sand was leveled at the bottom of the excavation at the end of the second week of September. A water main break at the project site that weekend required emergency repairs and pumping to dry out the work area sufficient to stay on schedule to place the box culvert segments.

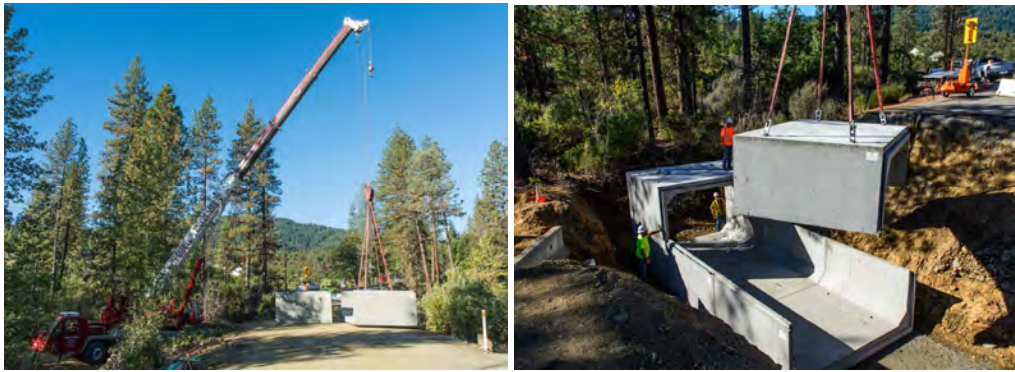
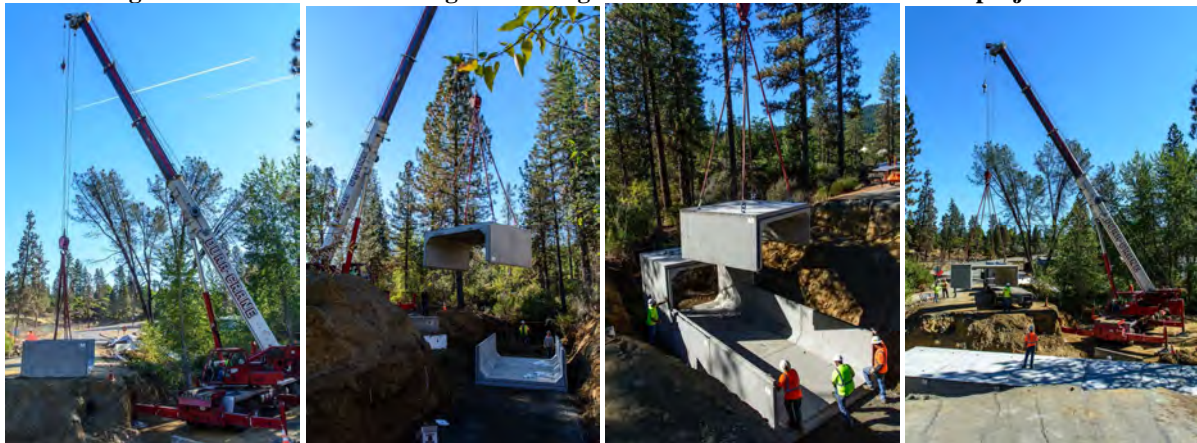
Figures 6 to 11. Box culvert segments being lifted from the road and set in the project site

The 15-20 ton Jensen Pre-Cast concrete box culvert sections arrived from the Fresno area the day before being set and were temporarily staged at the Alps View School parking lot utilizing a flatbed truck with a 20 ton self-loading crane. The self-loading crane was used to off load the culvert segments and then reload each one for delivery to the work site approximately 300' away. At the work site, a pad had been constructed to lift, or pick, each segment with a 100 ton crane. The pick distance for the upstream culvert segments was the maximum feasible for the 100 ton DuraCrane and required additional grading to assure stability of the pad. The crane set up, culvert segment placement and crane breakdown was completed in under 8 hours. With the box culvert set the DoT immediately started replacing fill and compacting the material in lifts. Once the fill reached the elevation of the underground utilities the pipe and conduit were reinstalled. The section was then filled and compacted to the subgrade level. Asphalt grindings were then placed to allow for vehicle traffic to use the road in lieu of the detour route.

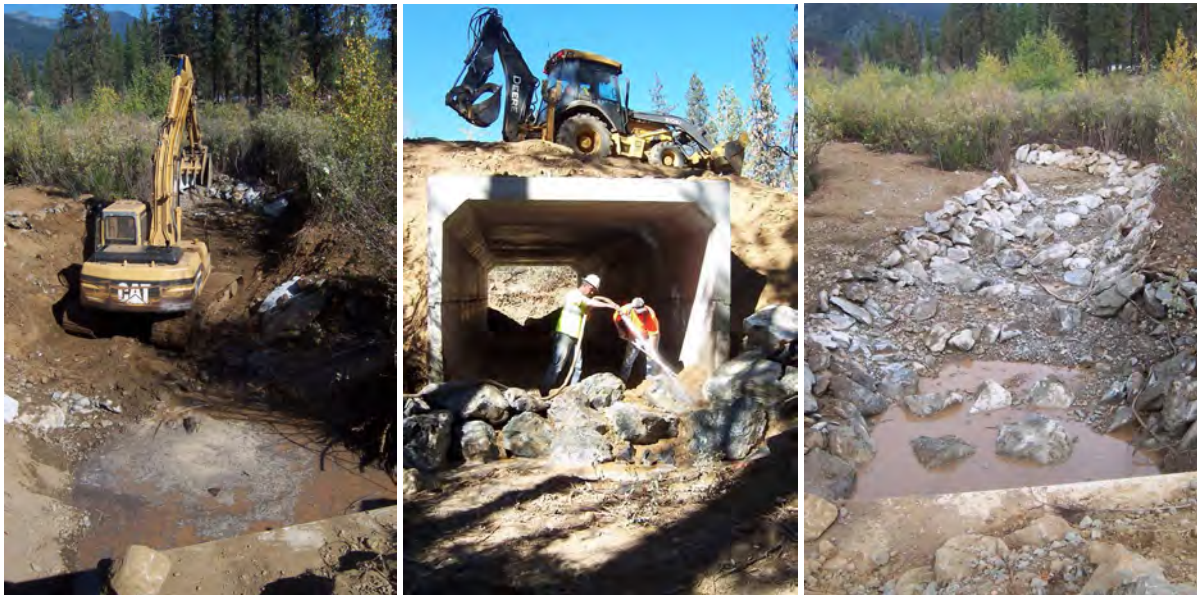
**Figures 12 to 16. Upstream channel construction began with cutting excess material and preparing the channel bottom (Left). Jetting fine sand and clay into voids in a grade structure (Middle). Placing the roughened channel bottom, grade structures and apron upstream of the crossing inlet (Right).**

The 220 feet of constructed channel consists of 8 rock ribbon grade-control structures (1 and 1.5-ton RSP), buried 2 layers deep and keyed into the banks as well as a 50 foot roughened channel set at 5.7% slope. At the downstream terminus of the roughened channel a channel ribbon and low gradient transition were installed upstream of the culvert inlet to dissipate energy from the roughened channel before the flow enters the culvert. The side channel was partially rocked with RSP.

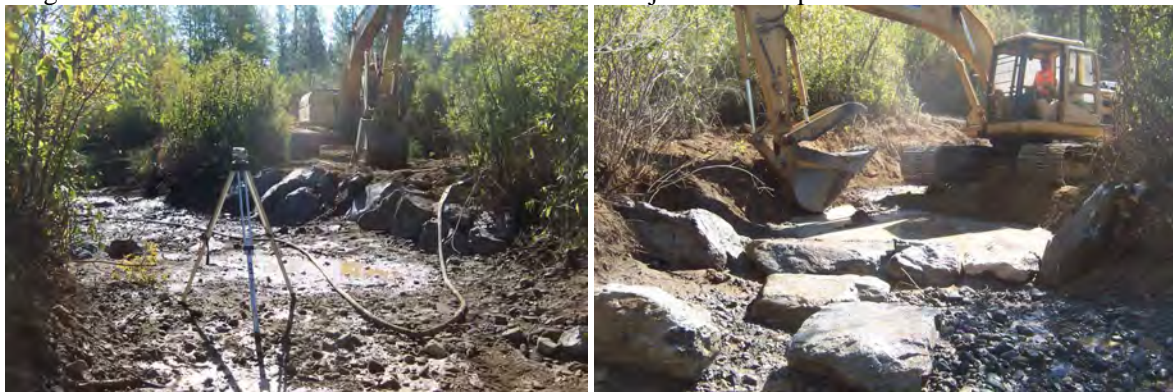
**Figures 17 and 18- Channel grade was set with a level and large grade rocks set in the channel and on the banks.**

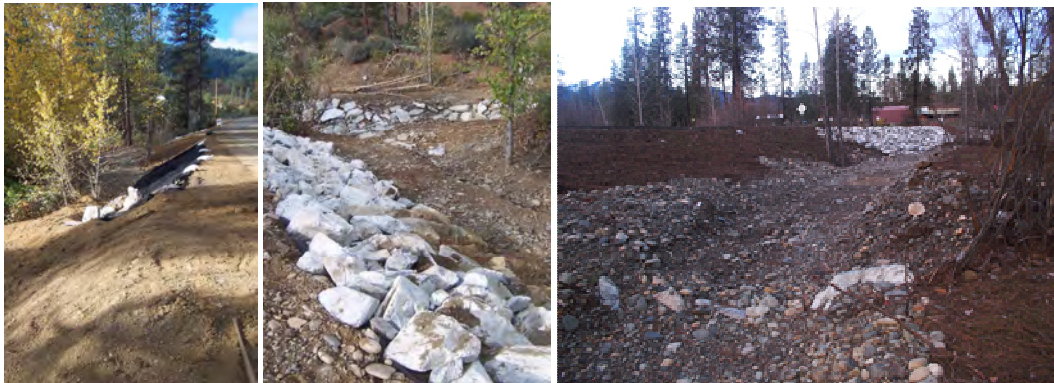
**Figure 19 - 21-** The overflow channel on the downstream side of the road was designed with larger RSP where the water overtops the road and a return channel to Sidney Gulch.

A static overflow channel was constructed on the downstream of the road to carry overbank/over road flows back to the stream. The critical dip in the road is relatively broad (10') allowing for low flow velocities and shallow depth when the road floods. The RSP for the overflow channel was sized to remain stable when the road overflows and the channel bottom was rocked to prevent downcutting.

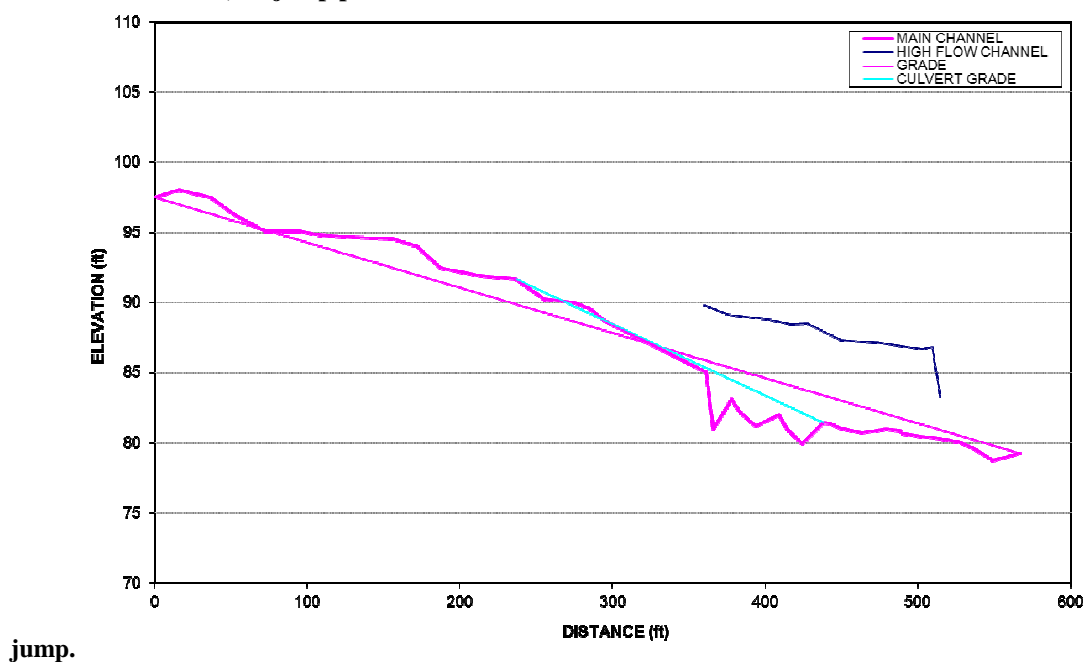
**Figure 22 (Below) Pre-project Thalweg Survey showing aggraded channel reach upstream of the culvert, the jump pool at the outlet and the scour reach downstream of the**

Longitudinal Profile/Thalweg Monitoring: The pre-project longitudinal and thalweg surveys utilized for designing the crossing and channel were completed in 2011 and entered into AutoCAD. Four cross-sections were also measured. A post-project profile was taken again immediately following project construction. Post project surveys of the same areas will be done at a future date in response to storm flows and channel adjustments.

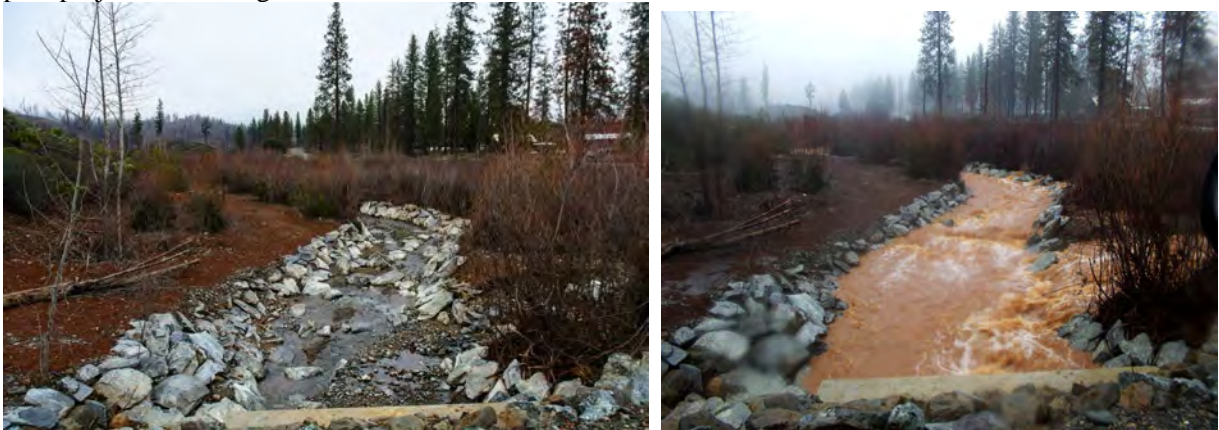
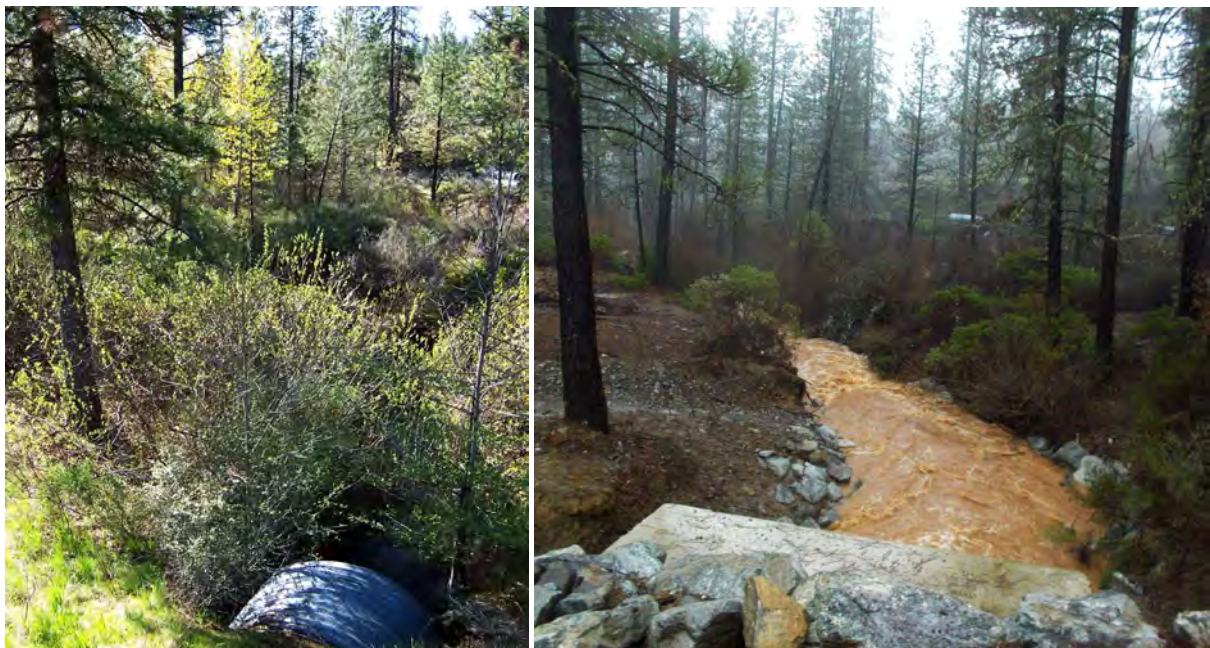
**Figure 24-Figure 27.** Above (Left) Upstream on December 20<sup>th</sup>, 2015 and Above (Right) on January 17<sup>th</sup>, 2016 during a ~Q<sub>7</sub> flow. Below Left- Pre-project looking downstream of outlet of 7’ culvert and Right looking downstream during Q<sub>7</sub> flow on January 17<sup>th</sup>, 2016 from 12’ x 6’ box culvert.

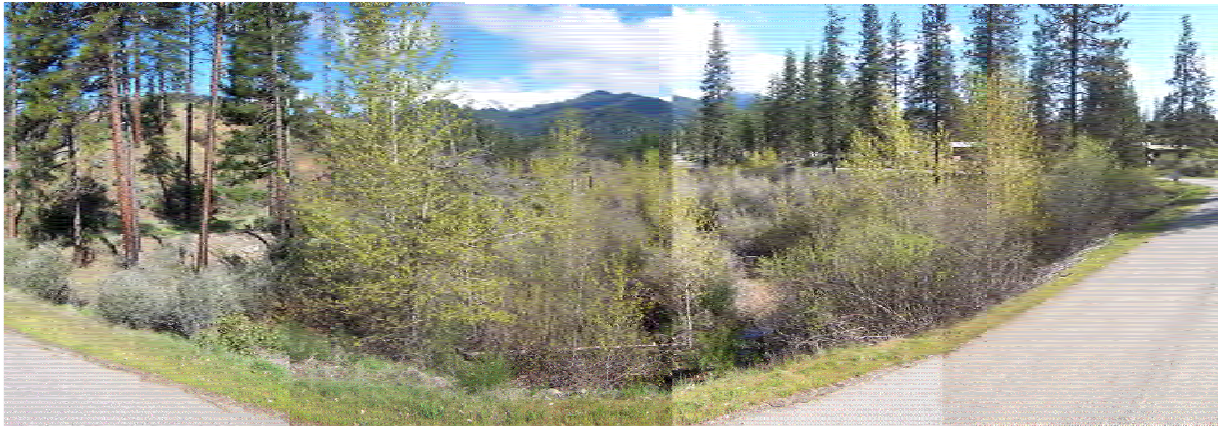
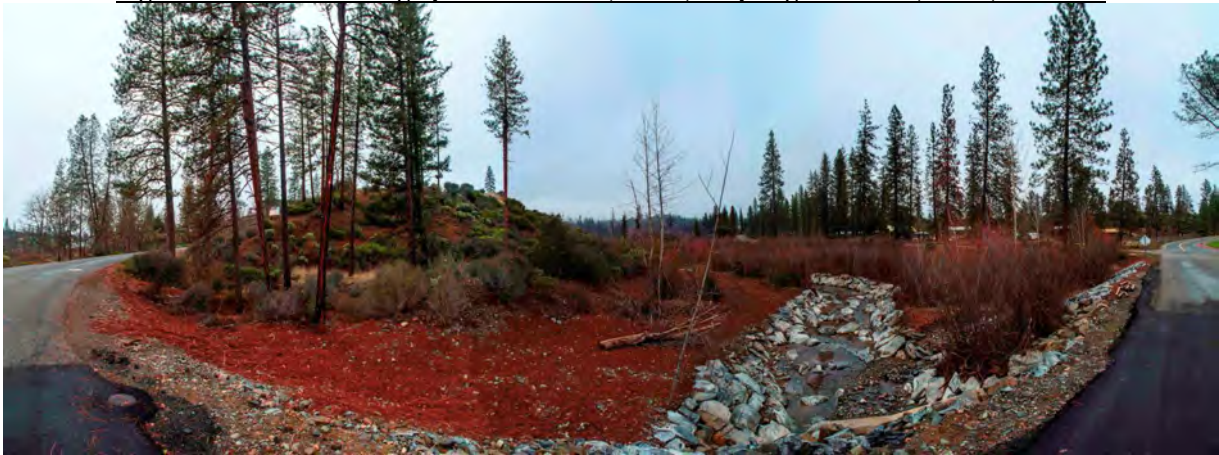
**Figure 28 and 29- Looking upstream before (Above) in spring and after (Below) in winter**
