# Trinity Drinking Water Source Sediment Reduction Project 06-142-551-2 Final Report – September 2010

Project Type: Implementation, Integrated Watershed Management Program, Prop 40

Prepared by:  
Trinity County Planning Department  
&  
5 Counties Salmonid Conservation Program

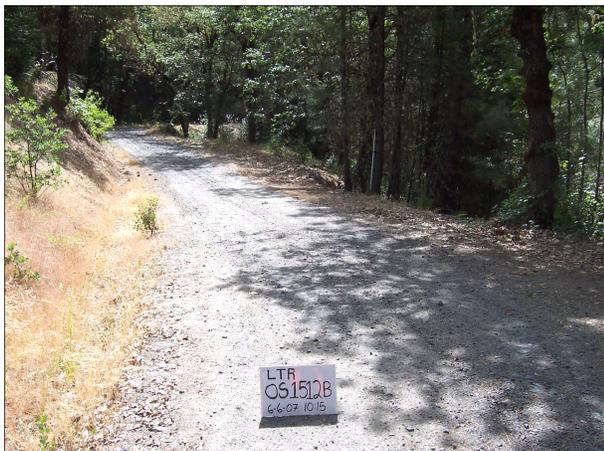
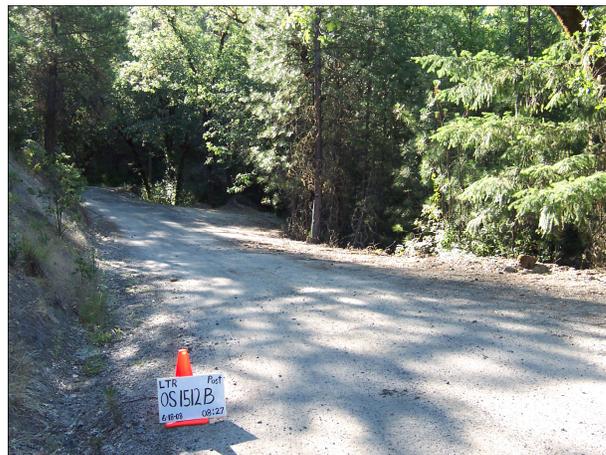
Outsloping: Before (on left) and After (on right) on Lewiston Turnpike Road.

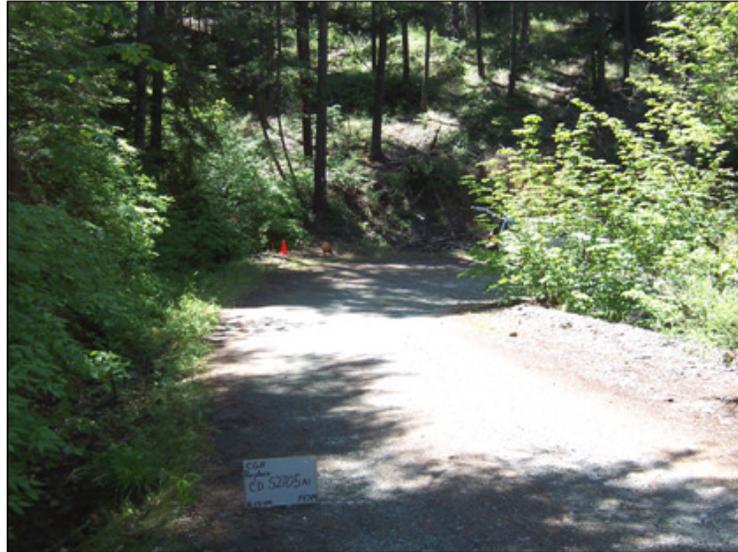
#### D. Existing data and/or Before Photos

Numerous pre-project photos like the one shown above were taken and are found in Attachment A. This one is of a crossing on China Gulch Road.

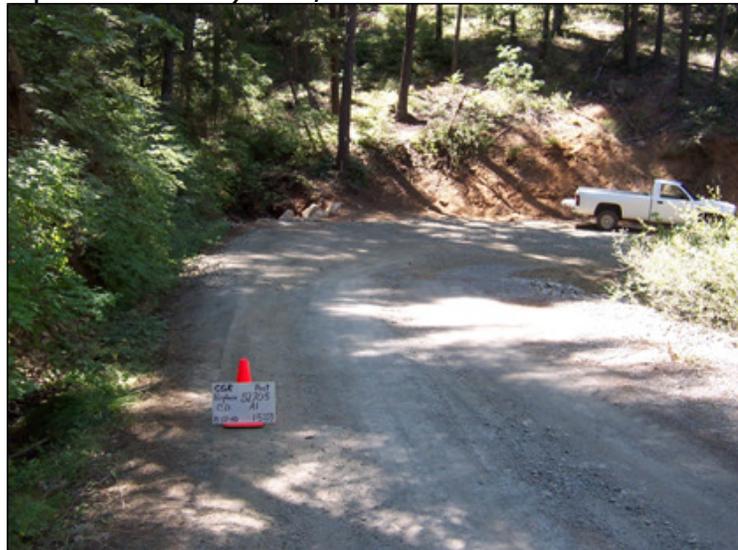
#### E. New data (graphs & tables) and/or After Photos

Numerous post-project photos like the one shown above were taken and are found in Attachment A. This one is an "After" photo of the same China Gulch

site shown in the previous photo that has been upgraded crossing with a critical dip.
