Five Counties Salmonid Conservation Program (5C)

Summary Report Usal Road LITH Design/Build Project

Project Location: Usal Road, CR 431 Milepost 10 to 12, Sections 5& 8, T23N, R16W, HB&M

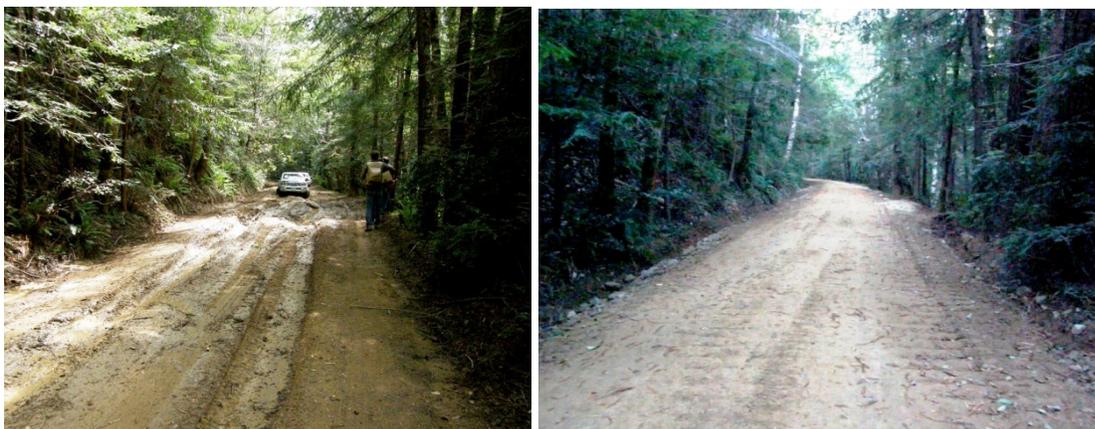
Figure 1. the lower “Quagmire” site ~400’ south of Waterfall Gulch before (left) and after (right). The treatment included outslope with berm breaks, non-woven geo-textile fabric, 8” of roller compacted rock surfacing, and upgraded stream crossings (Photos by Richard Gienger).

Outslope Segment #2- Modify road surface for ~75' by outsloping, placing non-woven geo-textile and 6" road base, roller compacted. The "lower quagmire site" was treated with 300' of non-woven geo-textile fabric, outsloped, and surfaced with 6" of roller compacted rock.

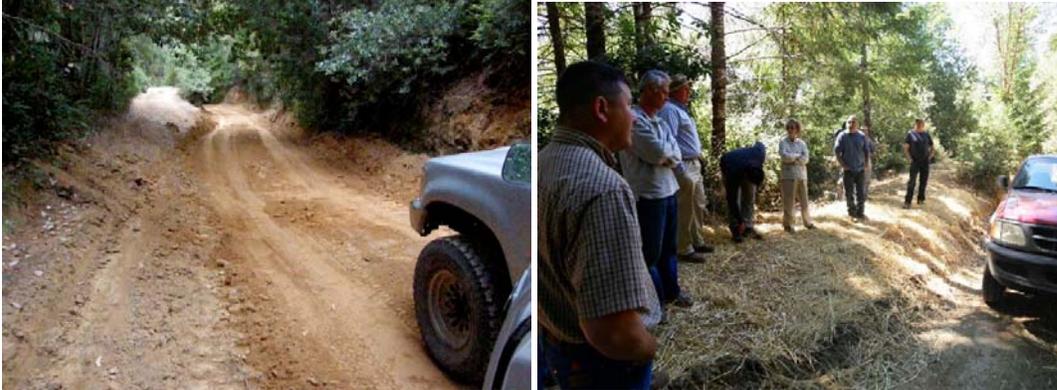
Below Left: Usal Road at the “Quagmire” Site. The road is impassable in winter and following rainstorms. The banks are 3’-6’ high and the road narrowed down to a single lane. Cars drive around the site when the road is wet. Below Right the top of the “Quagmire” site which show the detour route (straw area) that was created by trespass.

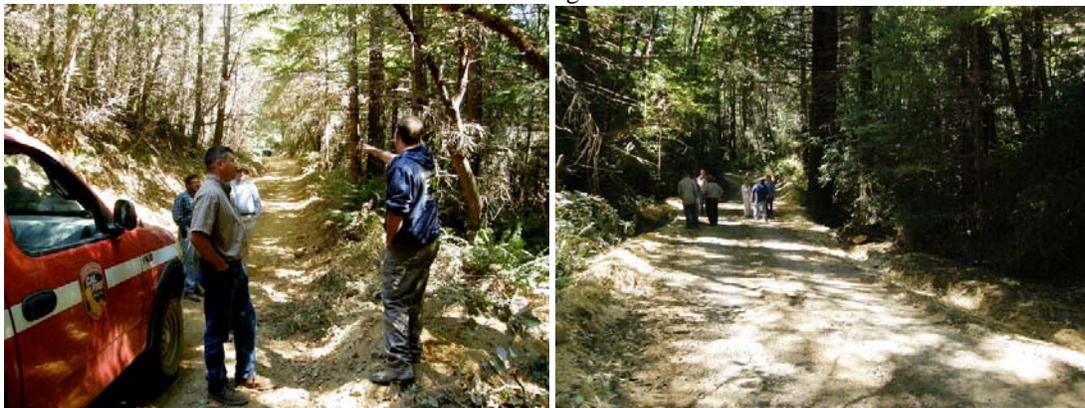
Below Left: Looking south from Waterfall Gulch at the road through cut. Below Right: Usal Road south of Waterfall Gulch Creek, where deep ditches on either side of the road can run for hundreds of feet and can only discharge into the stream.
