# Yontocket Slough

## Fish Passage and Habitat Enhancement Planning Project

Final Report  
May 2006

Prepared By: Michael Love & Associates  
P.O. Box 4477  
Arcata CA 95518  
(707) 476-8938  
mlove@h2odesigns.com

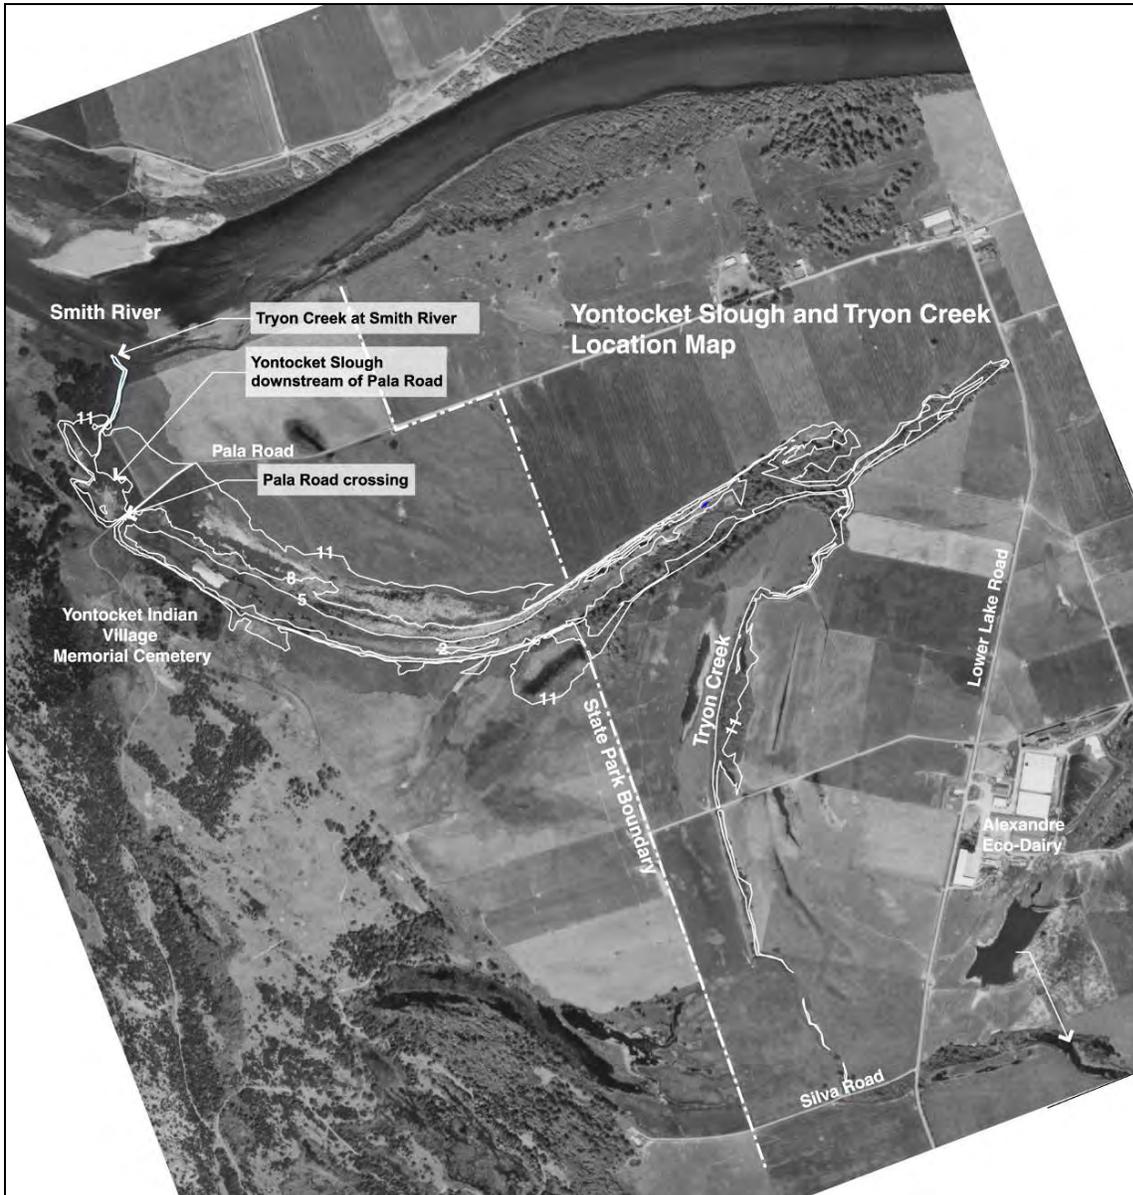
**Figure 3.1** - Aerial photo showing area of mapped topography, which included (1) Yontocket Slough, (2) the Tryon Creek channel from Silva Road to the slough, and (3) the channel from the slough outlet to the Smith River. Elevations of contours are in NAVD88 datum.

All survey points were accumulated in AutoCAD LDD3 software to build a digital terrain model (DTM) from which contour lines were generated. The final DTM was built from approximately 20,000 points, 17,000 of which were corrected and filtered bathymetry points collected using sonar.

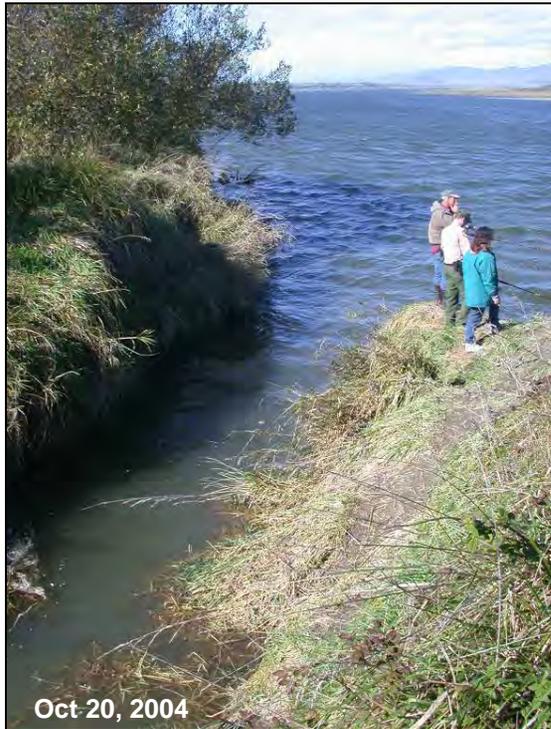
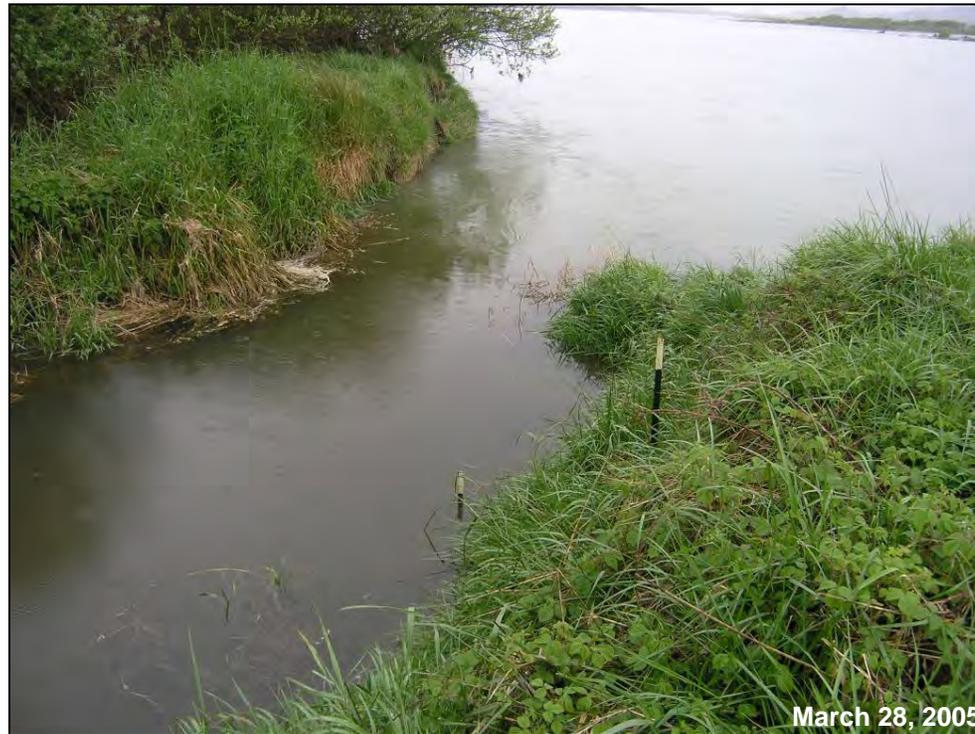
**LOCATION 1** – Confluence of Tryon Creek with the Smith River. River levels are tidally influenced. During spring tides and higher river levels the Smith River will backwater and fill the lower portion of Yontocket Slough. When the river at Dr. Fine Bridge is near monitoring stage, the Smith River will completely inundate Yontocket Slough and Pala Road.

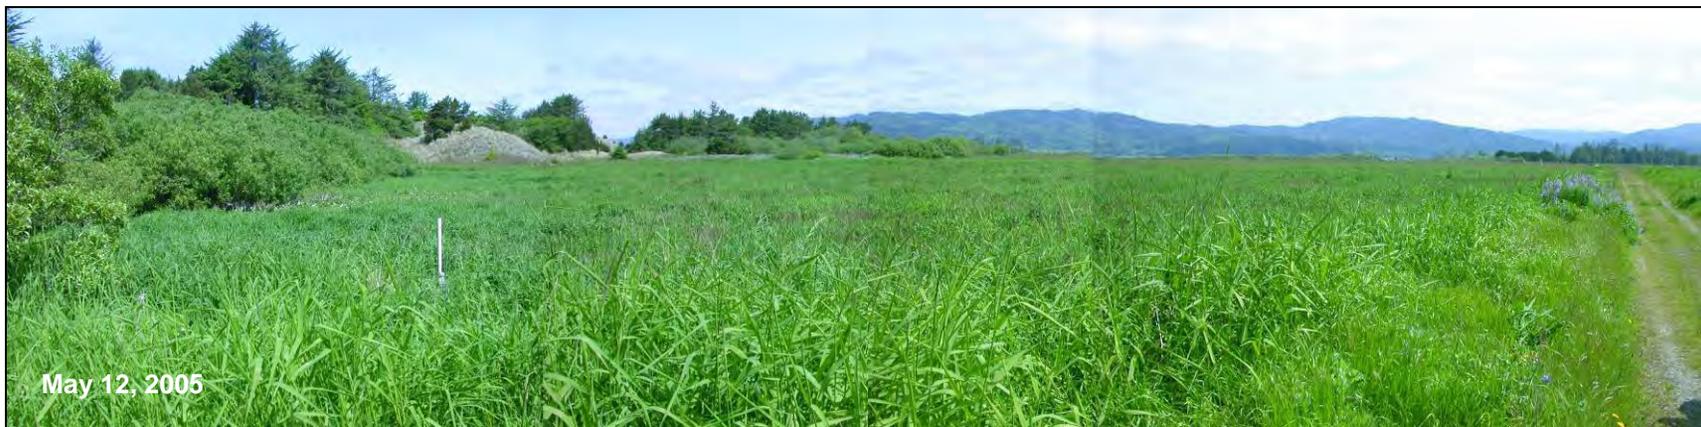
**LOCATION 2** – Downstream of Pala Road, reed canary grass has colonized almost the entire slough.

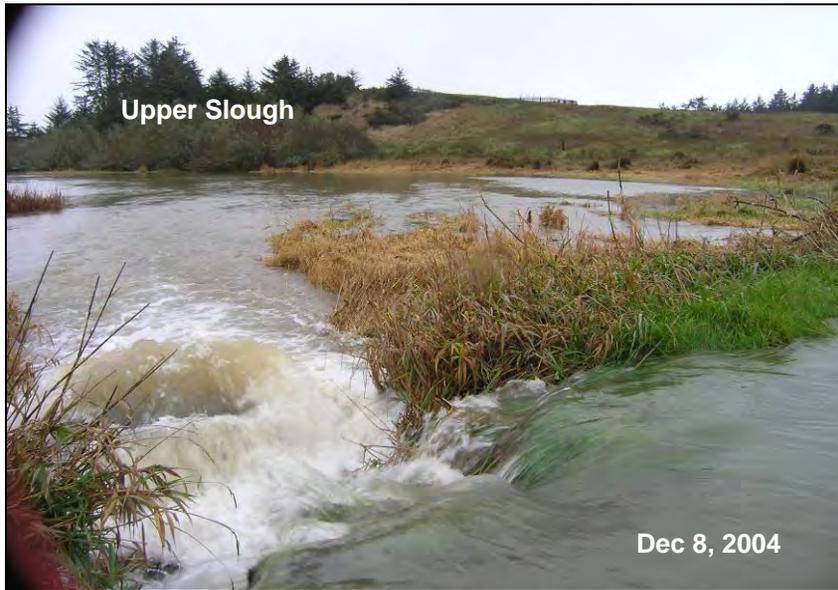
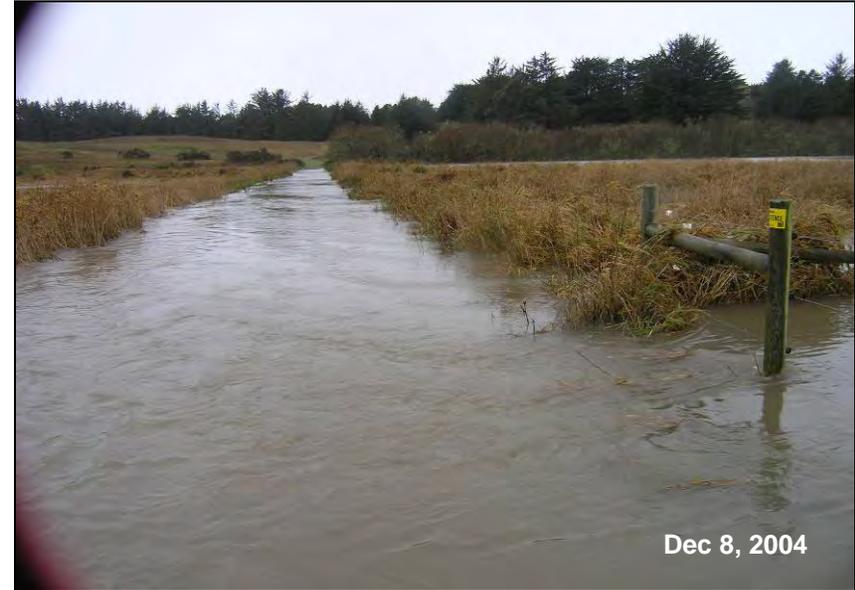
**LOCATION 3** – Pala Road during high water in December. The road was overtopped by the Smith River, filling Yontocket Slough.

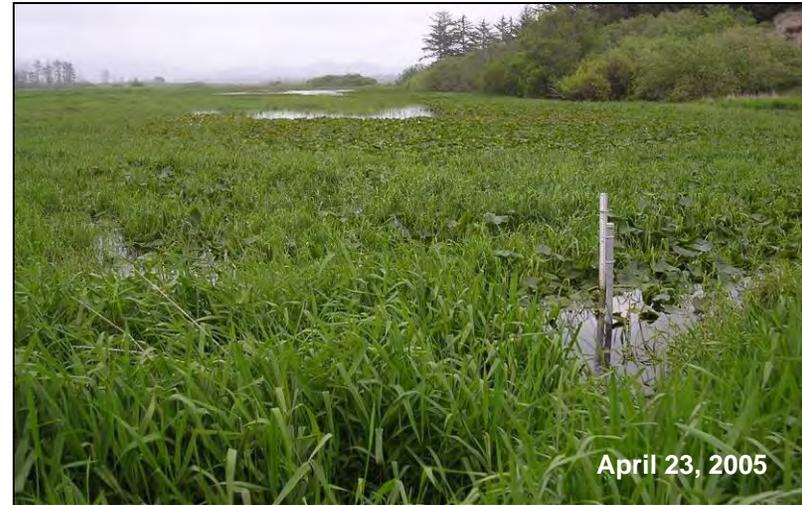
**LOCATION 4** - Yontocket Slough upstream of Pala Road during mid-spring. Reed canary grass dominates much of the slough, with yellow (Spatterdock) lily growing among the grass and in deeper sections that are free from grass.

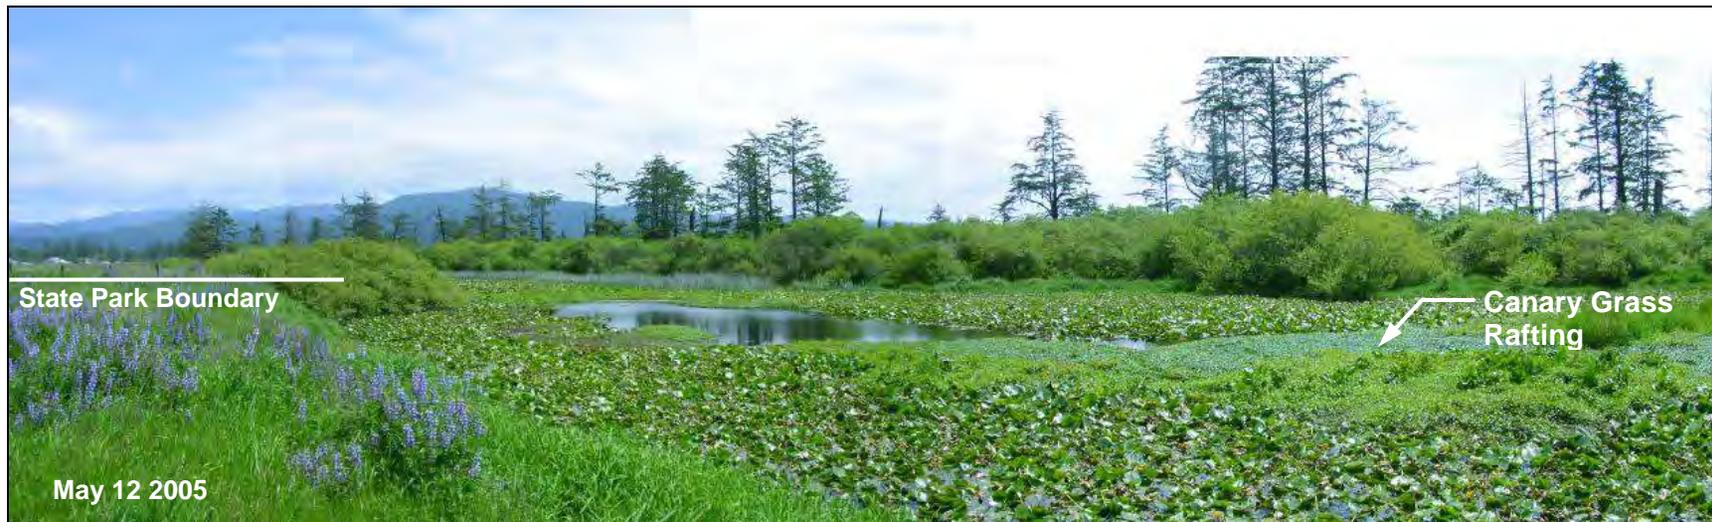
**LOCATION 5** – Yontocket Slough at the State Park property boundary. Reed canary grass dominates much of the banks and rafts in the mid sections of the slough. There is a lack of riparian vegetation within the State Park properties.

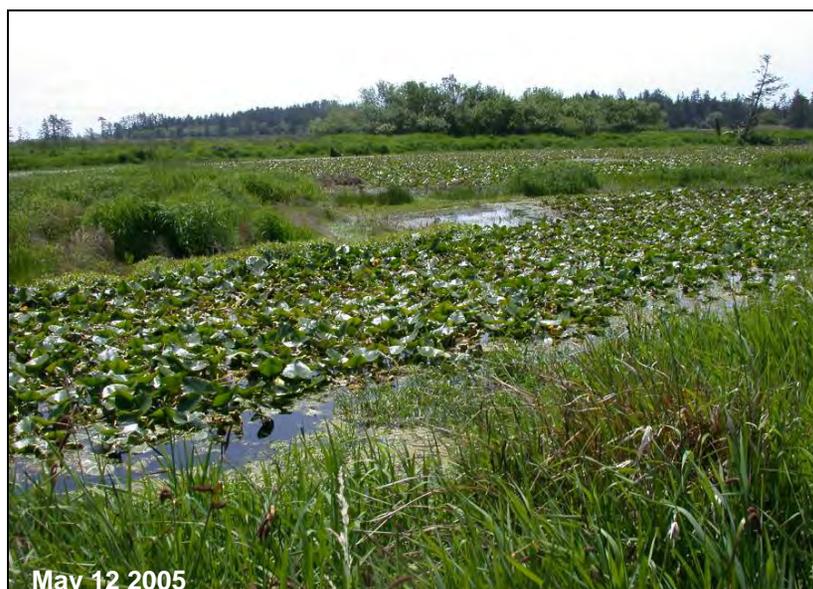
**LOCATION 5** – Yontocket Slough within the State Park. This section of slough lacks riparian vegetation. Reed canary grass has colonized the margins and rafts within the slough.

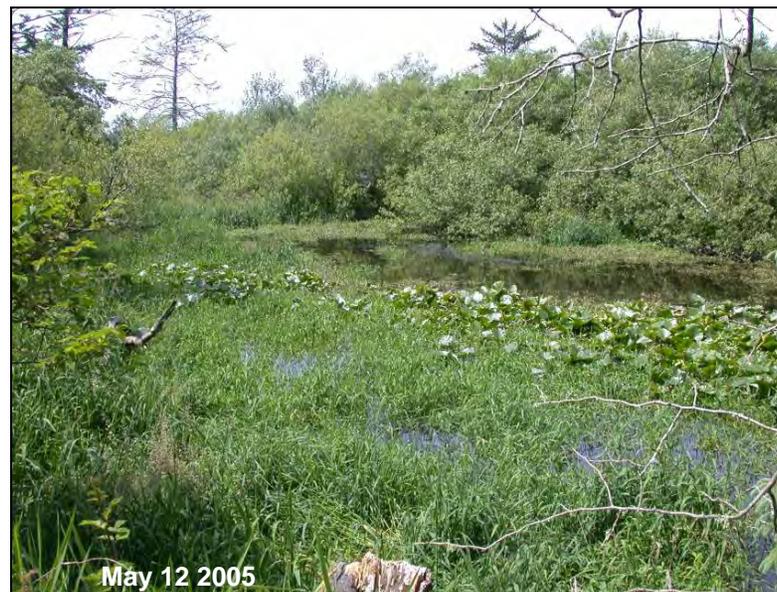
**LOCATION 6** – Yontocket Slough near confluence with Tryon Creek. Dense softwood riparian with spruce trees grow on south bank. This section is characterized by areas of open water and lilies with reed canary grass along the margins.

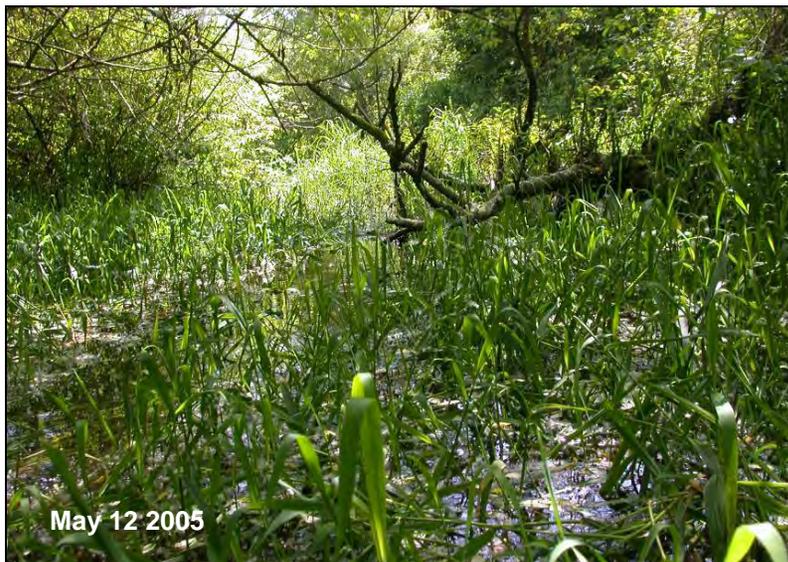
**LOCATION 7** – Tryon Creek near confluence with Yontocket Slough is characterized by dense hardwood riparian with reed canary grass growing throughout channel.

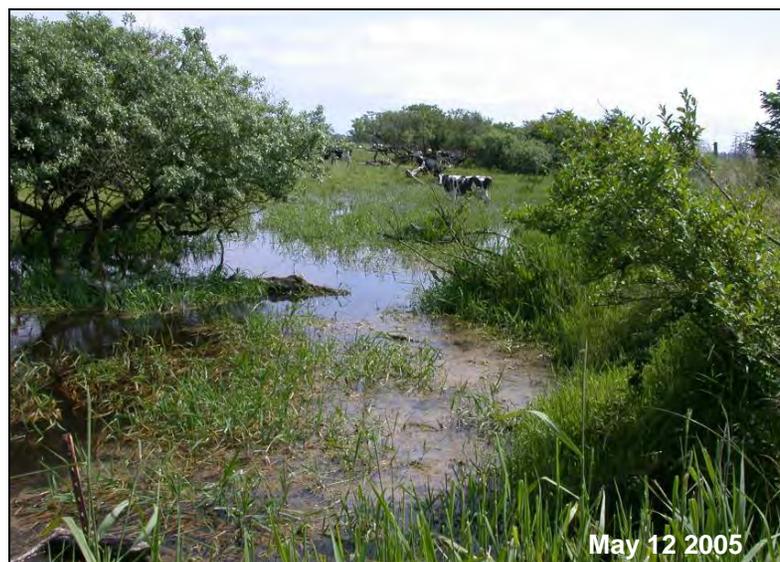
**LOCATION 8** – Tryon Creek is unfenced along the right bank and has little riparian vegetation. In this reach, the channel is poorly defined with water spreading outward during high flows.

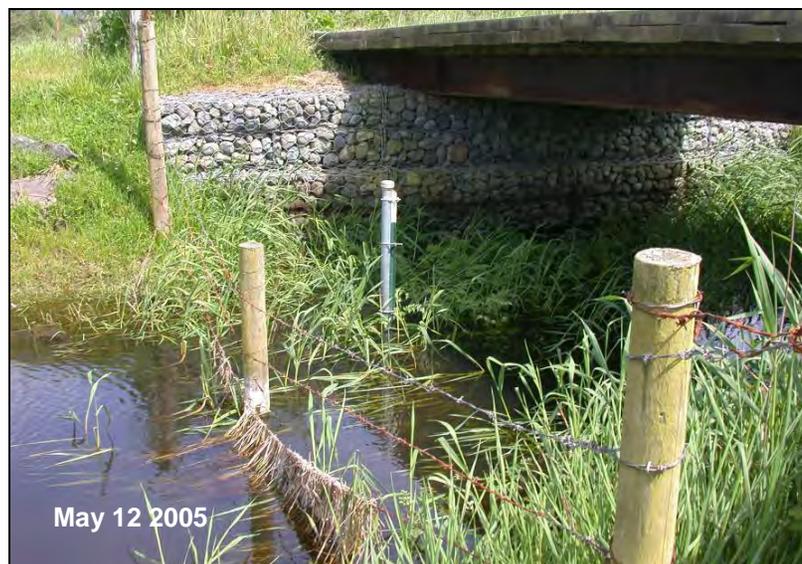
**LOCATION 9** – Staff gage at Silva Road Bridge
