Channel Morphology - Stream Crossing Interactions

An Overview

Michael Love
Michael Love & Associates
mlove@h2odesigns.com
(707) 476-8938

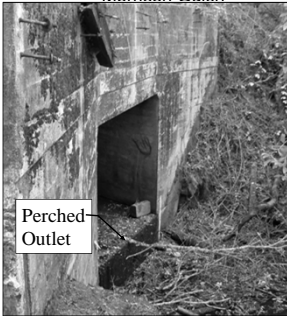
<p>Perched Outlet</p>
<p>Upstream of perched culvert, prior to removal</p>	<p>Perched Outlet replaced by a culvert</p>

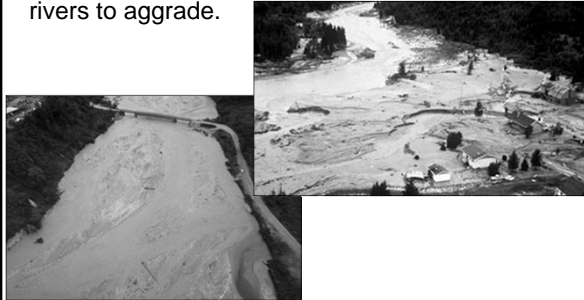
Increased sediment loads combined with large flood can cause entire streams and rivers to aggrade.

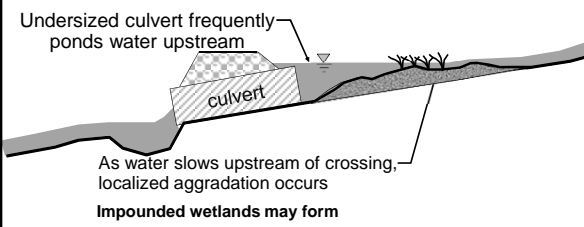
Undersized culvert frequently ponds water upstream

As water slows upstream of crossing, localized aggradation occurs

Impounded wetlands may form

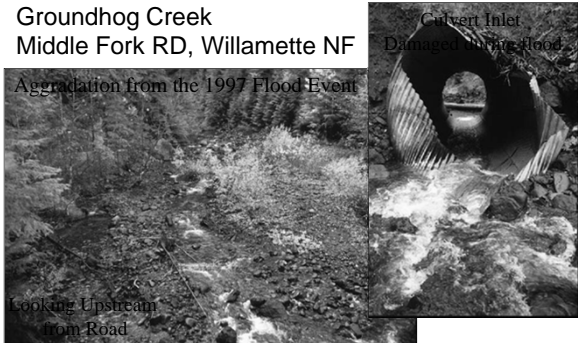
Groundhog Creek
Middle Fork RD, Willamette NF

Case Example
Upstream Aggradation

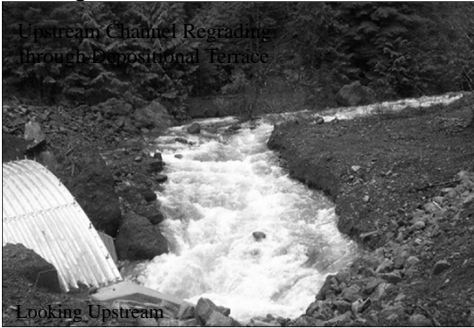
Groundhog Creek Middle Fork RD, Willamette NF

Looking Upstream
