Post-project Monitoring

Ross N. Taylor
Ross Taylor and Associates

Fish Passage Design
Workshop

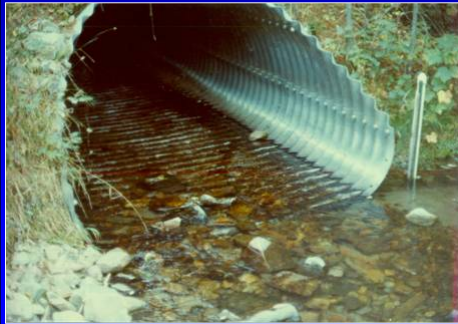
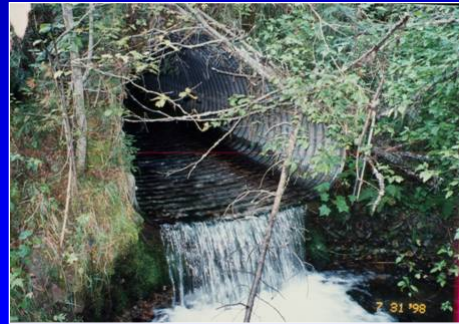
1979

Streams + Culverts = Channel
(dynamic) (static) Adjustment

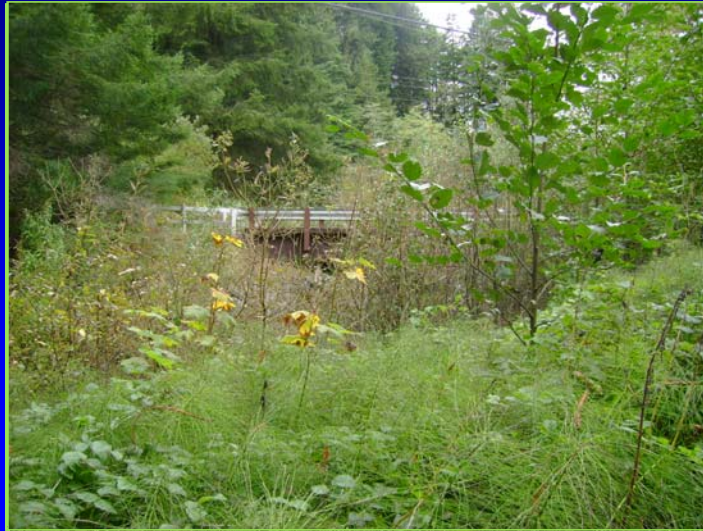
Photo Monitoring – McCready Gulch

Effectiveness

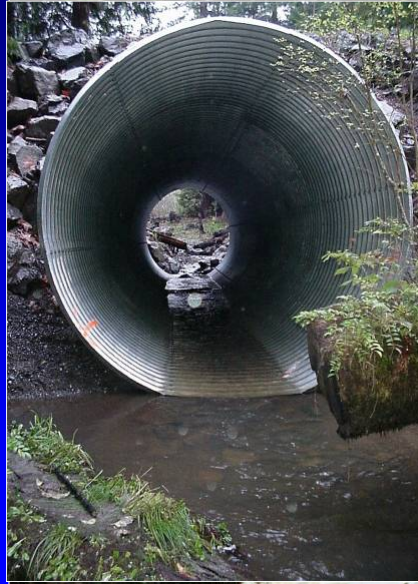
Morrison Gulch – Case Study of Design versus As-built

- **Slope through culvert = 0.0%.**
- **Elevation of downstream weir relative to culvert outlet = 0.5 feet higher.**
- **Design concept – install culvert, then construct grade-control weirs.**

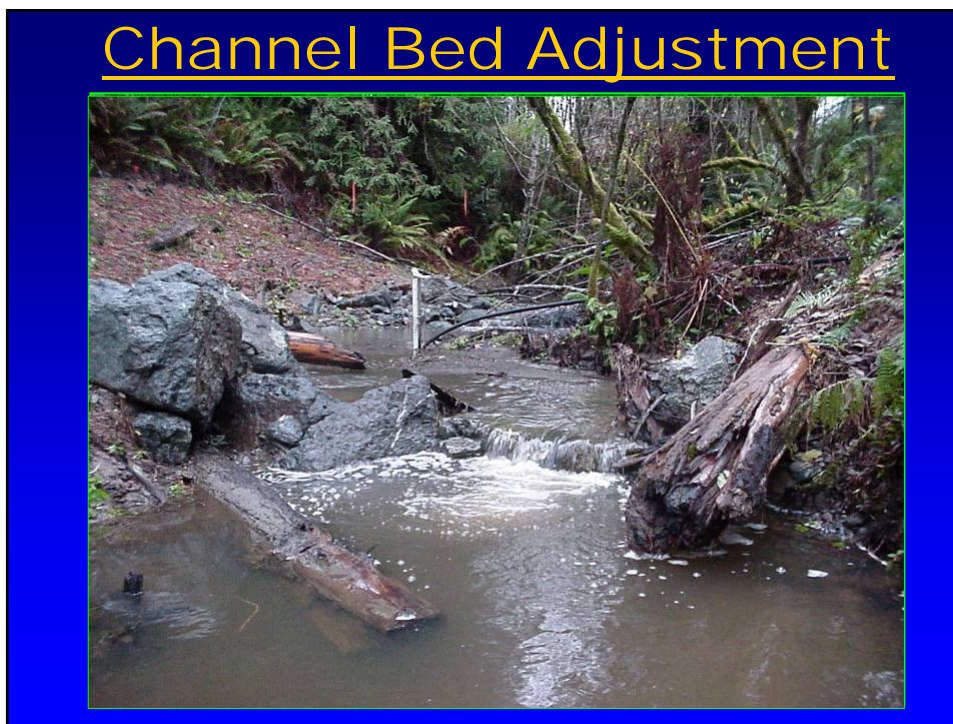
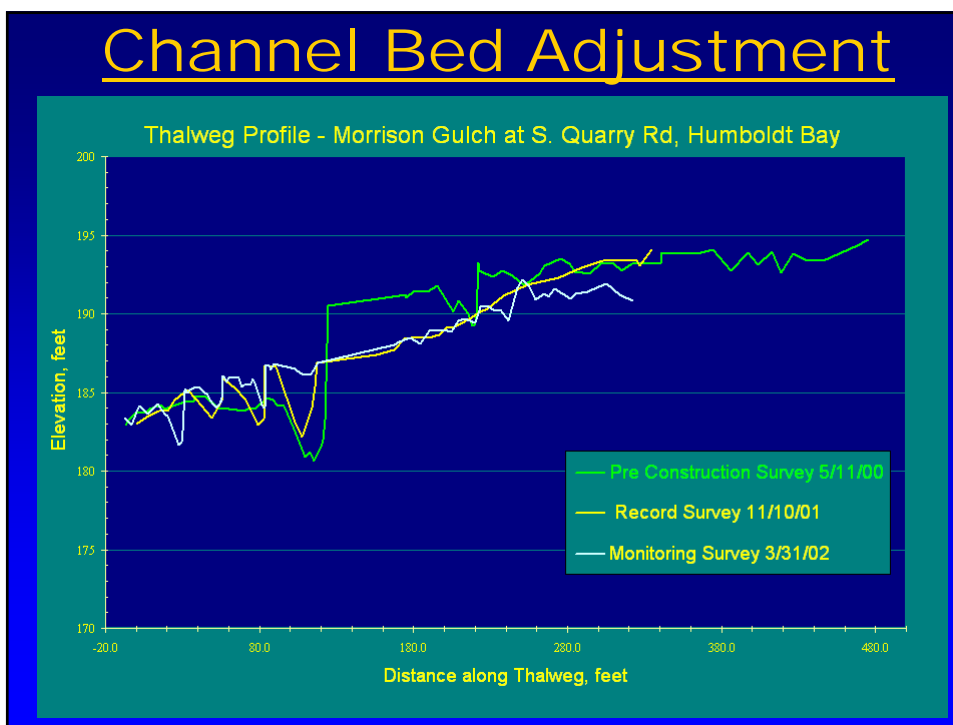
Morrison Gulch – As-Built Features

- Slope through culvert = 1.17%.
- Elevation of downstream weir relative to culvert outlet = set at same elevation.
- Grade-control weirs were constructed first - then culvert was installed.

- Utilized re-survey data and new culvert specification.
- Assessed with FishXing.
- Adult passage = 90% - insufficient depth.
- Resident/2+ passage = 30% - excessive velocity.
- 1+/y-o-y passage = 0% - excessive velocity.
- Have visually observed y-o-y upstream of culvert, failing to pass grade-control weirs.

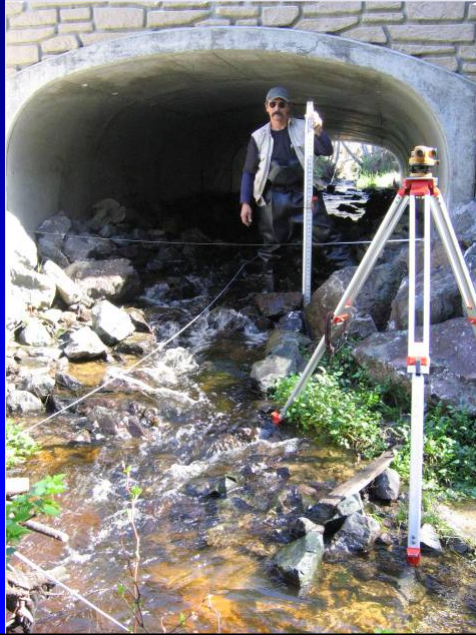
Digger Creek – Case Study

- High-priority – severity of barrier, poor sizing + condition, length of potential upstream habitat.
- No current fish presence.
- Raised in priority based on funding opportunities.
- Stream simulation design option selected.
- Grade-control structures not utilized.

- **Open-bottom ConSpan® arch - 2003.**
- **Re-surveyed in May 2004.**
- **Long profile from Highway 1 outlet to 115' below Ocean Drive = 717' total length.**
- **Slope thru Xing = 4.25%**
- **Channel slope u.s. = 1.95%; d.s. = 4.6%.**
- **Ave riffle depth w/in xing = 0.38'**
- **Ave riffle depth in channel = 0.36'**

- **Second re-survey in March 2005.**
- **Long profile started 96' u.s of Ocean Drive = 250' total length.**
- **Slope thru Xing = 3.98%**
- **Channel slope u.s. = 2.0%; d.s. = 4.6%.**
- **Ave riffle depth w/in xing = 0.54'**
- **Ave riffle depth in channel = 0.52'**

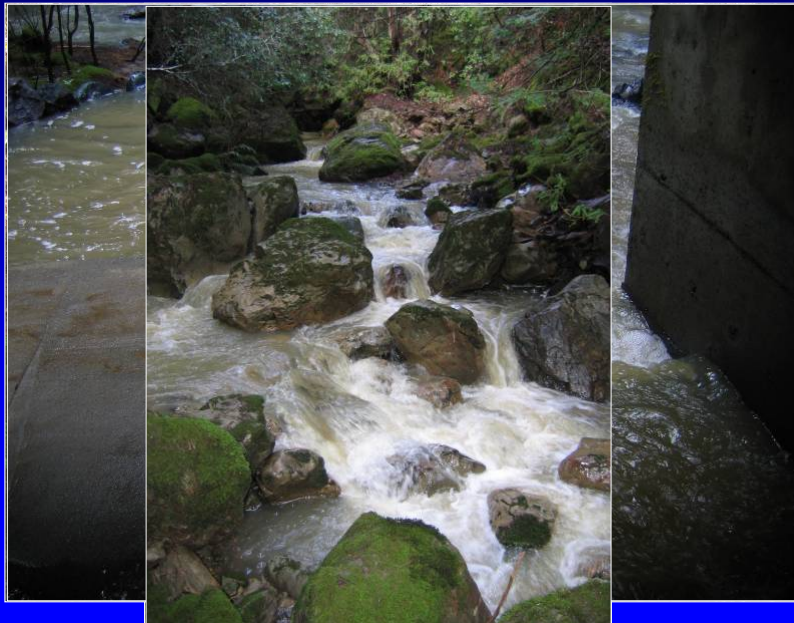
Qualitative Monitoring - Retrofits

- **Baffles and weirs within crossing.**
- **Grade-control structures.**
- **Re-visit photo points over time.**
- **Assess hydraulics during migration flows.**
- **Assess performance in passing storm debris.**
- **Assess longevity of structures.**

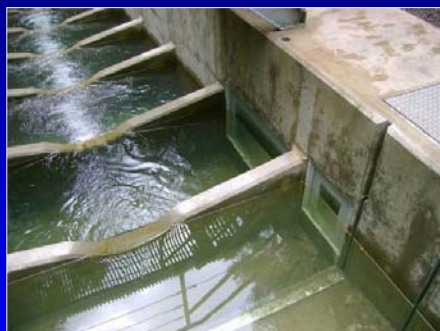
Additional Types of Biological Monitoring

- View Ports
- PIT Tag Antenna Array
- Time-Lapse Camera

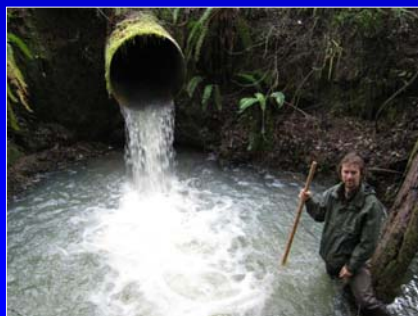
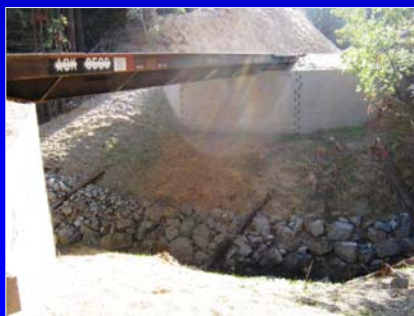
Frykman Gulch 2010 pre-project electrofishing

Downstream of barrier: juvenile steelhead, juvenile coho salmon, prickly sculpin and Pacific lamprey ammocetes.

Upstream of barrier: juvenile steelhead and prickly sculpin.

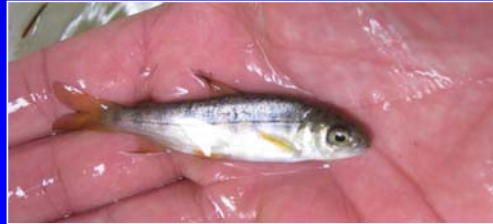
Frykman Gulch 2012 post-project electrofishing

Downstream of Bridge: juvenile steelhead, juvenile coho salmon, prickly sculpin and Pacific lamprey ammocetes.

Upstream of Bridge: juvenile steelhead, juvenile coho salmon, and prickly sculpin.

Coho salmon – most likely non-natal. Juveniles often are initial colonizers of newly opened habitat (Pess et al. 2011).

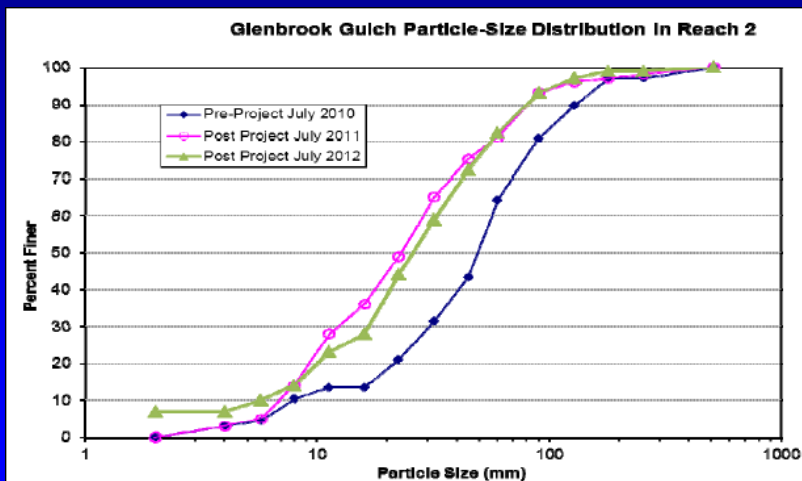
Glenbrook Gulch – Dam Removal Project

Downstream of barrier: channel scoured to bedrock.

Solution– minimal removal of stored sediment during dam removal. Use of boulder and log structures to capture mobilized sediment.

Monitoring – photo points and pebble counts (pre and post).
