APPENDIX B:

CATALOG OF HUMBOLDT COUNTY CULVERTS LOCATED ON FISH-BEARING STREAM REACHES

SITE-SPECIFIC CULVERT INFORMATION

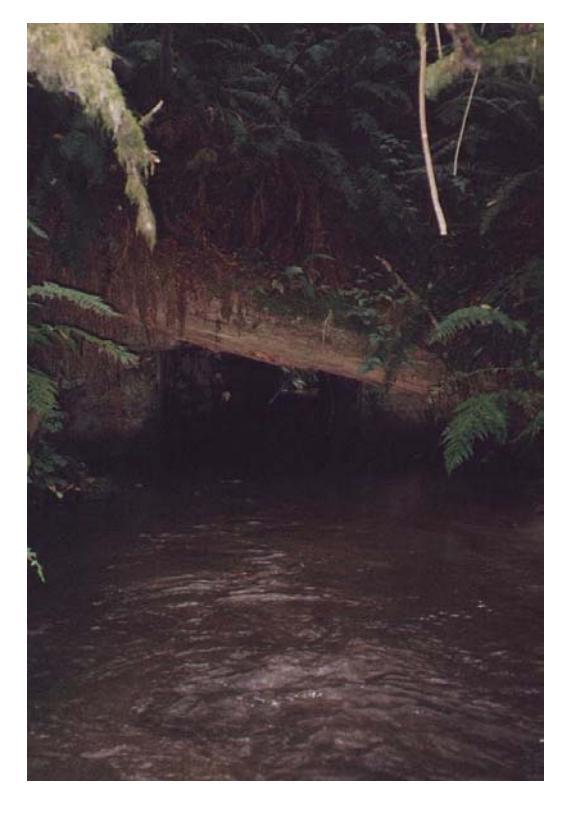
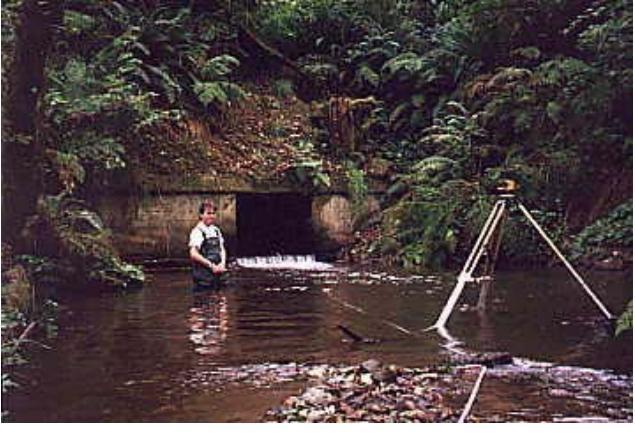
Modifications: None Fill Estimate: 9,057 cubic yards Overall condition: Good.

Additional Barriers: Downstream box culvert with concrete channel at Highway 101 (< 500'). Upstream = County culvert at Dow's Prairie Road (about 1 mile upstream).

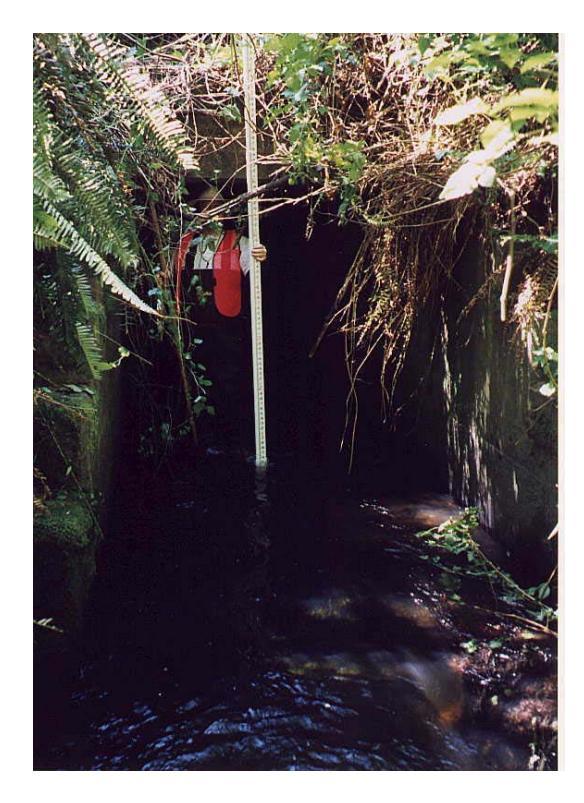
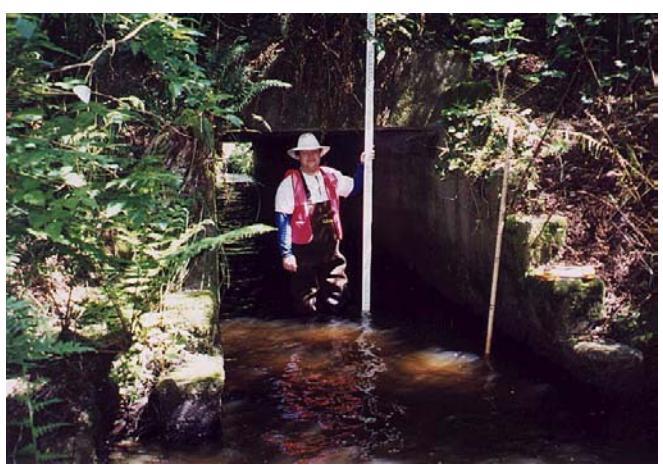
Site #10: Mill Creek #2; Central Avenue Priority Ranking = #41

Modifications: None. Fill Estimate: N/A Overall condition: Good.

Additional Barriers: Mill Creek falls located less than 300' downstream. Upstream approximately 6,000', culverts at Azalea Road.

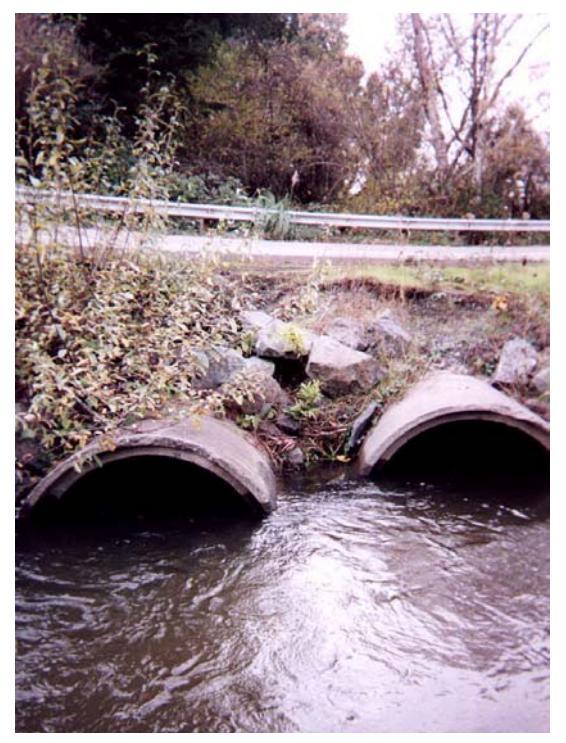
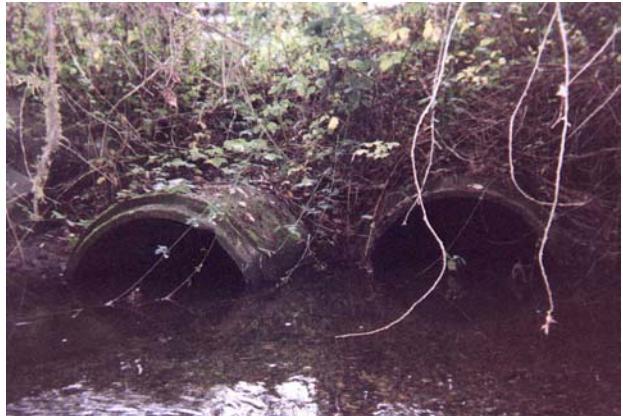
Site #22: Sullivan Gulch; Riverside Drive **Priority Ranking =** #2

Fill Estimate: 1,282 cubic yards **Overall condition:** Fair. **Sizing:** Slightly undersized, a 50-year would start to pond-up on upstream side of culvert. However, sizing did not account for baffles.

Barrier Status: Extensive observations conclude that adult passage is adequate (although entry jump is difficult for some fish), but culvert is nearly a complete barrier for juveniles of all age-classes. Over five winters, extremely high levels of avian predation on juveniles observed.

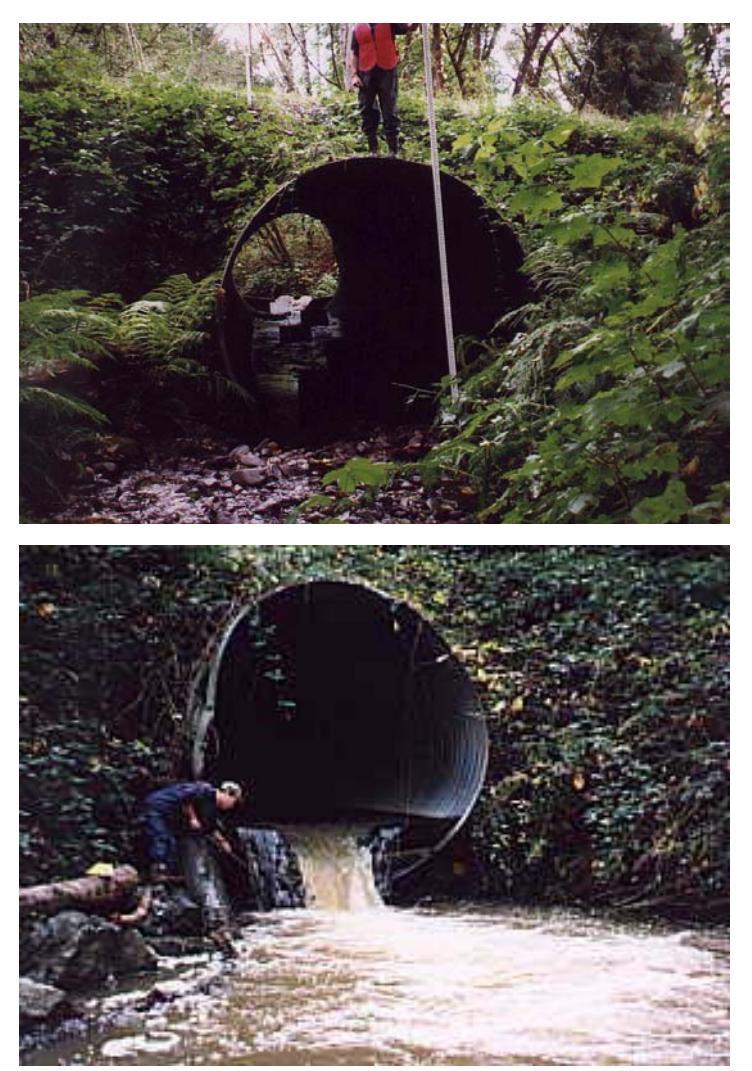
Site #23: Mill (Watek) Creek; Riverside Drive Priority Ranking = #47

Overall condition: Fair.

Sizing: Extremely undersized, less than a five-year flow. Has flooded Riverside Drive on several recent storms and caused damage to Simpson Timber Company's nursery.

Photo note: Inlet photo only.

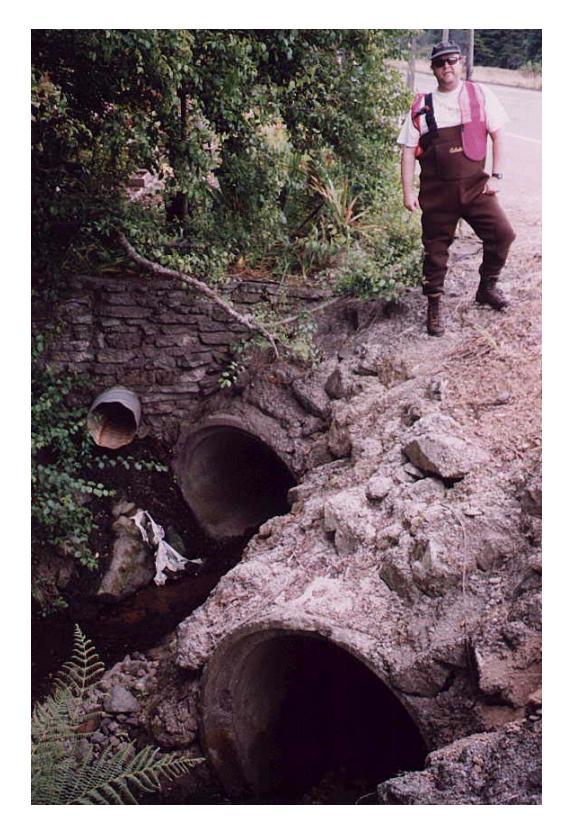
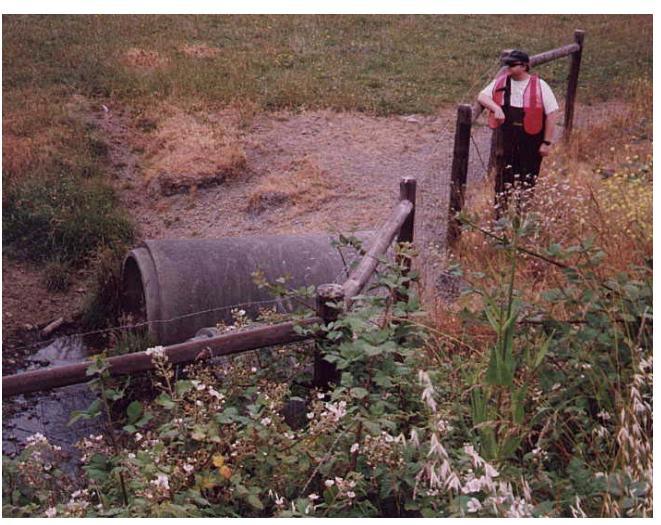
Site #25: Baywood Golf Course Creek; Jacoby Creek Road Priority Ranking = #38

Overall condition: Fair, some rusting through culvert floor. SSP is placed at or slightly below channel grade, slight backflooding at low flows.

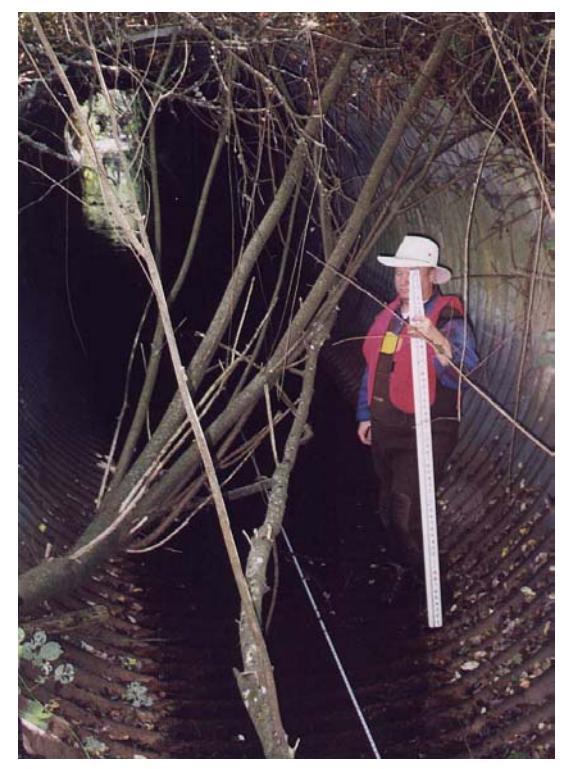
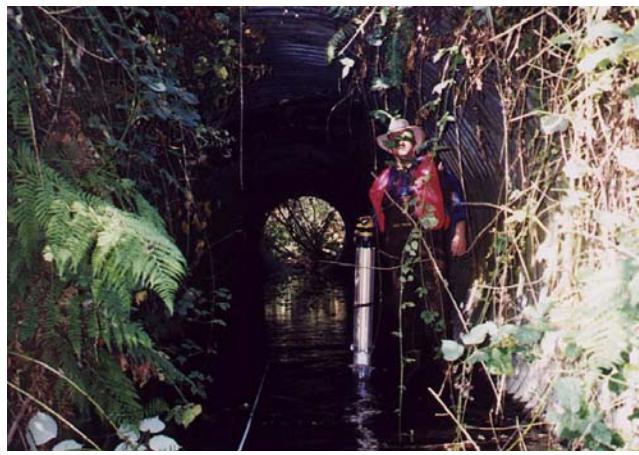
Site #26: Morrison Gulch; Quarry Road Priority Ranking = #1

Overall condition: Poor, culvert floor is rusted, low flow fails to reach outlet.

Barrier Status: Yes, high entry jump (>5') prevents all juveniles and most adults (all species) from entering CSP. Excessive velocities occur in pipe at a moderate range of expected migration flows. Highest levels of observed jump attempts by adult coho salmon.

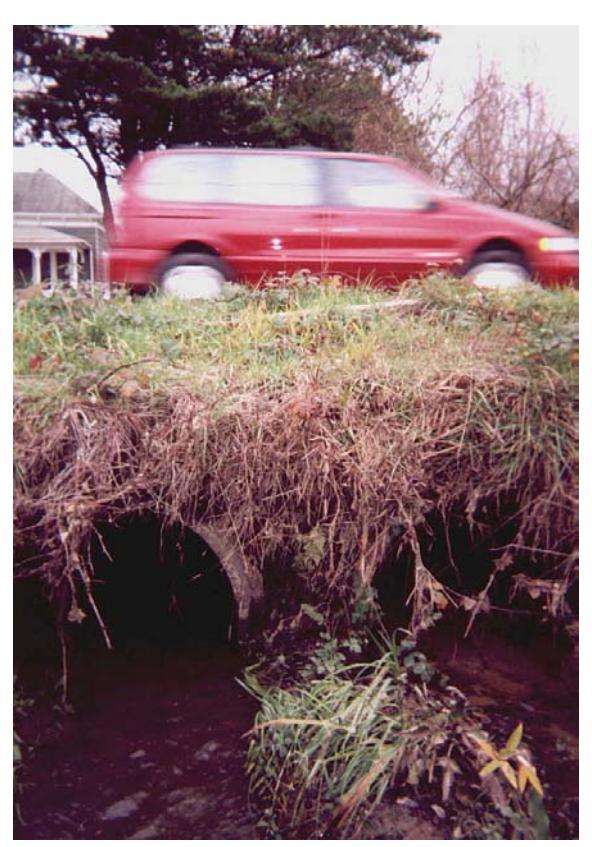
Site #29: Cochran Creek #2; Ole Hanson Road Priority Ranking = #59

Overall condition: Good. Sizing: Undersized, especially with large amount of deposited sediment.

Photo Note: Inlet at low flow and peak of 11/21/98 storm.

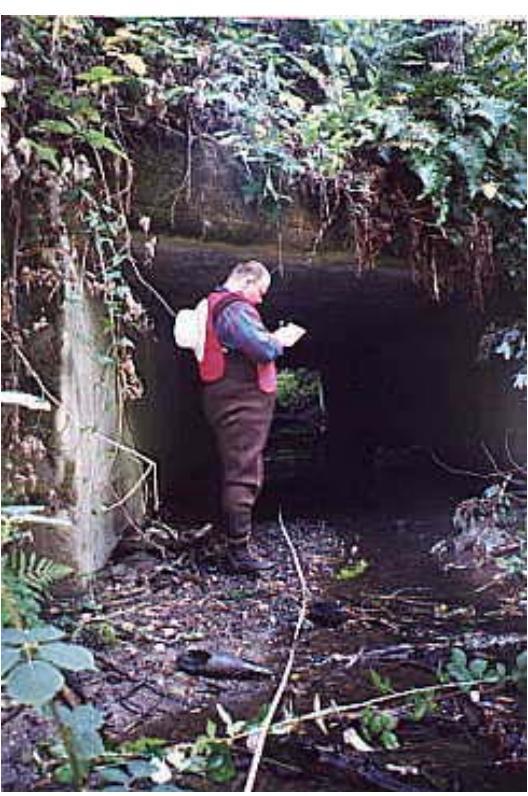
Site #32: Cloney Gulch; Kneeland Road Priority Ranking = #12

Fill Estimate: 2,081 cubic yards **Overall condition:** Good. **Sizing:** Good – should pass greater than a 50-year flow.

Additional Barriers: None.

Habitat: Quantity = 11,200' of potential anadromous habitat. Quality = Good, one of the better spawning and rearing tributaries within the Freshwater Creek watershed.

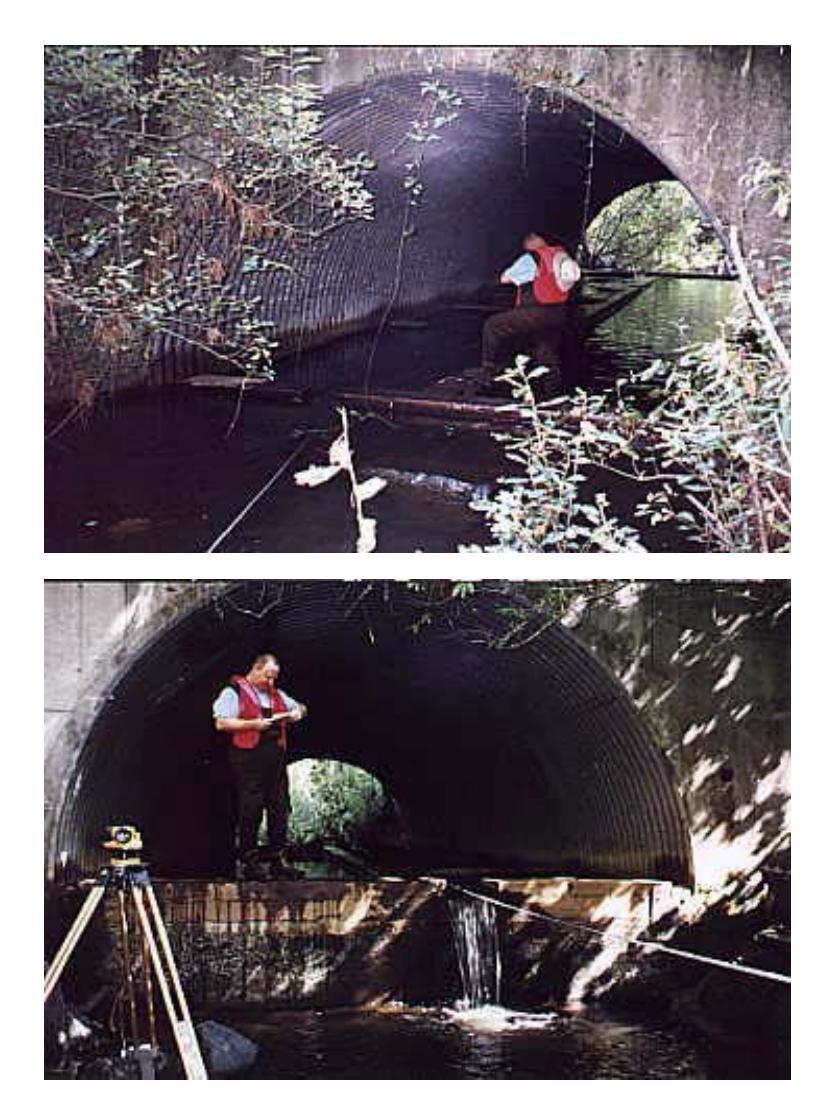
Site #33: Graham Gulch; PALCO Camp Road Priority Ranking = #29

Fill Estimate: 1,853 cubic yards Overall condition: Floor and outlet are rusting, numerous holes in floor.

Habitat: Quantity = 13,400' of potential anadromous habitat. Quality = fair to poor, in the past ten years the channel has experienced excessive loading of fine sediments from hillslope failures. Instream restoration structures provided complexity, but have been buried by sediment inputs.

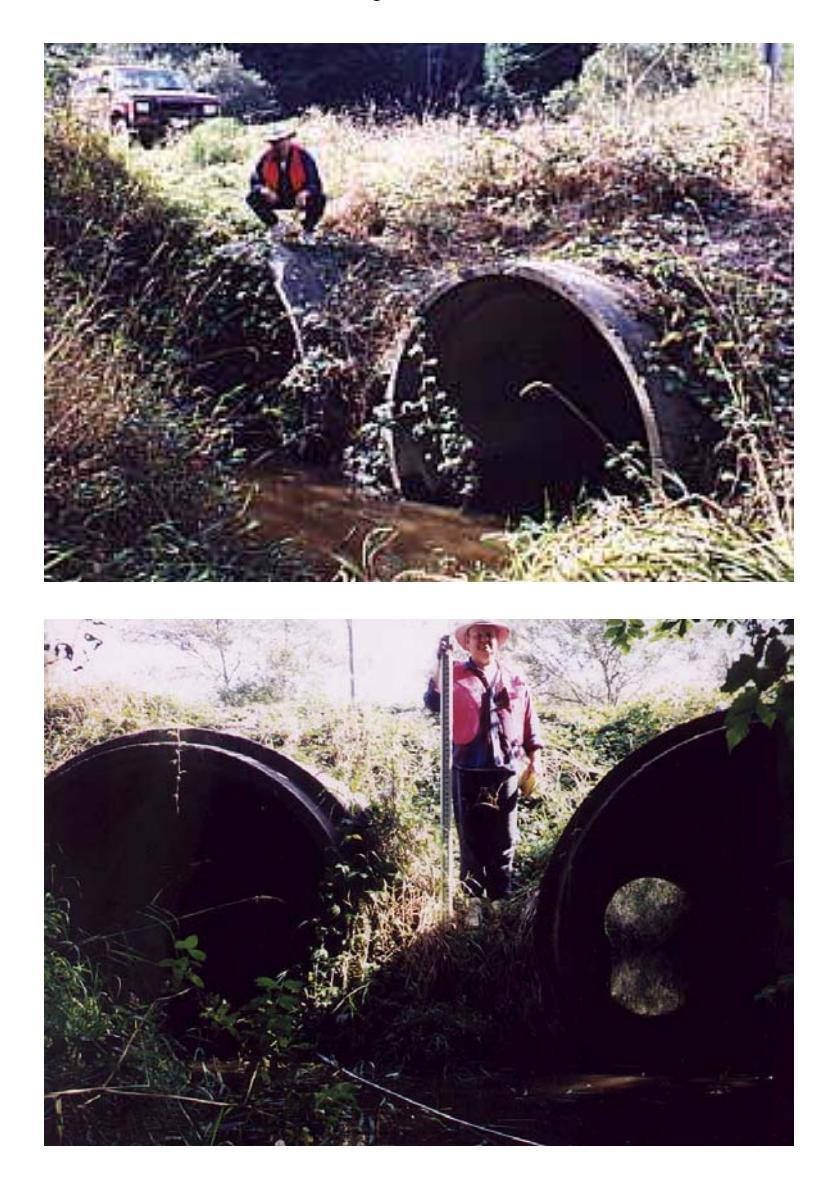
Overall condition: Good. Sizing: Poor, sized for less than a 10-year flow.

Barrier Status: Passable for most adults and partial barrier for all juveniles. Fish Xing determined that the inadequate sizing created a velocity barrier for juveniles at the upper range of migration flows.

Additional Barriers: None downstream, Highway 101 is bridged over lower Martin Slough. Upstream, Campton Road has the five, 4' concrete pipes at grade.

Habitat Upstream: Quantity = 22,000' of potential anadromous habitat; Quality = poor, heavy siltation and lack of inchannel habitat from current and past land management activities. Huge sediment introduction from recent built residential developments.

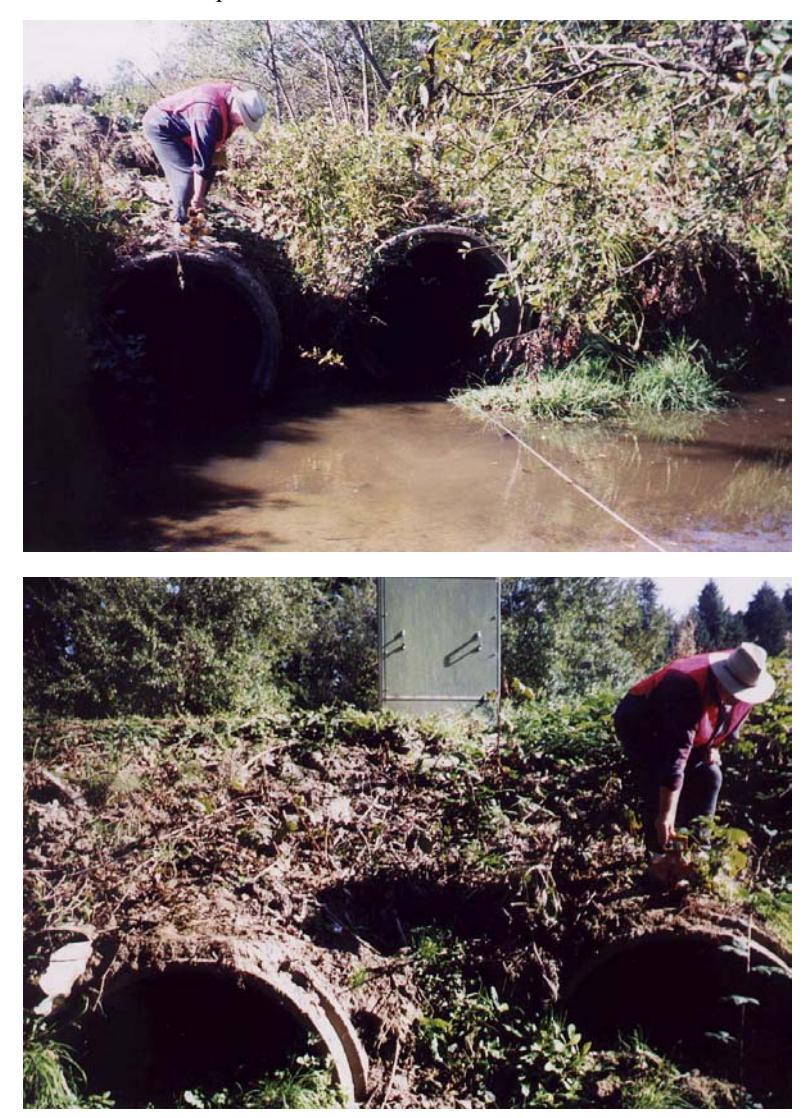
Site #35: Martin Slough #2; Campton Road Priority Ranking = #61

Overall condition: Good. **Sizing:** Poor, sized for less than a 10-year flow. Several pipes were partially filled with fine sediment.

Barrier Status: Passable about 40 to 60% of expected migration flows for most adults and nearly a complete barrier for all juveniles. Fish Xing determined that the inadequate sizing created a velocity barrier at a wide range of migration flows.

Additional Barriers: Downstream is Herrick Road culverts and then Highway 101 bridge over lower Martin Slough.

Habitat Upstream: Quantity = 13,200' of anadromy above culverts; Quality = poor, heavy siltation and lack of inchannel habitat from current and past land management activities. Huge sediment introduction from recent built residential developments.

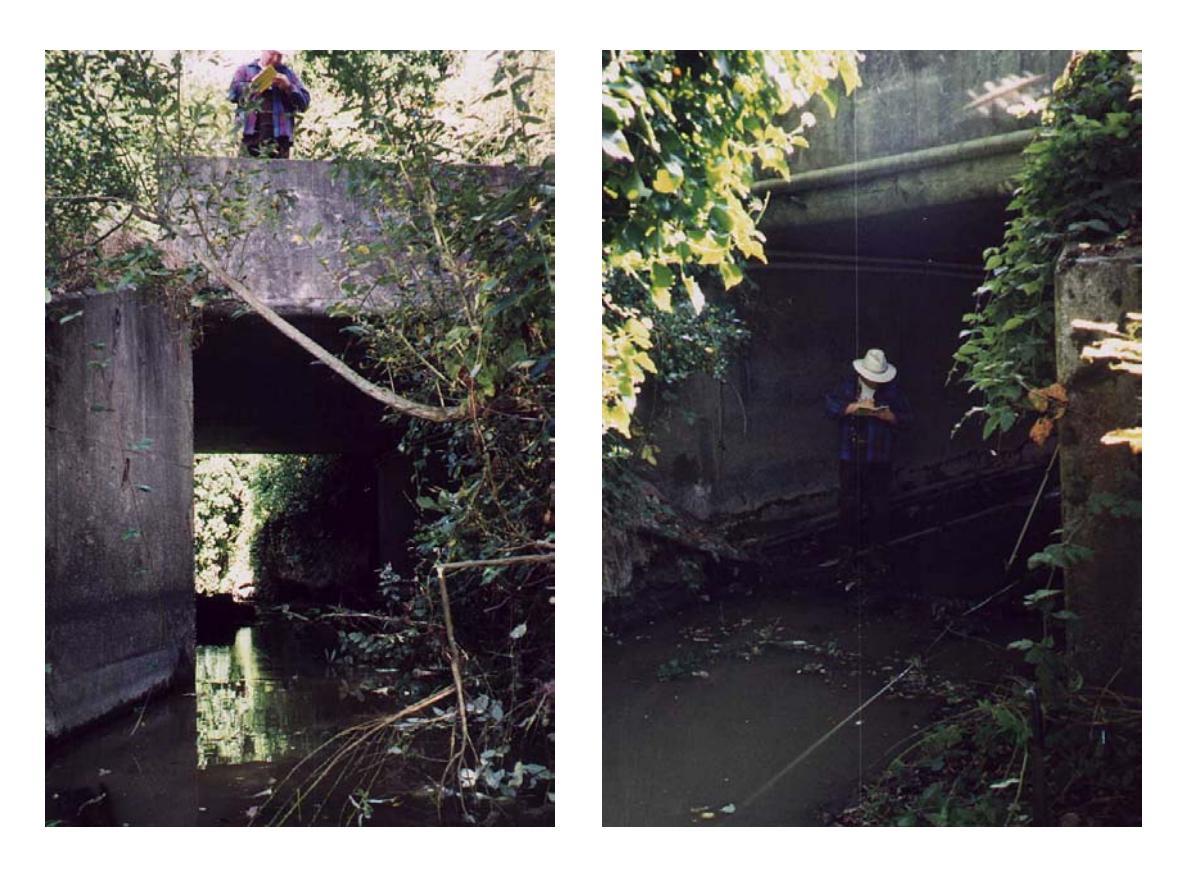
Site #36: Russ Creek; Centerville Road Priority Ranking = #62

Overall condition: Good. Sizing: Good, sized to pass at least a 50-year storm flow.

Additional Barriers: None downstream, enters what is left of the lower Salt River. Upstream, none, however no access to private property.

Habitat Upstream: Quantity = approximately 18,000' of potential anadromous channel; Quality = poor, severe impacts from over a century of timber harvest, channelization, and unfenced dairy grazing.

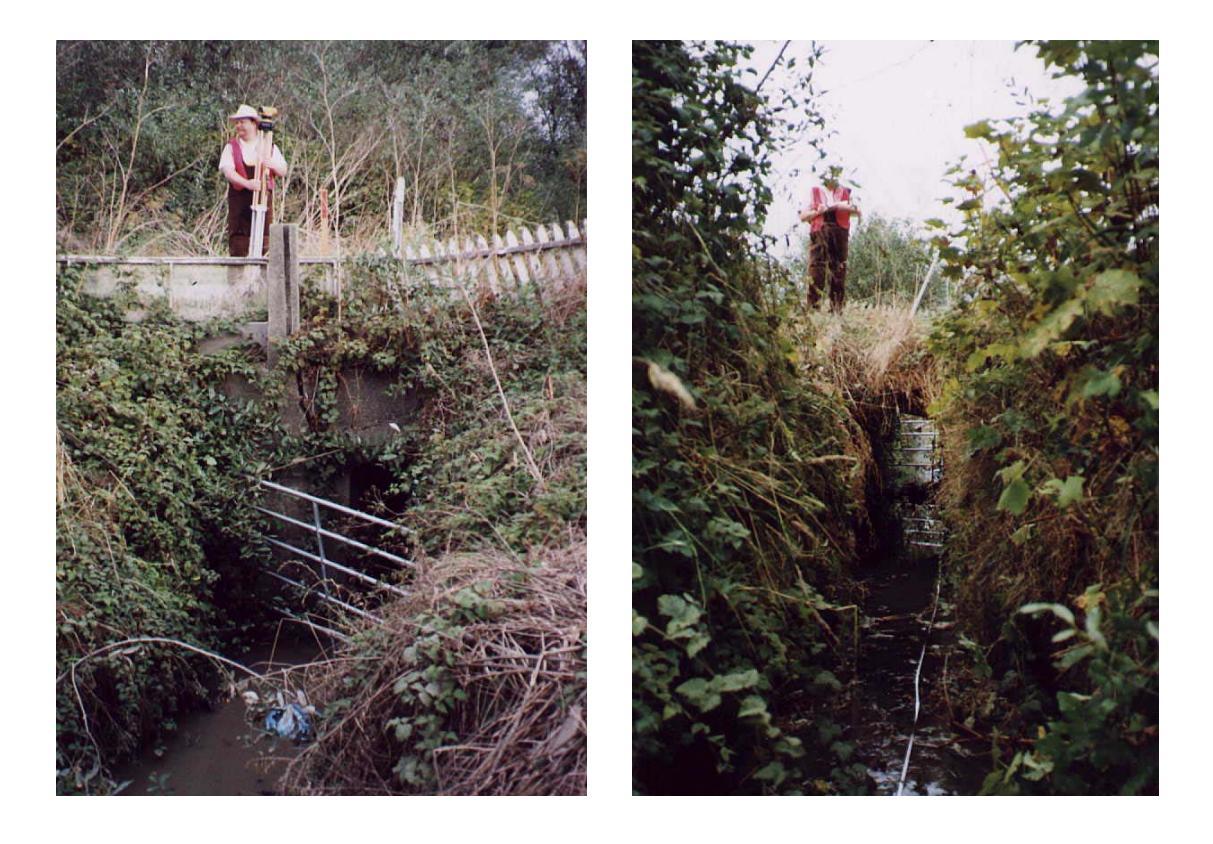
Site #37: Reas Creek #1; Port Kenyon Road Priority Ranking = #63

Overall condition: Good. Sizing: Poor, sized for less than a 5-year flow.

Barrier Status: Passable for most adults and partial barrier for all juveniles. Fish Xing determined that the inadequate sizing created a velocity barrier at a wide range of migration flows.

Additional Barriers: None downstream, enters what is left of the lower Salt River. Upstream, next culvert crossing is at Centerville Road which is a partial due to lack of depth at lower flows.

Habitat Upstream: Quantity = 20,300' of anadromous channel; Quality = poor, severe impacts from over a century of timber harvest, channelization, and unfenced dairy grazing.

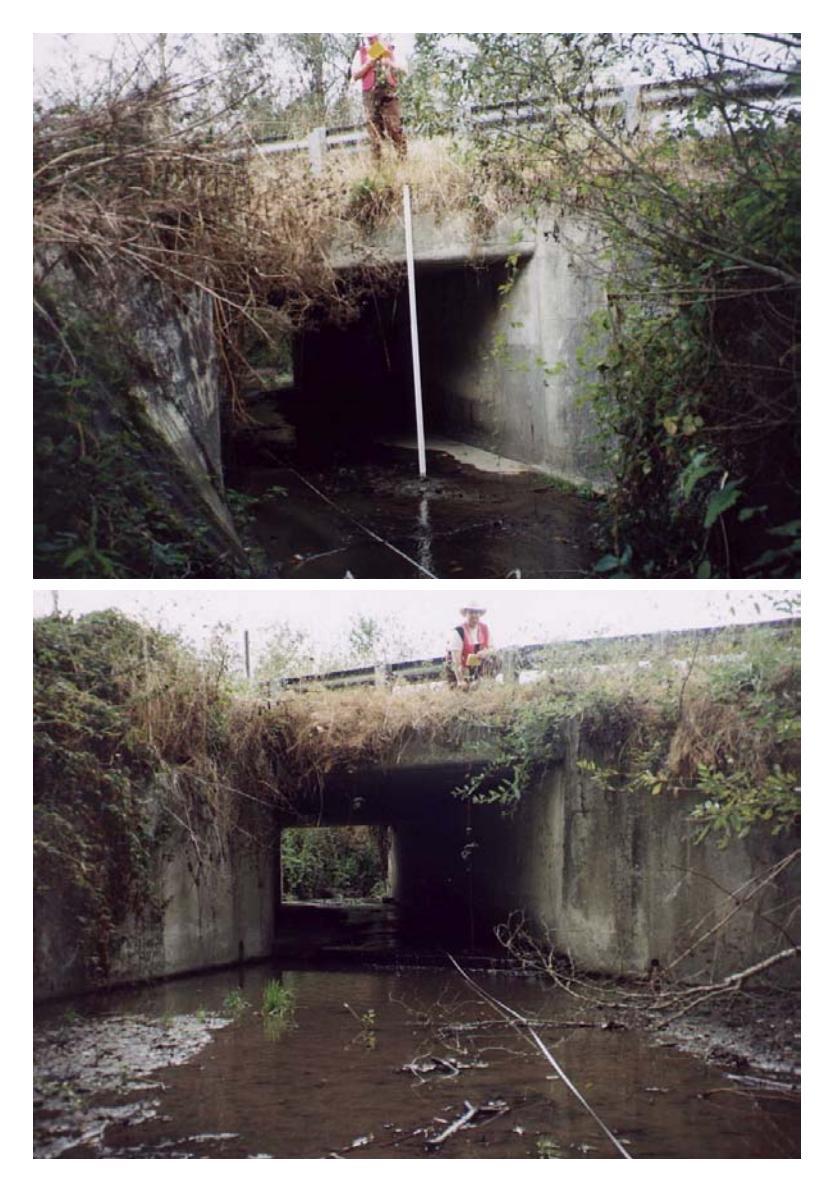
Site #38: Reas Creek #2; Centerville Road Priority Ranking = #64

Overall condition: Good. Sizing: Good sized for close to 50-year flow.

Additional Barriers: Yes, downstream 2,400' is the undersized Port Kenyon Road box culvert. Upstream 5,600' is CSP at Descheger Road.

Habitat Upstream: Quantity = 17,900 of anadromous channel; Quality = poor, severe impacts from over a century of timber harvest, channelization, and unfenced dairy grazing.

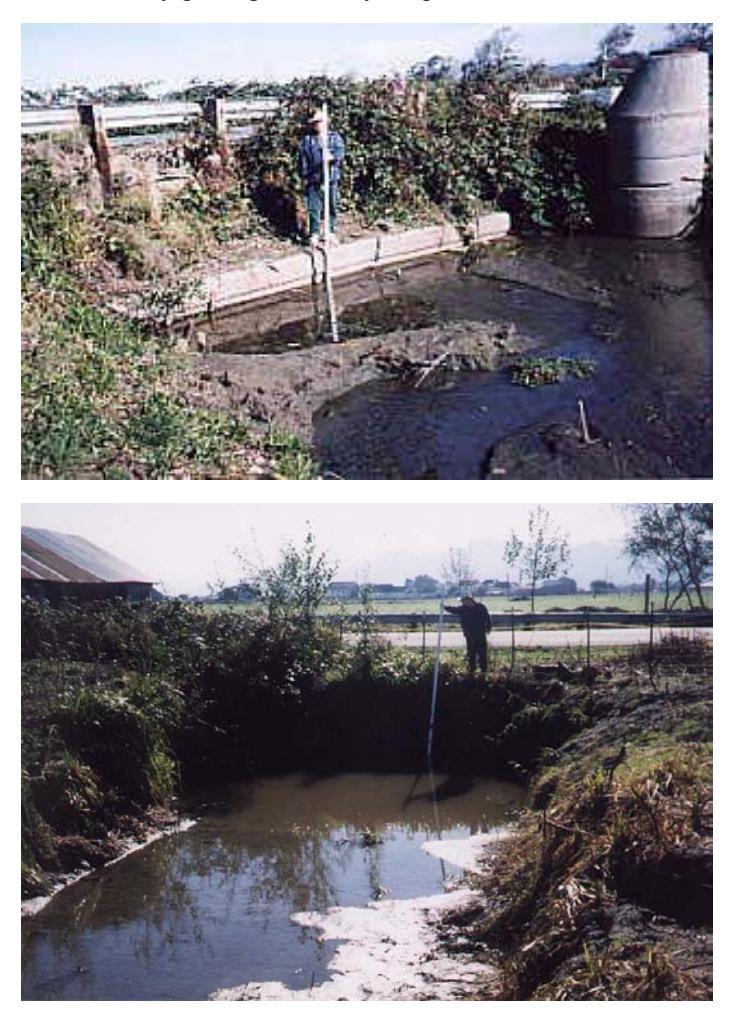
Overall condition: Fair, top of foundation has taken a beating on high flows.

Additional Barriers: None downstream flows into remnant Salt River channel. Upstream, yes flows through concrete ditch and numerous culverts through downtown Ferndale. Not known what barriers exist upstream of downtown Ferndale (no access to private property.

Habitat Upstream: Quantity = approximately 22,000' of potential anadromous channel. Quality = Extremely poor, severe impacts from over a century of timber harvest, urban and residential development, channelization, and unfenced dairy grazing. Probably the poorest habitat encountered during the inventory.

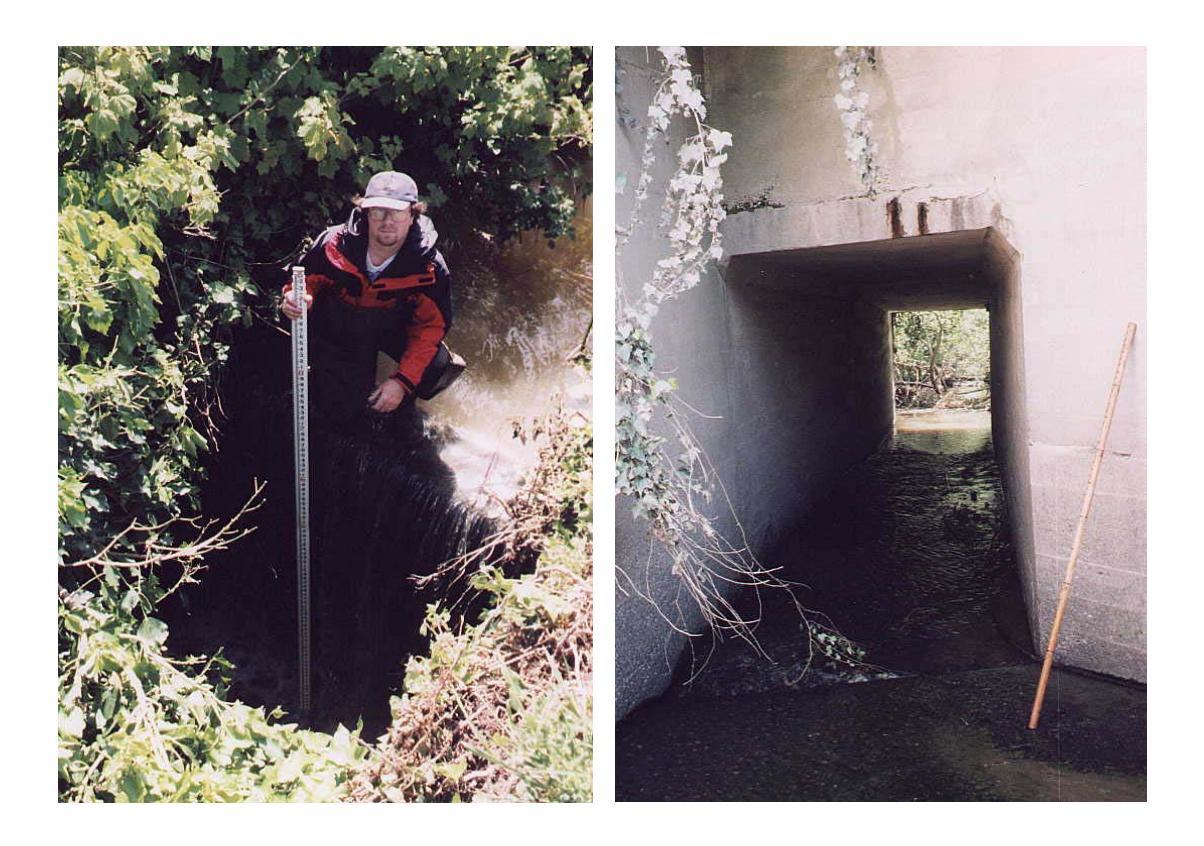
Site #41: Barber Creek #1; Grizzly Bluff Road Priority Ranking = #56

Overall condition: Good. Sizing: N/A, appears adequately sized.

Additional Barriers: Possible downstream - flow drops down steep riprapped section into mainstem Eel River. Upstream, yes flows through culvert on Price Creek School Road.

Habitat Upstream: Quantity = approximately 14,700' of potential anadromous habitat. Quality = poor, severe impacts from over a century of timber harvest, channelization, and unfenced dairy grazing.

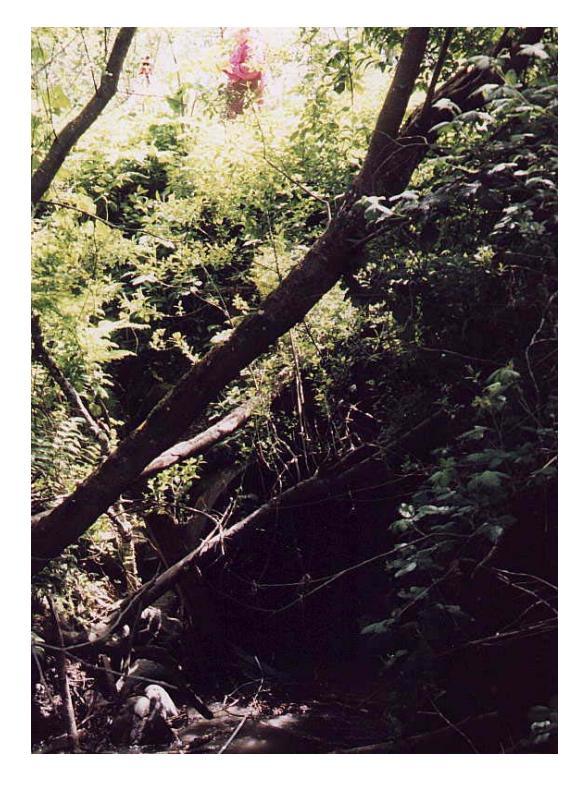
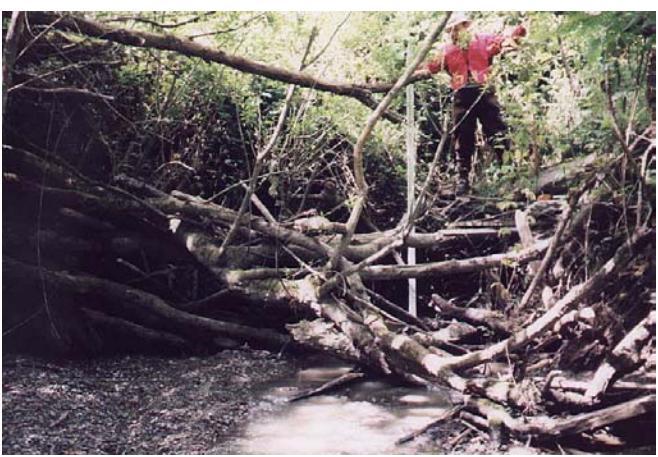
Site #42: Barber Creek #2; Price Creek School Road Priority Ranking = #57

Overall condition: Poor, rusting, crushed, lots of woody debris caught in riparian trees at culvert outlet.

Additional Barriers: Yes, downstream - flows through culvert on Grizzly Bluff Road, too high of jump at inlet sill. Upstream, unknown, no access to private property.

Habitat Upstream: Quantity = 9,700' of potential anadromous channel above culvert. Quality = No records on file at CDFG. Appears poor - warm, muddy flow, highly silted in substrate, collapsing banks, minimal pool development. Result of severe impacts from over a century of timber harvest, channelization, and unfenced dairy grazing.

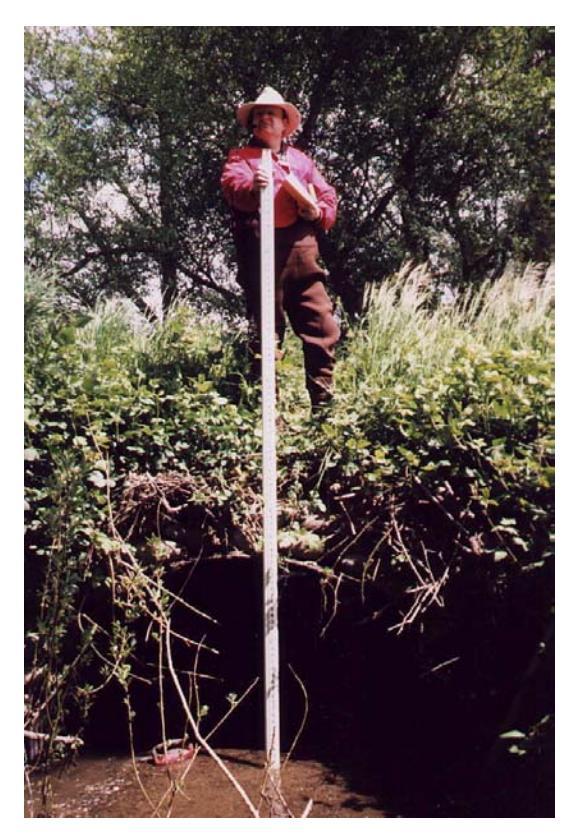
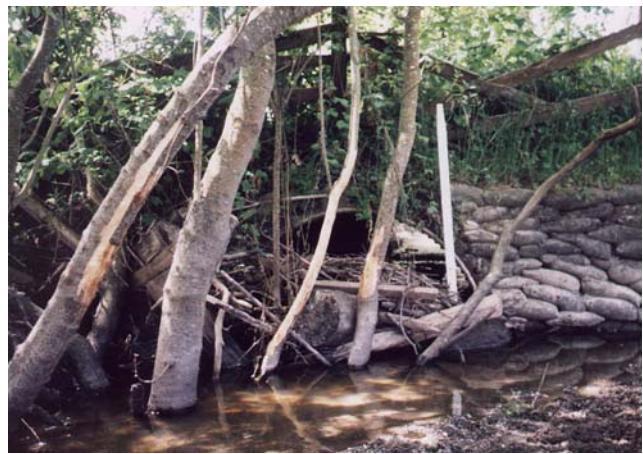
Overall condition: Poor, rusting, an slightly crushed, large debris jam at outlet due to riparian trees leaning across stream channel.

Additional Barriers: Partial, downstream is River Bar Road #1. Upstream, next culvert is on Rohnerville Road about 6,000' upstream, may be a velocity barrier to juveniles at some migration flows. NOTE: debris jam at outlet should be cleared by County Road Maintenance crews.

Habitat Upstream: Quantity = at least 20,000' of potential anadromous channel above culvert. Quality = poor, severe impacts from over a century of timber harvest, channelization, and unfenced dairy grazing. Habitat appears better above the Rohnerville Road culvert, finally upstream of unfenced grazing.

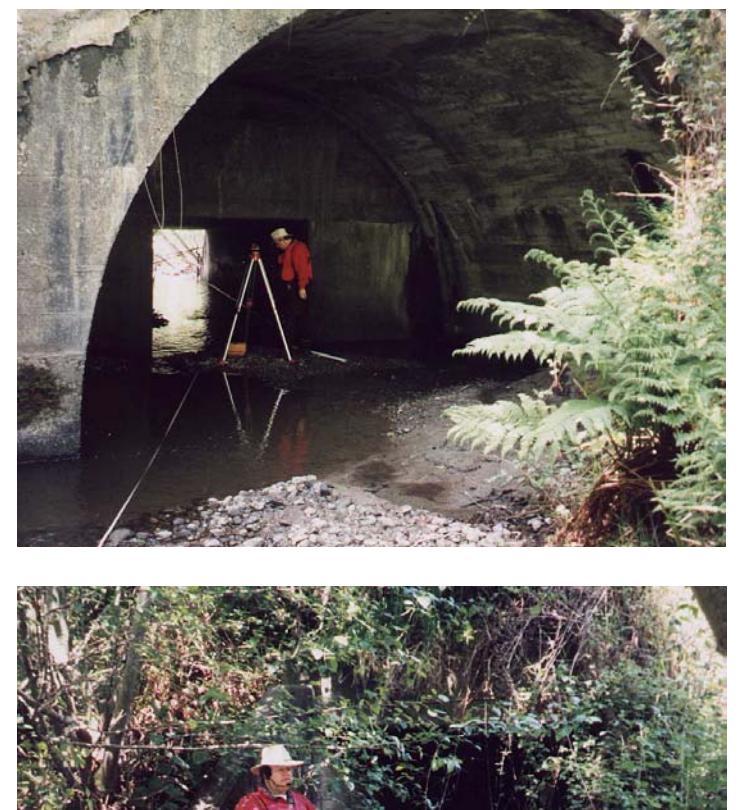
Site #45: Wolverton Gulch #3; Rohnerville Road Priority Ranking = #67

Overall condition: Good, relatively new crossing. **Sizing:** Not calculated, but appears properly sized for its location in the watershed (larger than the two county culverts located over a mile downstream).

Additional Barriers: Downstream, both River Bar Road culverts are probably velocity barriers to juveniles. Upstream, unknown, no access to private property.

Habitat Upstream: Quantity = about 14,000' of potential anadromous channel above culvert. Quality = fair, severe impacts from over a century of timber harvest. Habitat appears better above the Rohnerville Road culvert, finally upstream of unfenced grazing. However, lots of fine sediment aggraded in channel.

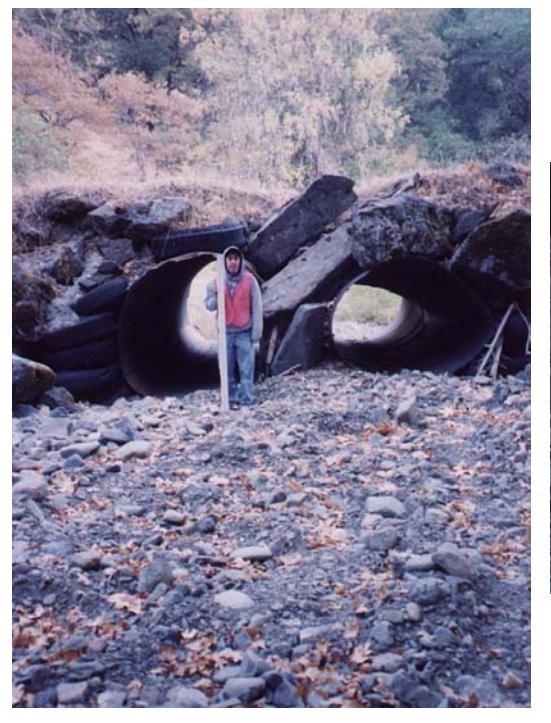
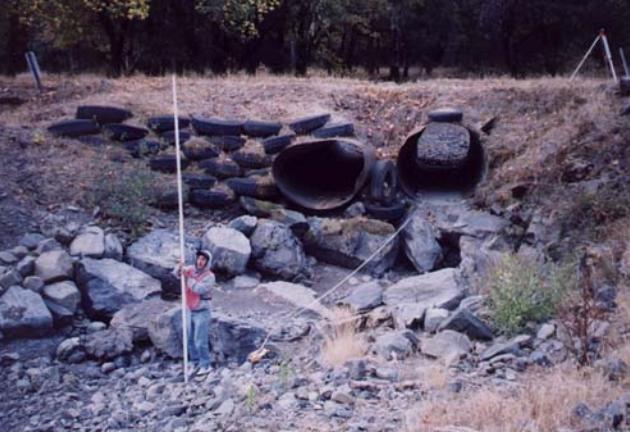
Site #46: Jewett Creek; Jewett Road Priority Ranking = #55

Overall condition: Poor, pipes are crushed and heavily rusted.

Additional Barriers: Downstream, natural falls/debris jam in channel about a mile below Jewett Road appears to be a partial barrier, with adult steelhead above this barrier in some years. Upstream, none.

Habitat Upstream: Quantity = about 1500' of potential anadromous channel above culvert. Quality = poor, impacts from timber harvest and unfenced grazing. Sparse riparian zone along a wide, aggraded stream channel. Stream was dry in fall prior to winter rain. Landowner is in process of installing cattle exclusion fencing.

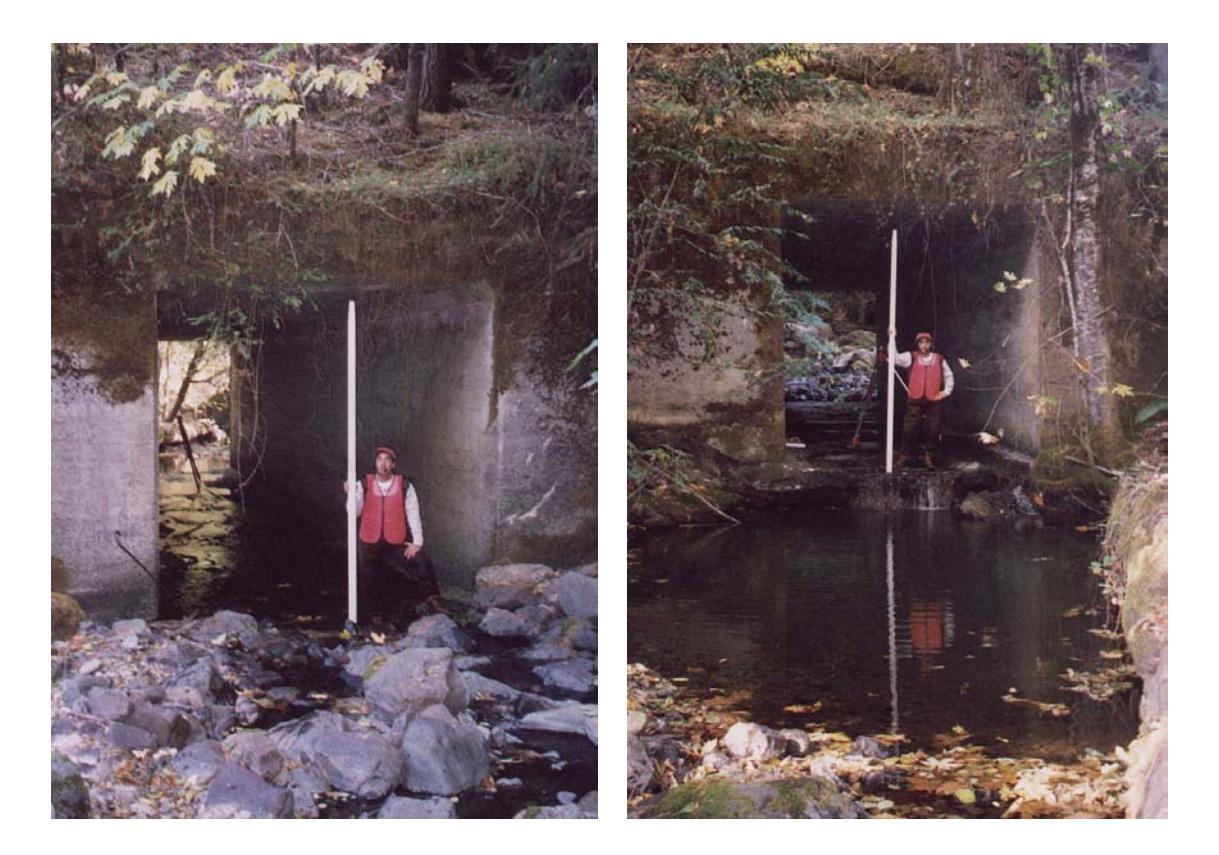
Site #47: Frenchman Creek; Harris Road **Priority Ranking =** #42

Overall condition: Fair, floor worn down to rebar. Irregularities in concrete floor probably improve passage conditions for salmonids.

Additional Barriers: Downstream, natural falls/debris jam in channel about a mile below Jewett Road appears to be a partial barrier, with adult steelhead above this barrier in some years. Upstream, none.

Habitat Upstream: Quantity = about 1000' of potential anadromous channel above culvert. Quality = Good, ample flow of cool water in late August, dense riparian zone of second-growth conifer and hardwoods. Boulder dominant channel, with numerous deep pools and minimal amounts of fine sediment.

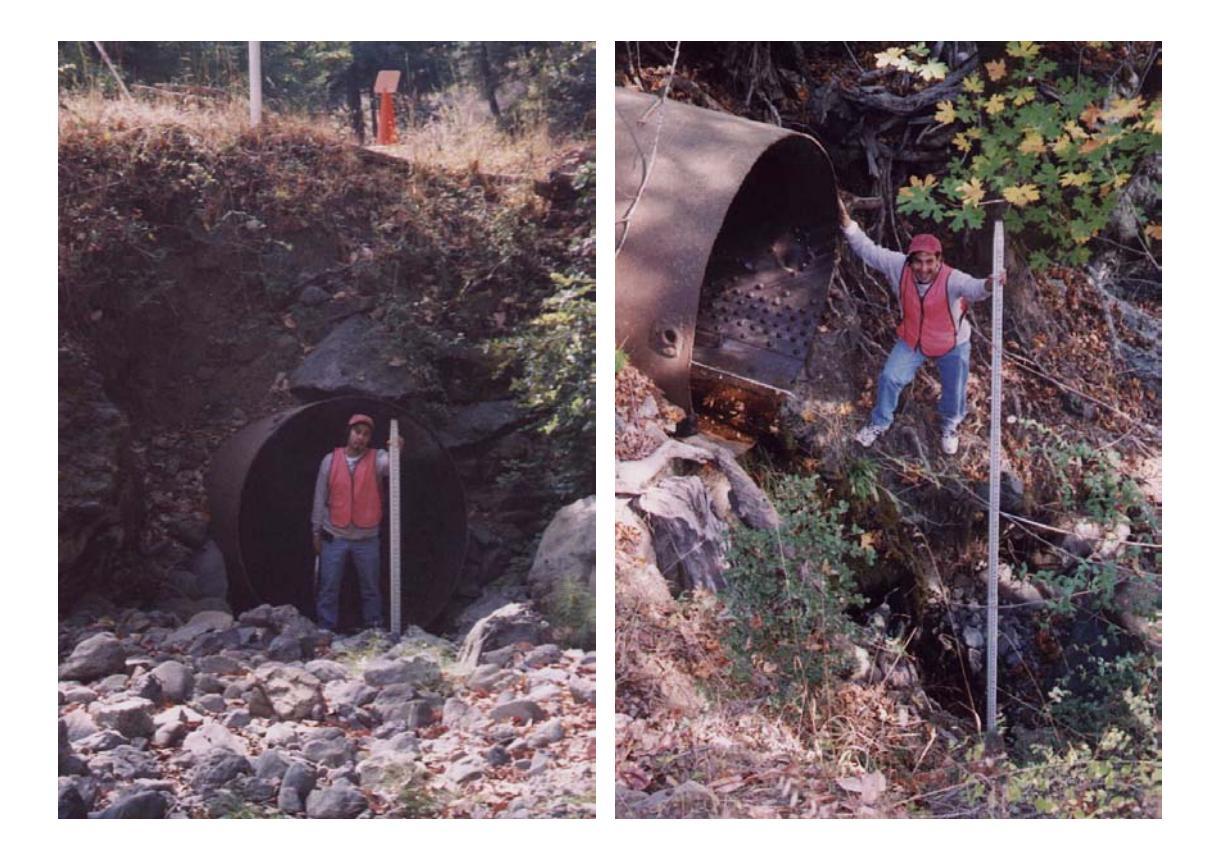
Site #48: Perington Creek; Harris Road Priority Ranking = #66

Overall condition: Fair, pipe is slightly crushed and starting to rust.

Additional Barriers: Downstream, natural falls/debris jam in channel about a mile below Jewett Road appears to be a partial barrier, with adult steelhead above this barrier in some years. Upstream, none.

Habitat Upstream: Quantity = about 700' of potential fish-bearing channel above culvert. However, it is questionable if this reach of Perington Creek is within limit of anadromy (channel is steep and incised). Quality = poor, impacts from timber harvest and unfenced grazing. Sparse riparian zone along a heavily aggraded stream channel. Stream was dry in fall prior to winter rain.

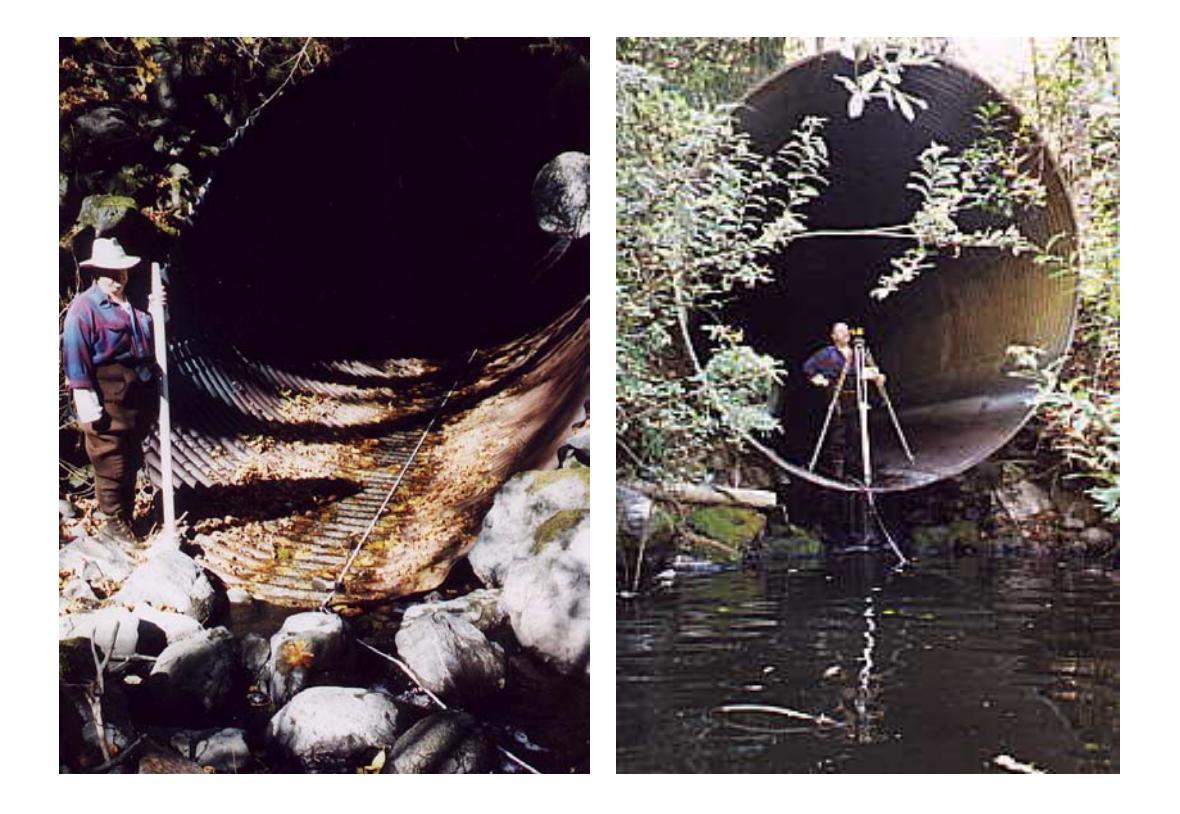
Site #49: Tributary to McNutt Gulch #1; Mattole Road **Priority Ranking =** #23

Overall condition: Fair, some rusting of floor, low flow does not reach the outlet.

Barrier Status: Yes, excessive slope and length combine to create a velocity barrier. Lack of depth and leakage create low flow problems for both upstream and/or downstream migration. Jump into culvert outlet is a problem for juveniles.

Additional Barriers: None downstream, enters mainstem McNutt Gulch within several hundred feet. Upstream, debris jam creates falls just below next culvert on Mattole Road about 3,000' upstream, a velocity barrier to adults and juveniles at most migration flows.

Habitat Upstream: Quantity = approximately 3,000' of potential anadromous channel until next culvert. Quality = fair, impacts from over a century of timber harvest and unfenced grazing. Dense canopy of mostly hardwoods along channel. Cool water temperature at end of summer flows. Appears highly aggraded with lots of fines. Low volume of inchannel LWD, especially conifers.
