APPENDIX B:

CATALOG OF HUMBOLDT COUNTY CULVERTS LOCATED ON FISH-BEARING STREAM REACHES

SITE-SPECIFIC CULVERT INFORMATION

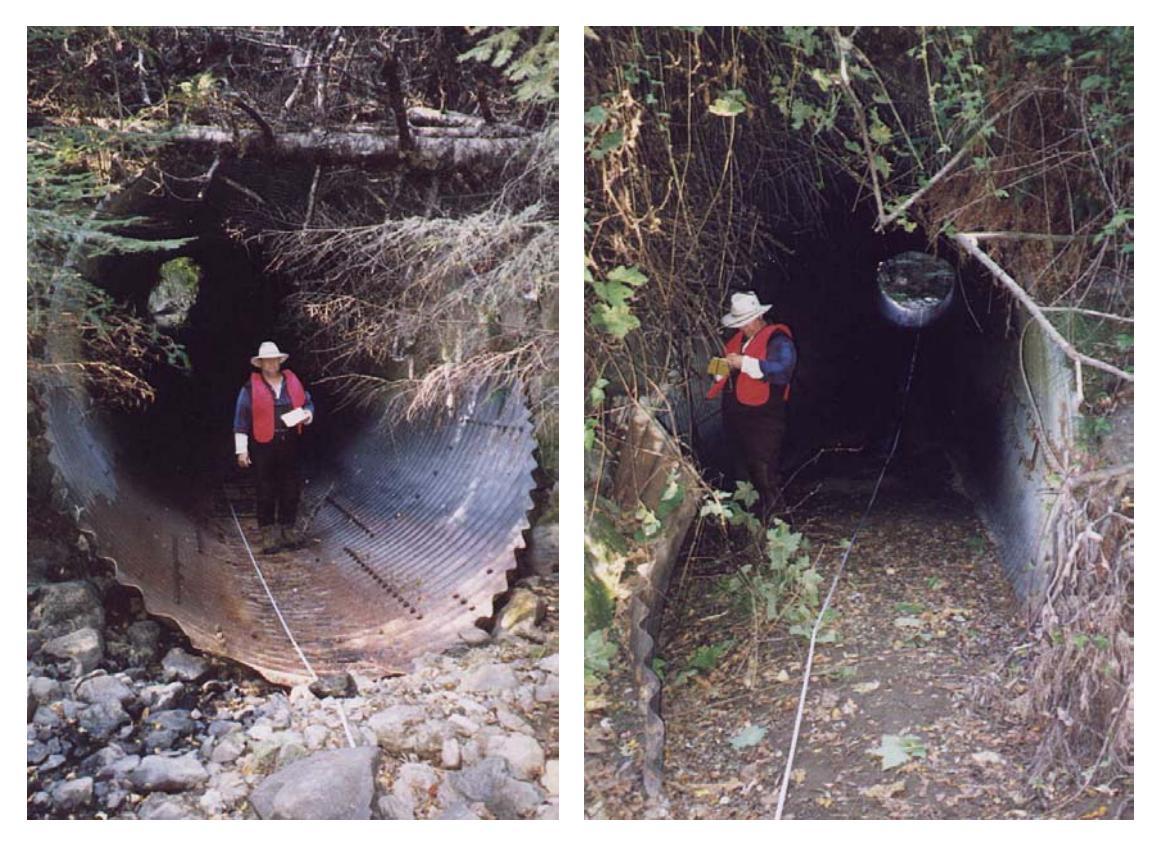
Site #50: Tributary to McNutt Gulch #2; Mattole Road Priority Ranking = #34

Overall condition: Poor, some rusting through of floor along upper section, after break-in-slope culvert is backwatered. The entire pipe appears bent and collapsing as entire hillslope appears to be moving (or shifted during a past event – flood or earthquake).

Additional Barriers: Yes, immediately downstream is steep drop just described, then approximately 3,000' is McNutt Gulch #1. Upstream, none.

Habitat Upstream: Quantity = approximately 9,400' of potential fish-bearing habitat. Quality = fair, severe impacts from over a century of timber harvest, channelization, and unfenced dairy grazing. Cool water temperature at end of summer flows. Appears highly aggraded with lots of fines. Low volume of inchannel LWD, especially conifers.

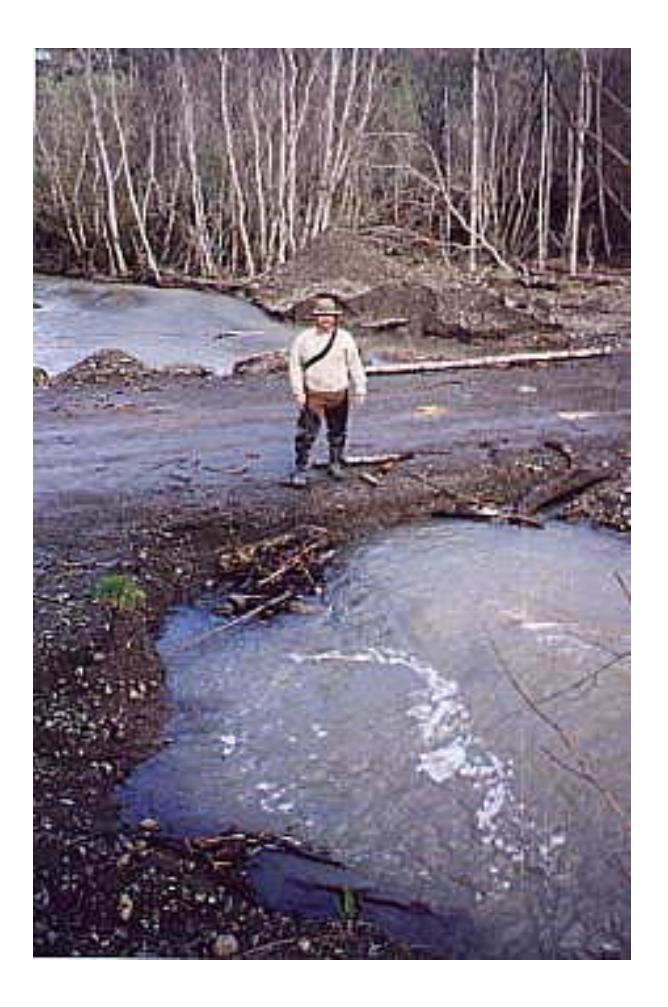
Overall condition: Extremely poor, the one exposed pipe is rusted and crushed. Second pipe is buried and possibly crushed – not passing any flow.

Additional Barriers: None, except aggraded flood terrace of mainstem Mattole River. Upstream, none.

Habitat Upstream: Quantity = 0.3 miles. Quality = HOBO temperature data indicates cool water during summer months.

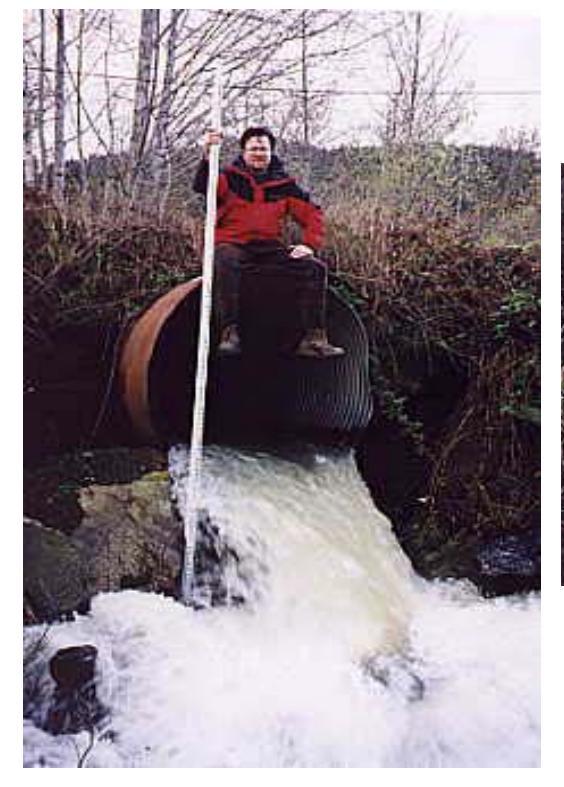
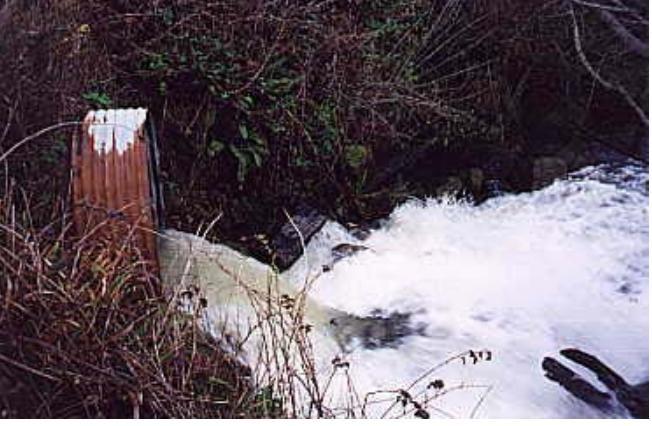
Site #52: Stansberry Creek; Lighthouse Road Priority Ranking = #5

Fill Estimate: 316 cubic yards. Overall condition: Poor, pipe is rusted.

Additional Barriers: Downstream none, less than 50 feet of channel to mainstem Mattole River. Upstream, none.

Habitat Upstream: Quantity = 3,600'. Quality = HOBO temperature data indicates cool water during summer months. However, lower channel is confined within a levee. Relative lack of inchannel woody debris.

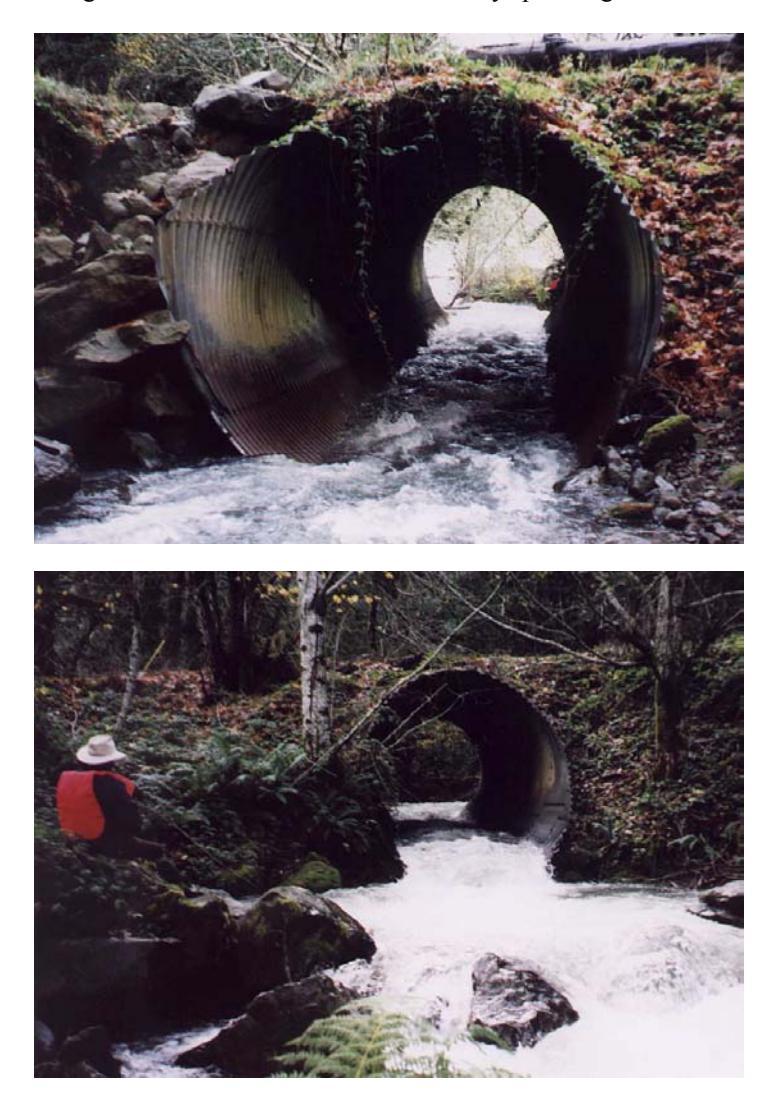
Site #53: Mill Creek; Lighthouse Road **Priority Ranking = #20**

Fill Estimate: 316 cubic yards. Overall condition: Good. Sizing: Good, able to pass a 50-year flow.

Additional Barriers: Downstream none, less than 150 feet of channel to mainstem Mattole River. Upstream, none.

Habitat Upstream: Quantity = 1.35 miles. Quality = Good, HOBO temperature data indicates cool water during summer months. The best tributary habitat remaining in the lower Mattole River. May provide coolwater refugia during summer. Past records confirm use by spawning coho and steelhead.

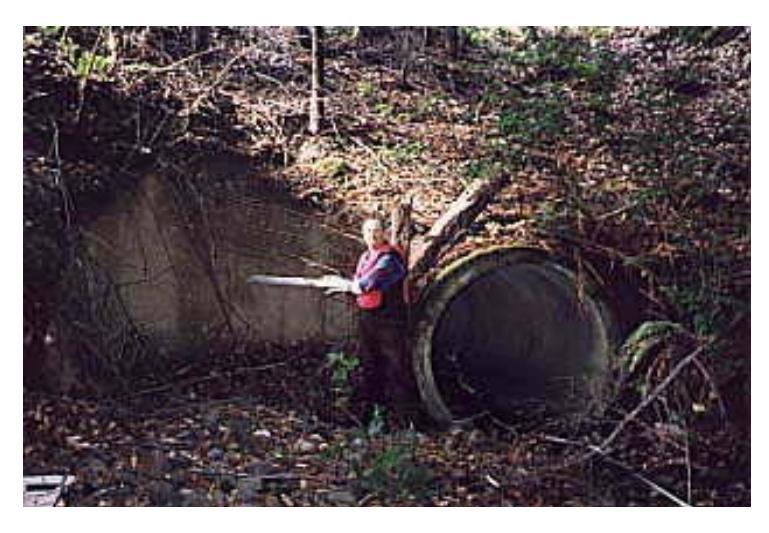
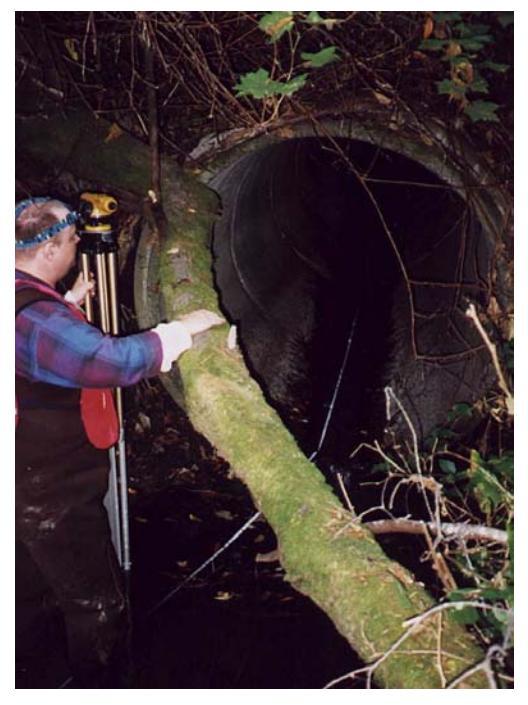
Site #54: Titus Creek; Lighthouse Road Priority Ranking = #46

Overall condition: Poor, floor is worn through. Sizing: Poor, unable to pass a 10-year flow.

Additional Barriers: Downstream none, less than 200 feet of channel to mainstem Mattole River. Upstream, unknown no access to private property.

Habitat Upstream: Quantity = 2,000' of potential anadromous habitat. Quality = Assessed as "poor", however little is known due to lack of access. During summer, water is withdrawn for domestic use that results in nearly a dry channel.

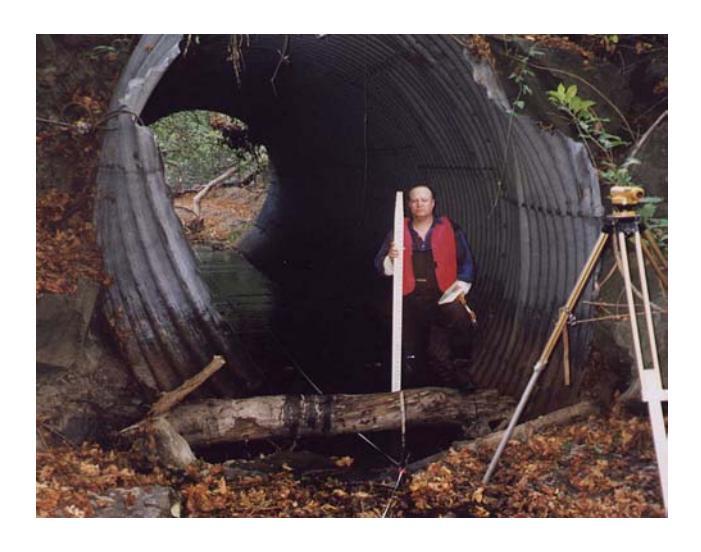
Site #55: East Mill Creek #1; Conklin Creek Road Priority Ranking = #17

Fill Estimate: 1,789 cubic yards. **Overall condition:** Poor, floor is rusting, projecting inlet is crushed and folded.

Additional Barriers: Downstream none, less than 150 feet of channel to mainstem Mattole River. Upstream, no, culvert at Chambers Road is a swim-through.

Habitat Upstream: Quantity = approximately 14,000' of potential anadromous habitat. Quality = Fair, lower reaches appear highly aggraded with minimal amounts of inchannel LWD. Cool summer water temperatures and numerous juvenile steelhead observed during initial site visit.

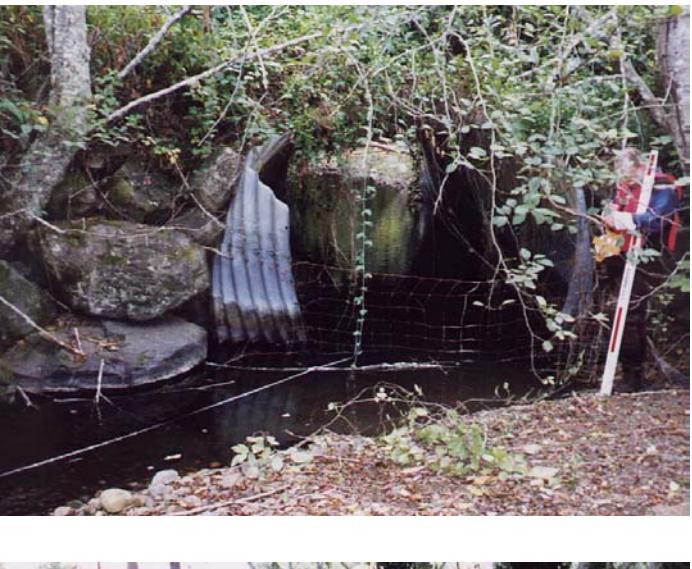
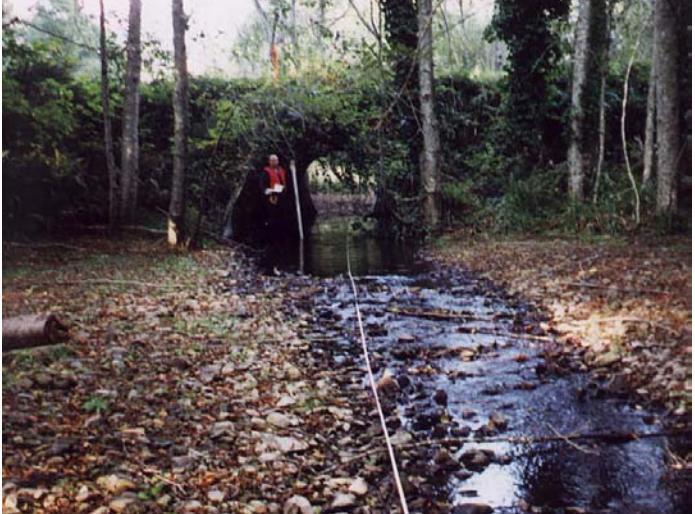
Site #56: East Mill Creek #2; Chambers Road **Priority Ranking =** #36

Overall condition: Fair, projecting inlet is crushed and folded.

Additional Barriers: Downstream yes, less than 0.3 miles to Conklin Creek Road culvert. Upstream, unknown, no access to private property.

Habitat Upstream: Quantity = approximately 10,500' of potential anadromous habitat. Quality = Fair, stream reach above culvert appears highly aggraded with minimal amounts of inchannel LWD. Cool water and numerous juveniles observed during initial site visit prior to winter rains.

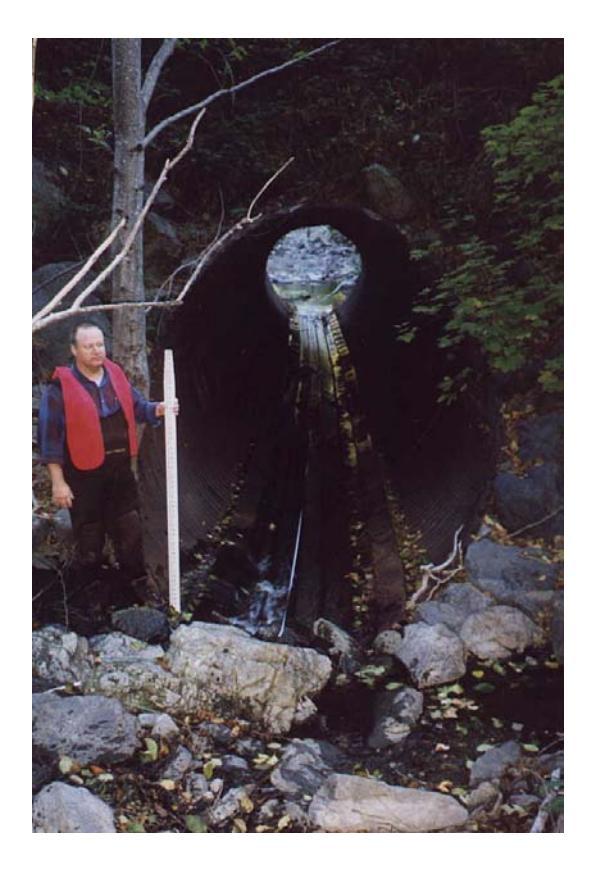
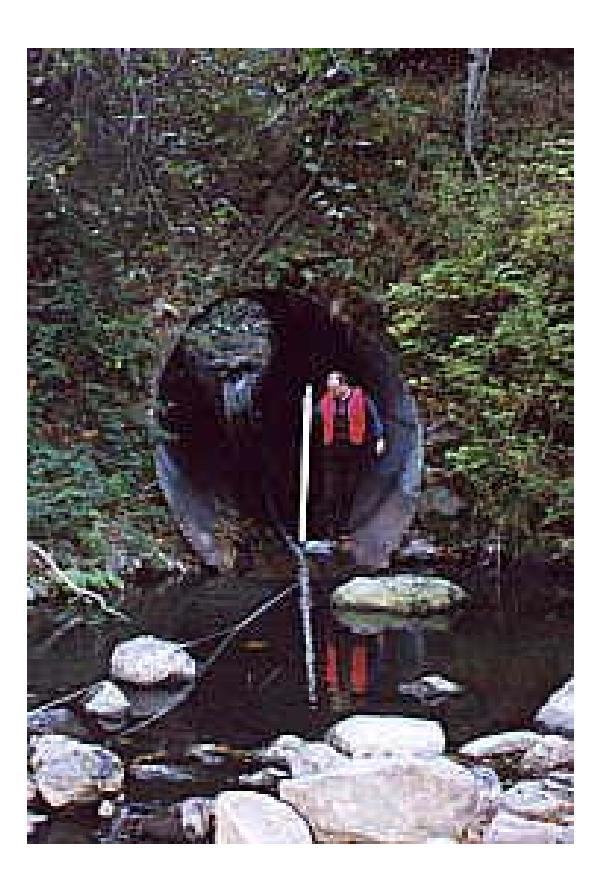
Site #57: Clear Creek; Mattole Road Priority Ranking = #7

Length: 88.2' **Slope:** 8.7%. **Modifications:** Parallel steel tracks down length of culvert floor (to protect bottom from wear and transport bedload?)

Fill Estimate: 5,308 cubic yards. **Overall condition:** Good. **Sizing:** Good, should pass at least a 50-year flow.

Additional Barriers: Downstream none, less than 150 feet of channel to mainstem Mattole River. Upstream, none until natural falls about 0.7 miles.

Habitat Upstream: Quantity = 0.7 miles. Quality = Good, some of the best coolwater refugia in lower Mattole River. Steep, boulder-dominant channel, dense riparian zone, good flow in late summer. CDFG surveys last observed coho and steelhead above culvert in 1983.

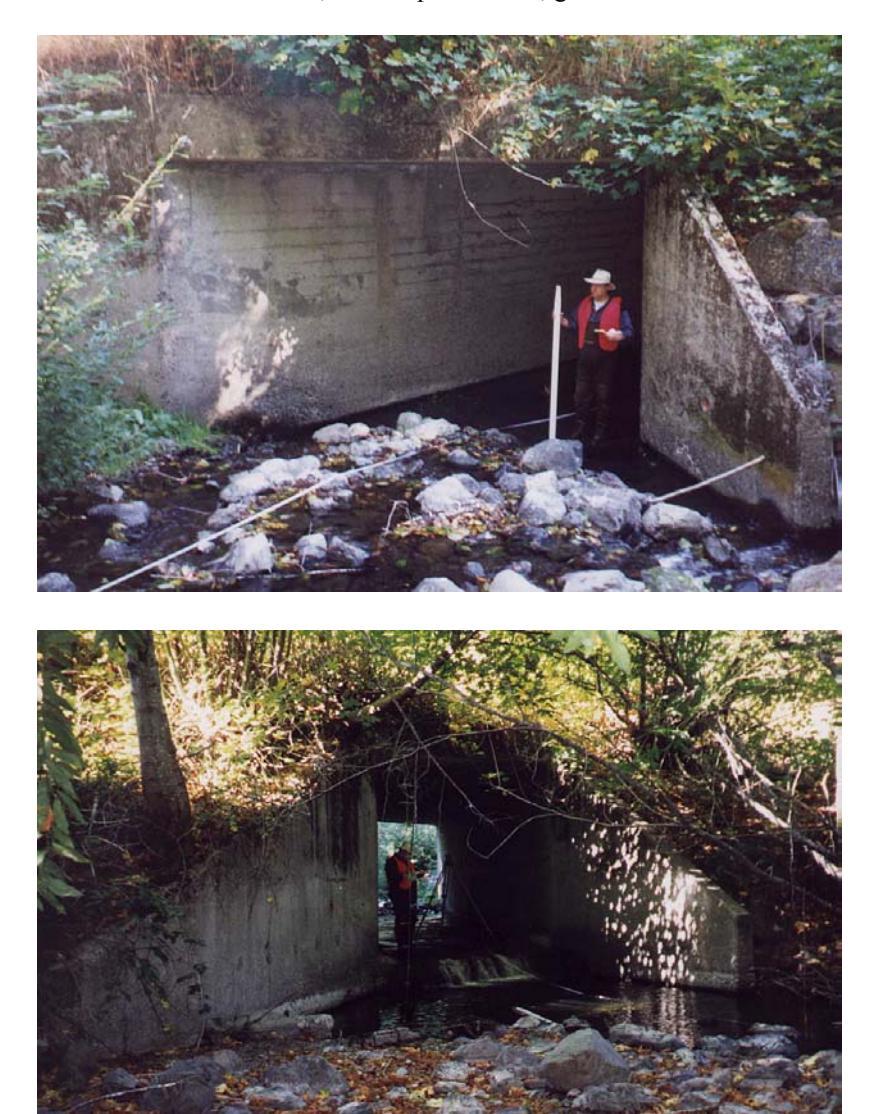
Overall condition: Good. Sizing: Good, should pass greater than a 100-year flow.

Barrier Status: Partial for adults, nearly complete for juveniles. Too shallow at low flows, excessive velocities at higher flows. Direct observation of juveniles suggest entry jump as well as flow velocities were problems. Kingfishers observed at outlet pool when juvenile steelhead were jumping.

Additional Barriers: Downstream none, less than 300 feet of channel to mainstem Mattole River. Upstream, none.

Habitat Upstream: Quantity = 1.2 miles. Quality = Good, has potential coolwater refugia. Moderatelysteep, boulder/cobble-dominant channel, dense riparian zone, good flow in late summer.

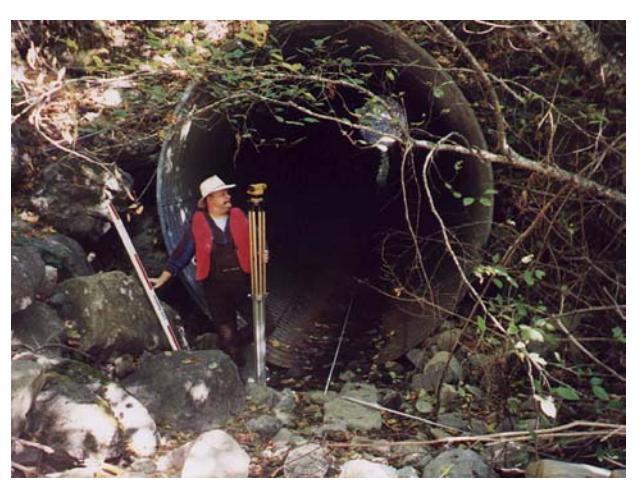
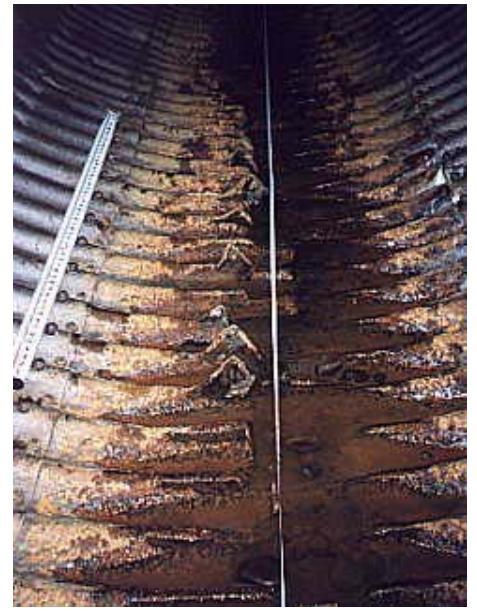
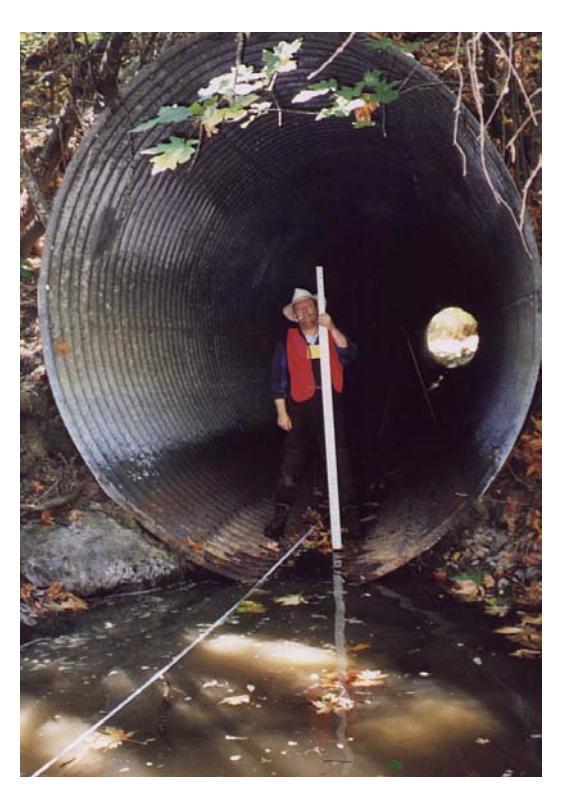
Site #59: Granny Creek; Mattole Road **Priority Ranking = #54**

Fill Estimate: 21,568 cubic yards. **Overall condition:** Poor, floor rusting and eroding away (see lower left photo).

Barrier Status: Partial/temporary for adult steelhead (only 20% passable), complete for adult coho and all juveniles. Too shallow at low flows, excessive velocities at higher flows. Both excessive slope and long length of culvert cause passage problems.

Additional Barriers: Downstream none, less than 300 feet of channel to mainstem Mattole River. Upstream, unknown, no access to private property.

Habitat Upstream: Quantity = 3,900' of potential anadromous channel. Quality = Poor, channel nearly dry in summer, remaining pools shallow and warm, impacts of unfenced grazing apparent in riparian zone and within stream channel.

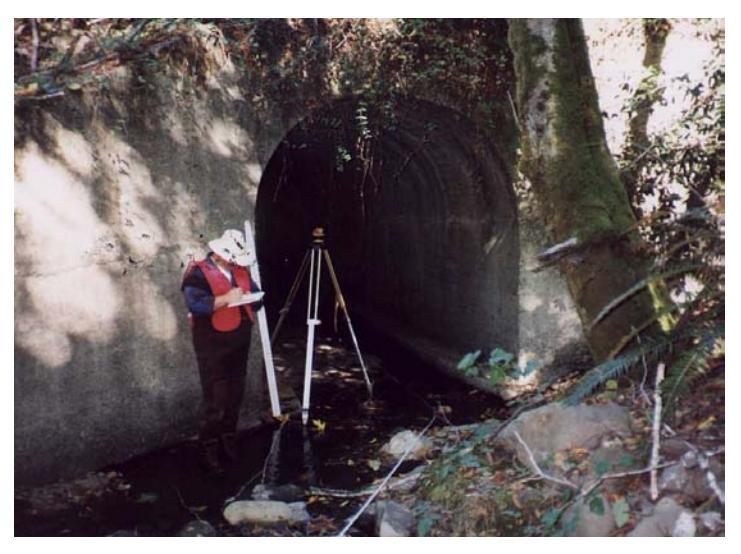
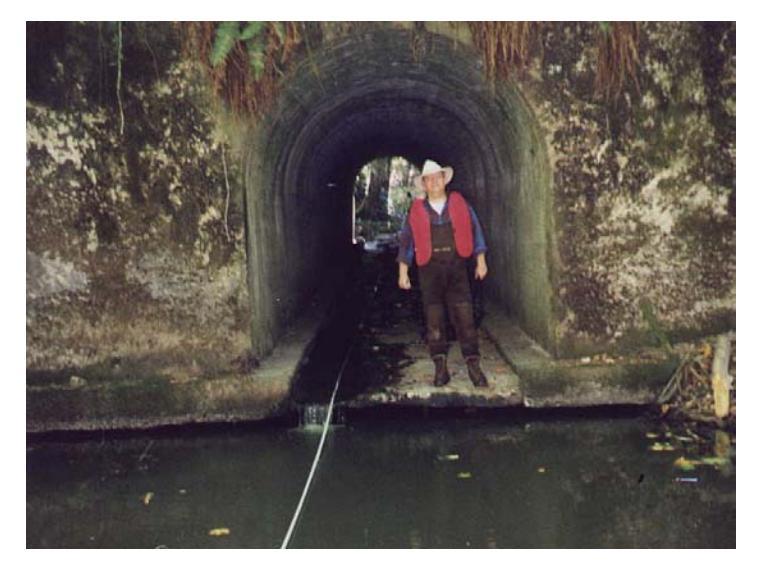
Site #60: Saunders Creek; Mattole Road **Priority Ranking = #16**

Overall condition: Poor, concrete floor cracked and eroding. **Sizing:** Good, should pass greater than a 50-year flow. Above inlet is plaque with the date 1939 – has passed many storm flows.

Barrier Status: Partial for adult steelhead (only 24% passable), complete for adult coho and all juveniles. Too shallow at low flows, excessive velocities at higher flows. Both excessive slope and smooth floor cause passage problems. Juveniles were observed failing to swim even several feet up culvert due to velocity. Measured velocities of 10-12 feet per second during a low-moderate winter migration flow.

Additional Barriers: Downstream none, less than 300 feet of channel to mainstem Mattole River. Upstream, unknown, no access to private property.

Habitat Upstream: Quantity = 3,600' of potential anadromous channel. Quality = Fair, channel was nearly dry in summer, remaining pools shallow and warm, impacts of unfenced grazing apparent in riparian zone and within stream channel. Steelhead observed at culvert during both winter visits.

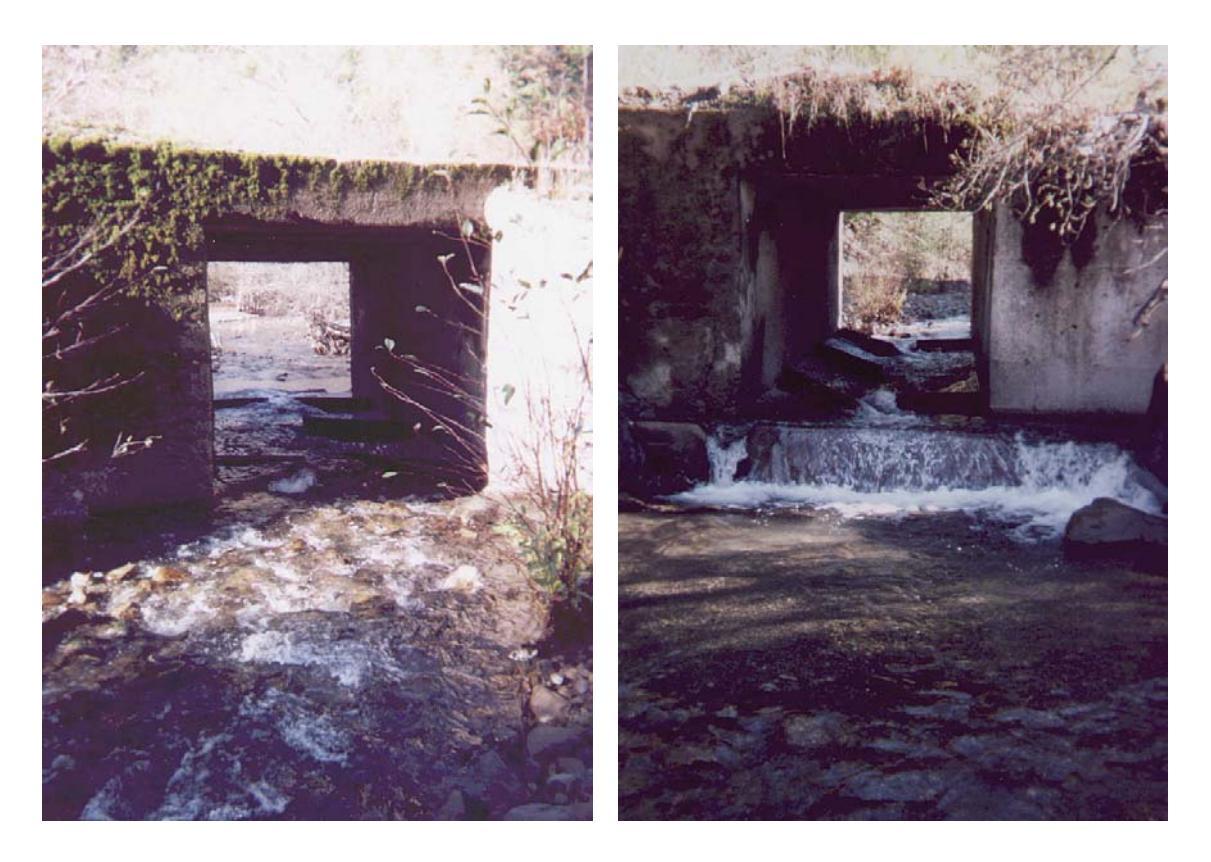
Overall condition: Fair, floor cracked and eroded. **Sizing:** Moderately undersized for drainage area above culvert and regional hydrology.

Barrier Status: Fish Xing determined the culvert is a complete for all adults and juveniles. Too shallow at low flows, excessive velocities at higher flows. Both excessive slope and smooth floor cause passage problems. The baffles are poorly installed, and flow is turbulent and fast during even moderate runoff. Lack of depth in outlet pool for jump into culvert.

Additional Barriers: Downstream none, less than 100 feet of channel to mainstem Honeydew Creek. Upstream, unknown, no access to private property.

Habitat Upstream: Quantity = 7,200' of potential anadromous channel. Quality = Poor, channel was nearly dry in summer, remaining pools shallow and warm, channel highly aggraded from timber harvesting and poor road construction.

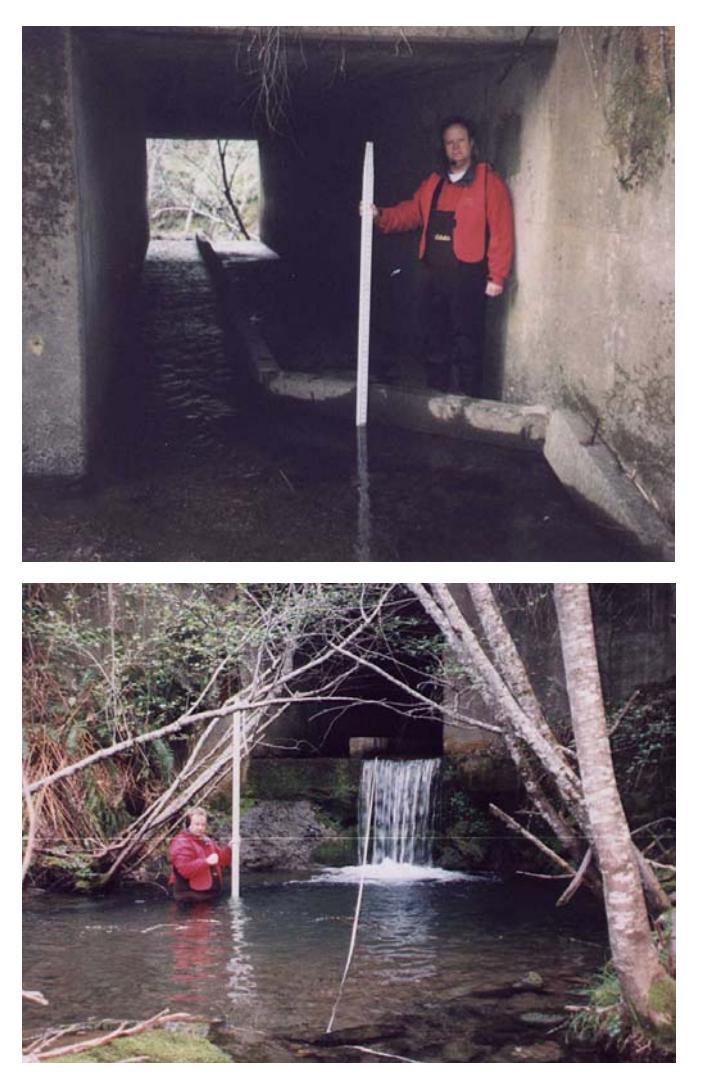
Site #62: Painter Creek; Shelter Cove Road Priority Ranking = #10

Fill Estimate: 3,197 cubic yards. **Overall condition:** Good. **Sizing:** Not calculated, but appears properly sized for the drainage area above culvert and regional hydrology.

Barrier Status: Fish Xing determined the culvert is a partial and temporary barrier for adults and a total barrier to juveniles. Excessive jump (3'-5') required to enter culvert. Fish Xing predicted that coho adults should have access on nearly 60% of expected migration flows, however no coho have ever been observed above culvert. The concrete divider reduces the "target" size of outflow that fish must jump into for entry.

Additional Barriers: Downstream none, less than 200 feet of channel to mainstem Honeydew Creek. Upstream, unknown, no access to private property.

Habitat Upstream: Quantity = 1.1 miles of potential anadromous channel. Quality = Good to fair, cool flow in summer, fairly aggraded with low volumes of inchannel LWD. In summer, coho and steelhead juveniles observed aggregated in pool below culvert.

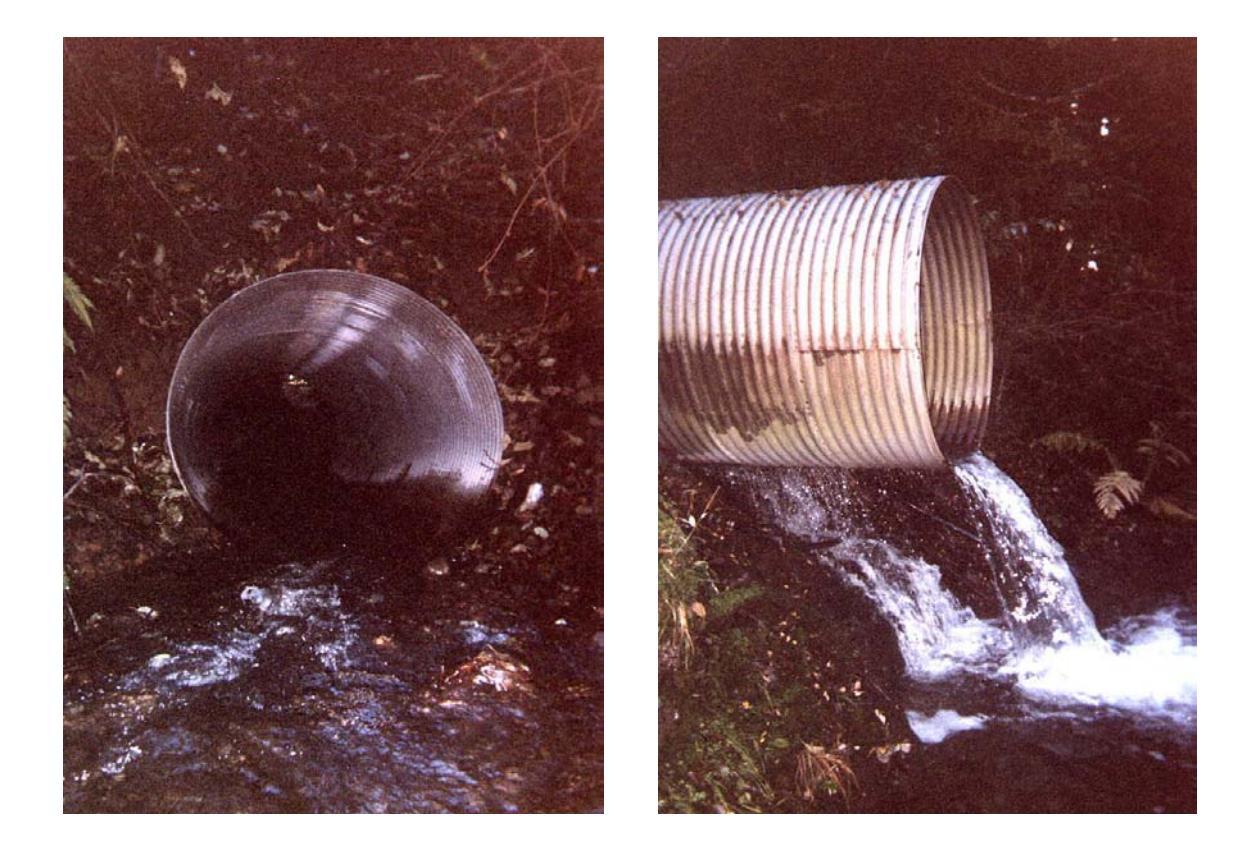
Site #63: East Anderson Creek; Whitethorn Road Priority Ranking = #20

Overall condition: Poor, crushed, and rusting out (note seepage through floor in outlet photo).

Barrier Status: Fish Xing determined culvert is a temporary barrier for adults (20-40% passable for coho and 60-80% passable for steelhead) and a total barrier to juveniles. Excessive jump required to enter culvert, even for adults. Excessive velocity caused by steep slope (at inlet, steeper slope along first 20').

Additional Barriers: Downstream none, empties directly into mainstem Mattole River. Upstream, unknown due to lack of access on private property (primarily Barnun Timber).

Habitat Upstream: Quantity = 1.1 miles of potential anadromous channel. Quality = Has not been surveyed and no access to private property. Appears to have dense riparian and fair instream cover, but creek is dry at county road crossing in summer due to extraction of surface water for residential use.

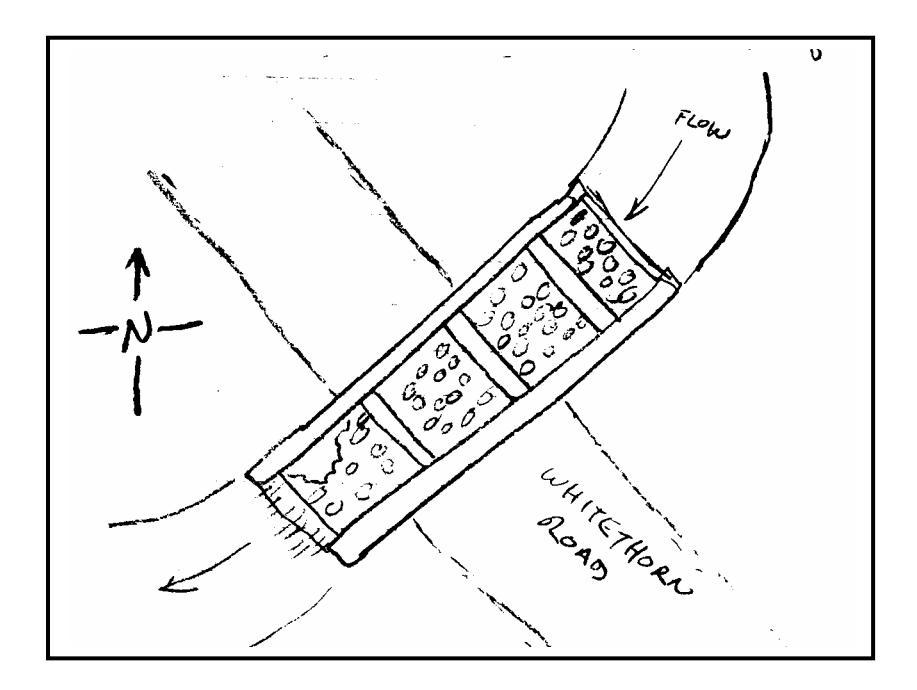
Site #64: Harris Creek; Whitethorn Road Priority Ranking = #40

Fill Estimate: 978 cubic yards. Overall condition: Good.

Note: No photo taken at Harris Creek culvert. However, a sketch is provided from the field notes.

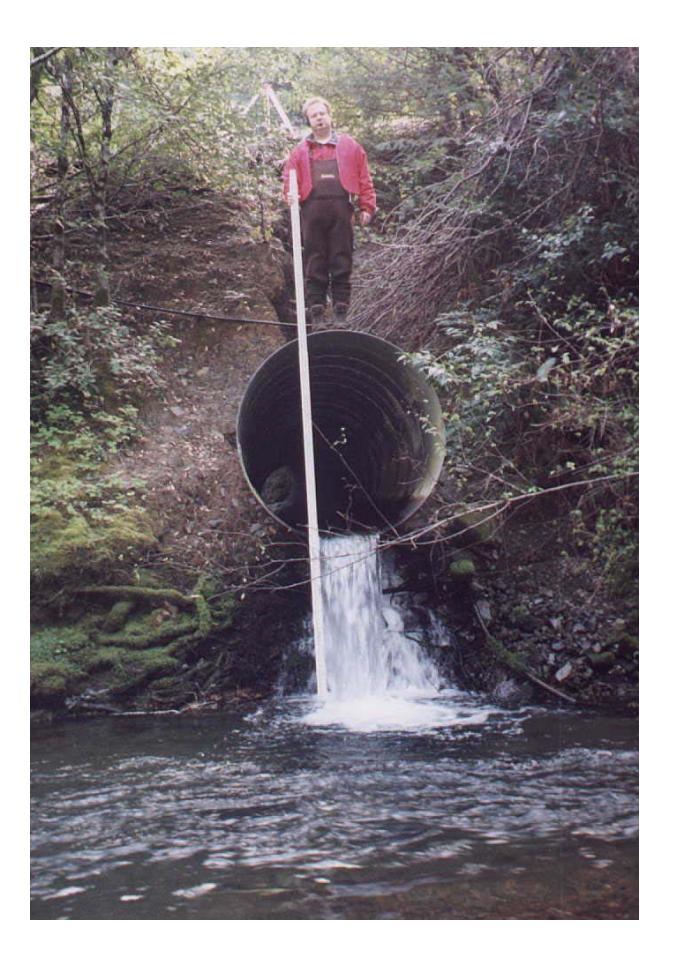
Site #65: Gibson Creek; Whitethorn Road Priority Ranking = #19

Modifications: None. **Fill Estimate:** 2,782 cubic yards. **Overall condition:** Poor, pipe is rusted, bent (break-in-slope near upper end), with flow seeping through culvert floor.

Habitat Upstream: Quantity = 1.0 to 1.7 miles of potential anadromous channel. Quality = Unknown, may have good spawning and spring rearing habitat. However, extraction of water during summer months dries up portions of stream channel.

Photo Note: Only outlet photo taken.

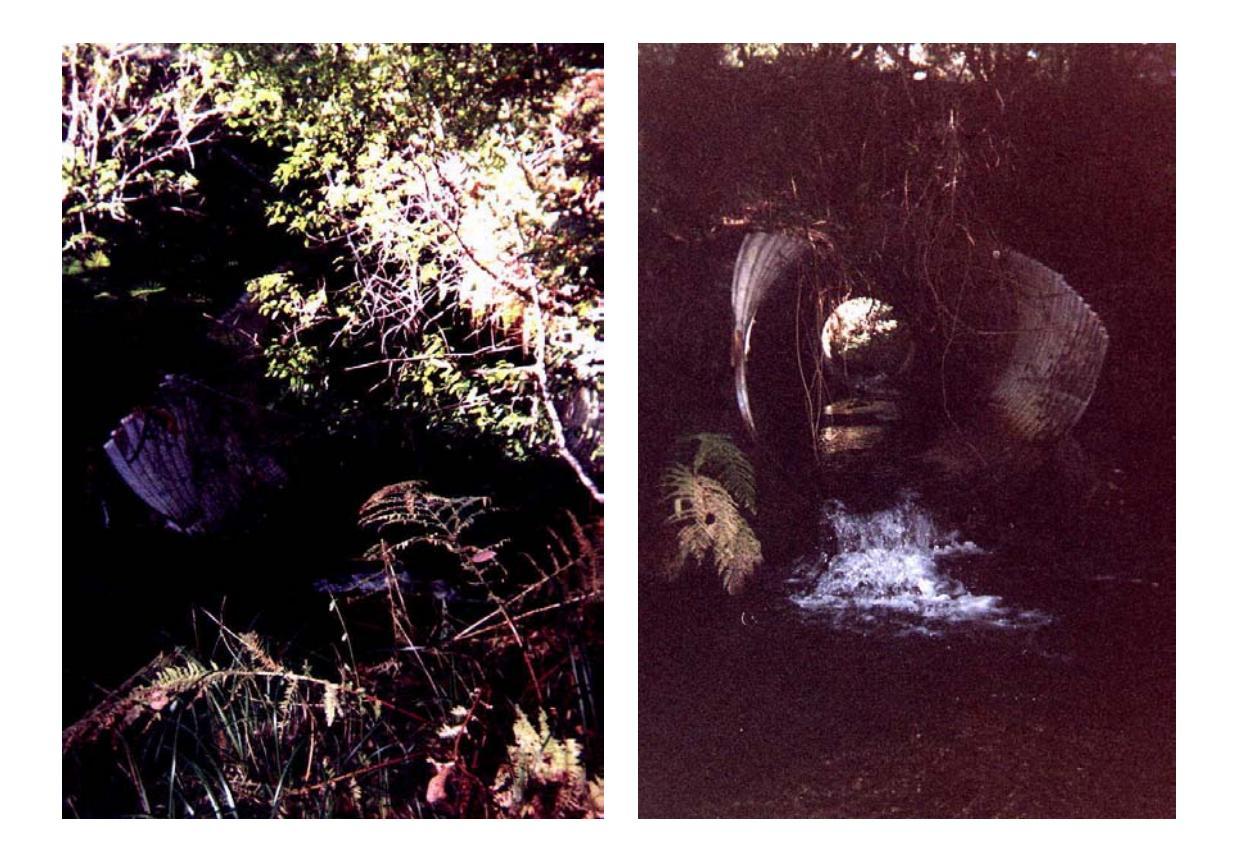
Site #66: Stanley Creek; Whitethorn Road **Priority Ranking = #15**

Modifications: LWD backflood structures at pooltail below outlet. Structures have failed and stream flows underneath.

Fill Estimate: 2,087 cubic yards. **Overall condition:** Extremely poor, pipe is rusted, twisted and crushed, with flow seeping through culvert floor in numerous places. Projecting inlet is slightly crushed.

Barrier Status: Fish Xing determined the culvert is probably not a barrier for adults, but a complete barrier to juveniles. For juveniles, an excessive jump is required to enter culvert. Leakage through rusted bottom may be harmful to out-migrating juveniles. Steelhead observed above culvert, however coho only seen below culvert.

Additional Barriers: Downstream none, empties directly (< 200') into mainstem Mattole River below Whitethorn Road. Upstream, unknown, no access to private property.

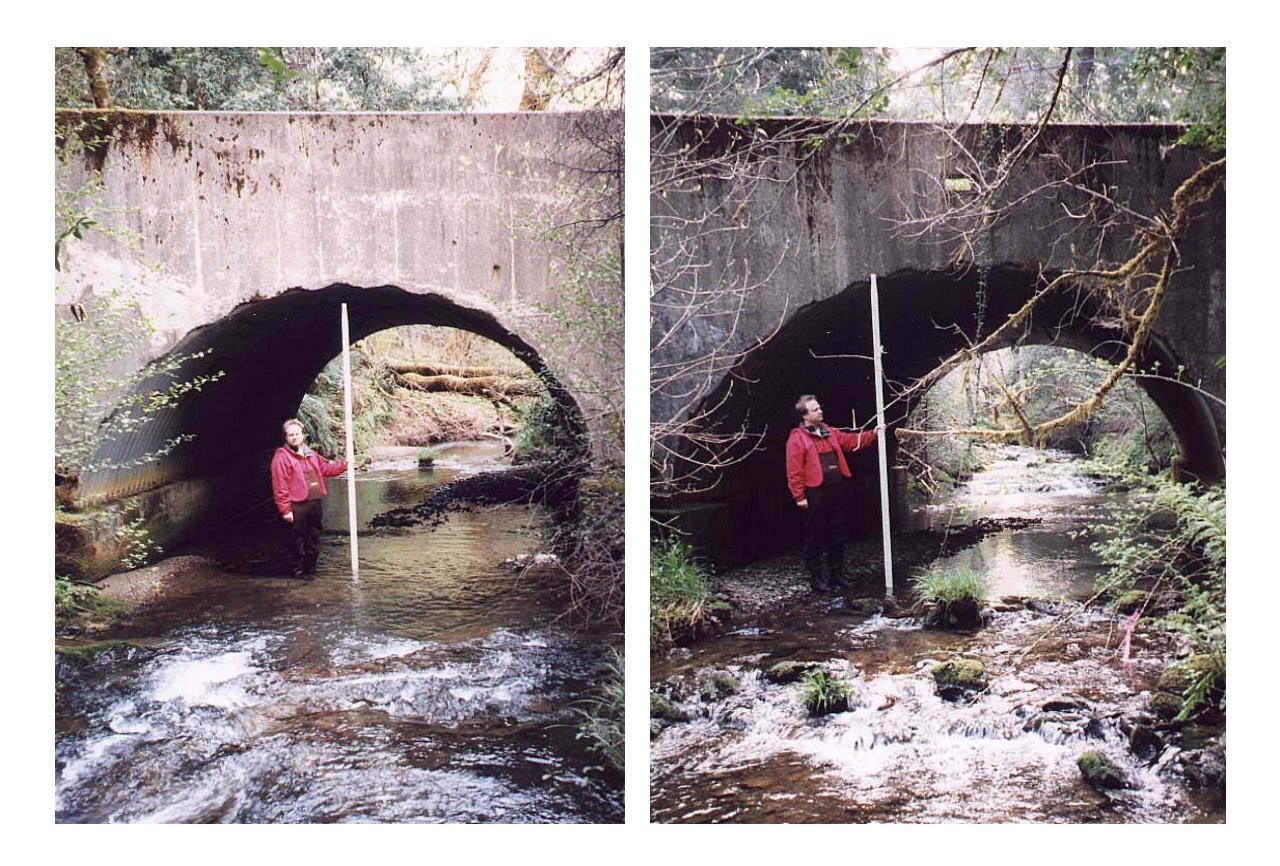
Site #67: Baker Creek; Whitethorn Road Priority Ranking = #43

Overall condition: Good. Sizing: Good, should pass greater than a 50-year storm flow.

Barrier Status: Not a barrier, short of a bridge the BEST crossing observed in Humboldt County.

Habitat Upstream: Quantity = approximately 8,700' of potential anadromous channel. Quality = Good; cool summer water temperatures, dense riparian canopy, pools formed by bedrock and/or woody debris.
