Indian Creek Road Sediment Reduction Project

Indian Creek – Trinity County – January 2009

FINAL REPORT

California Department of Fish and Game – Fisheries Restoration Grant Program
Contract No. P0510325

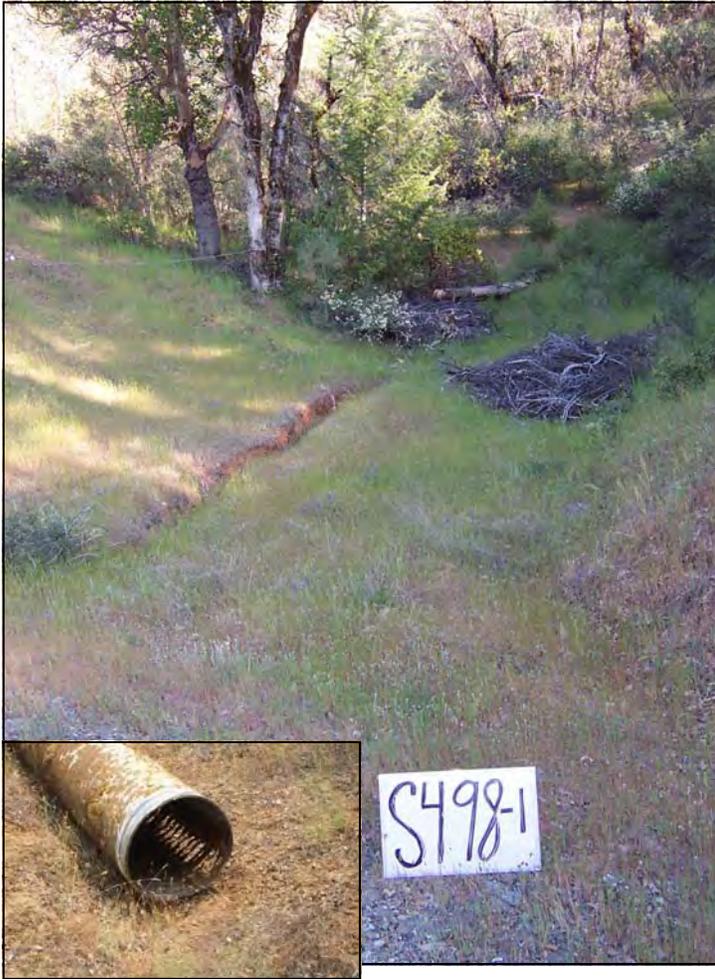
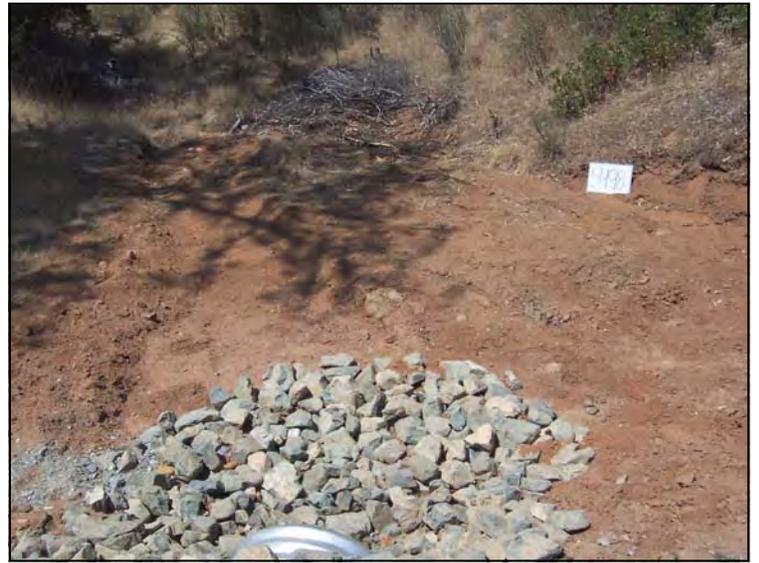
Site 498—Milepost 1.52—Treated Erosion: ~100 cyds

Stream crossing with undersized 18" x 40' CMP that was causing outboard fill face erosion due to short length

Treatment: Replace with a 24" x 60' CMP at bottom of fill, at channel grade & rock the outlet channel

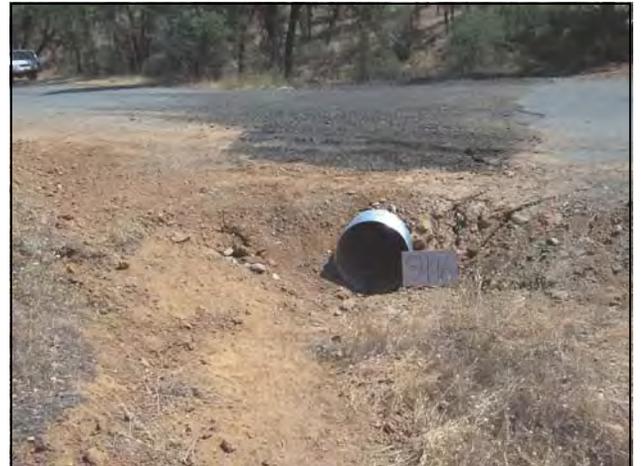
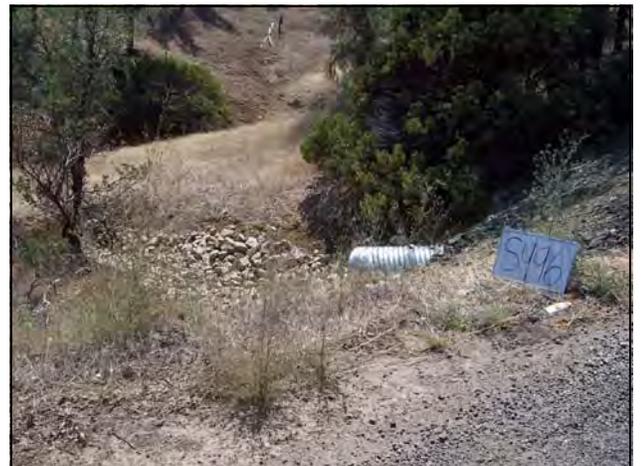
Bottom right top photo is the new 24" inlet

Bottom right photo is the rocked outlet channel

Treatment: Replace with 24" x 50' CMP at bottom of fill & rock the outlet channel

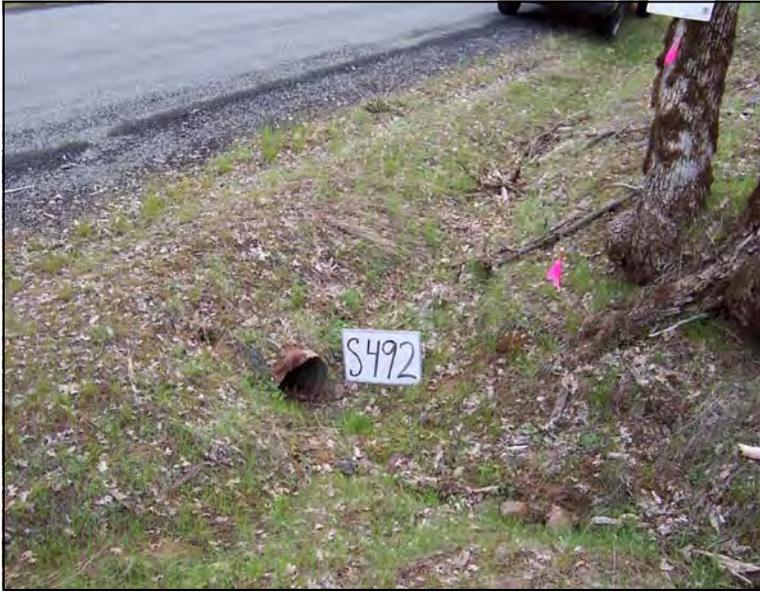
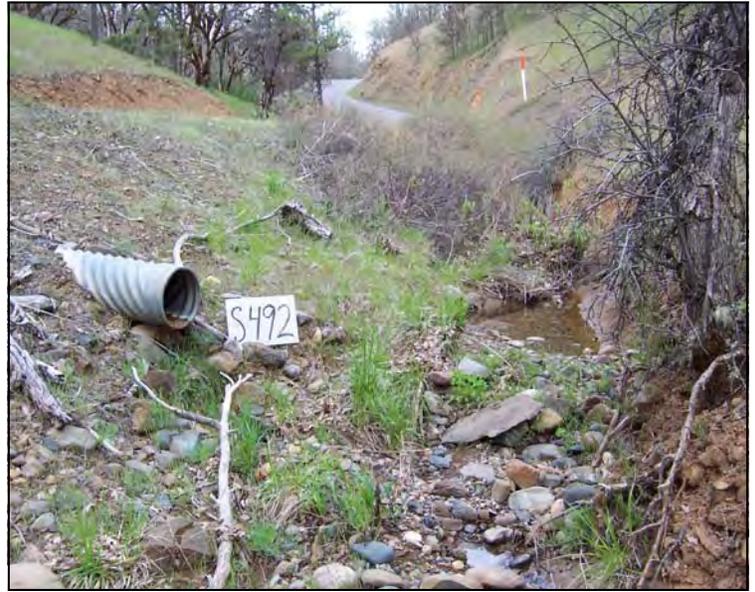
Site 492—Milepost 1.82—Treated Erosion: ~10 cyds

DRC with undersized 12" x 30' CMP that is also an overflow pipe for Site 493 up left.

Bottom left & right photos are after the 18" DRC installation (note outlet of 30" CMP at Site 493 in bottom right photo)

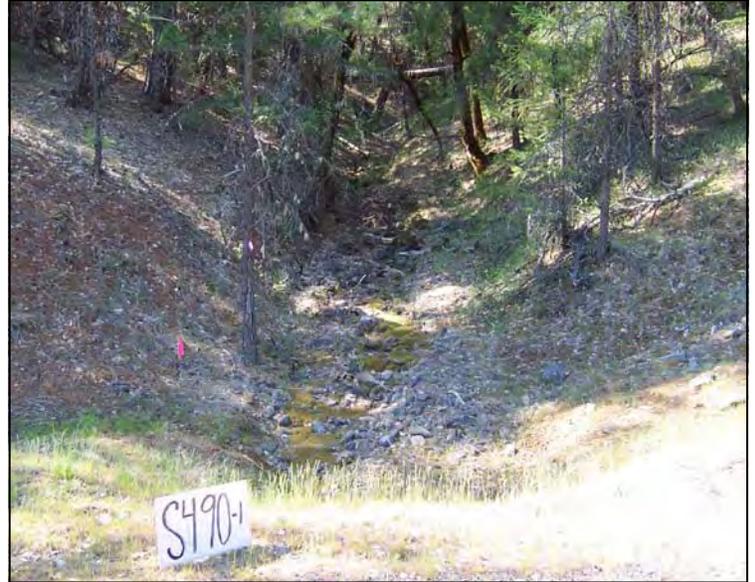
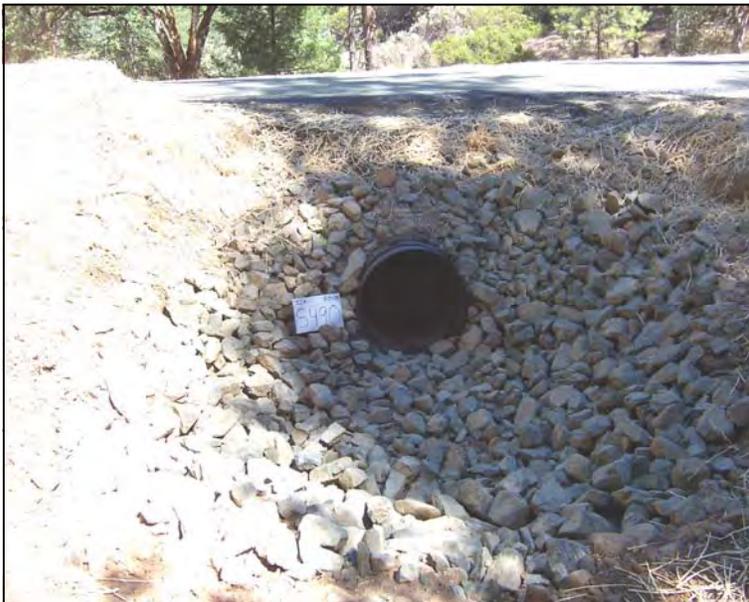
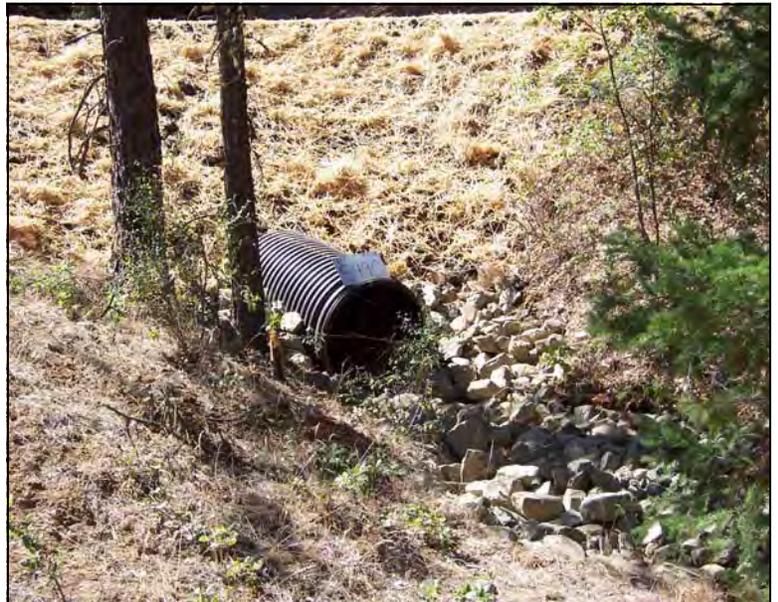
Site 490—Milepost 1.92—Treated Erosion: ~175 cyds

Stream crossing with 24" x 40' Hydraulic mining pipe at Inlet & 10' length of CMP at Outlet

Left photo is the outlet & top photo is the upstream channel prior to project implementation

Bottom photos are the inlet & outlet of the new 36" x 60' HDPE culvert with inboard & outboard rock armor

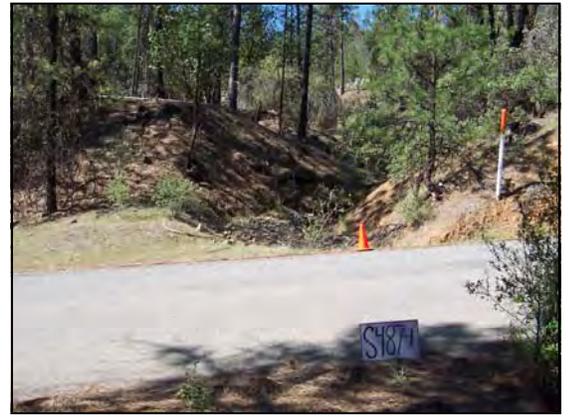
Site 487
Milepost 2.07—Treated Erosion: ~60 cyds

Stream crossing with a 30" x 40' plastic pipe installed at a flat grade that's eroding the outlet channel (shown in left photo)
Treatment: Rock Armor Outlet Channel (bottom photo)

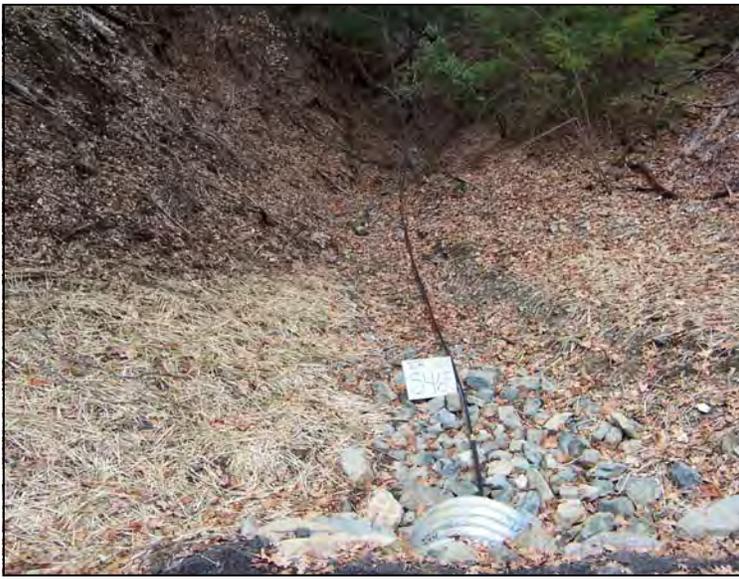
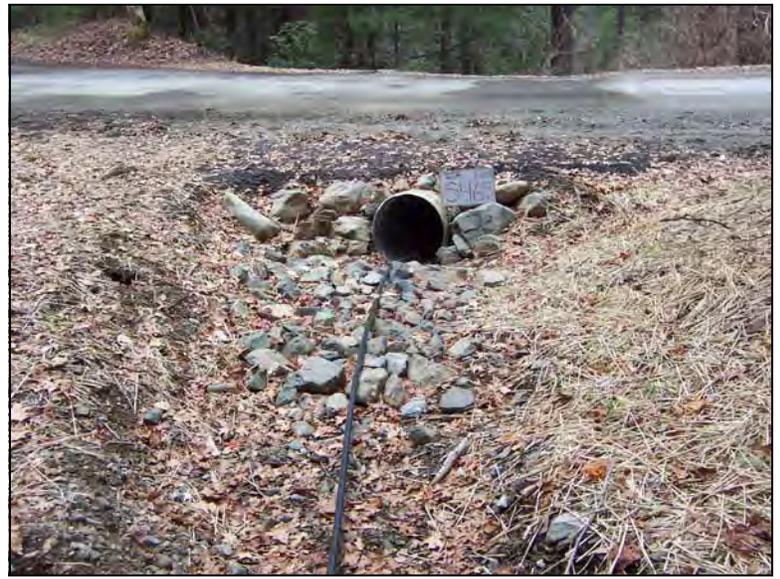
Site 465—Milepost 4.76—Treated Erosion: ~30 cyds

Class 3 fill/stream crossing with steep left road delivering to Site

Top photos are of upstream watershed area & inlet with rock armor; Bottom photo is outlet

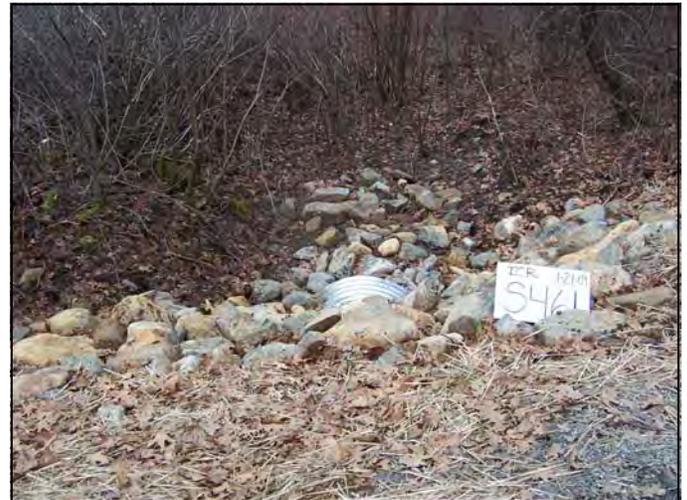
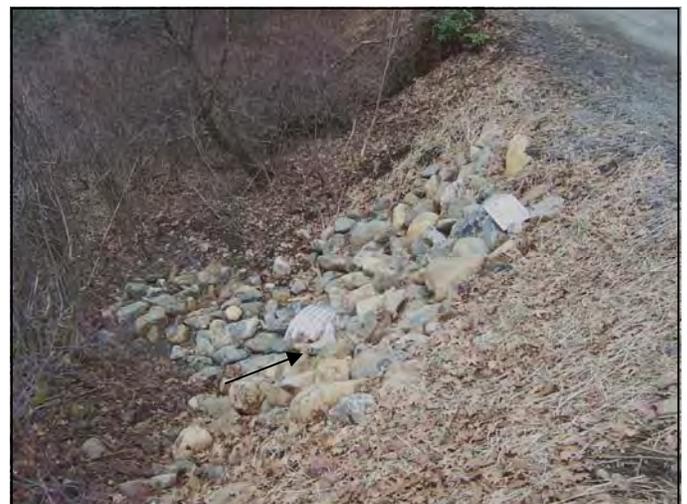
Site 461—Milepost 5.21—Treated Erosion: ~110 cyds

Stream crossing with undersized 18" x 40' CMP not at bottom of fill & substantial runoff from private road up left
 Treatment: Replace with arched 30" x 40' CMP at bottom of fill & at channel grade of 12%; Rock armor outlet channel;
 Surface the County Road for ~470 feet up left with asphalt grindings
 This is where the County Road surface changes from chip seal to native surface.
 Top & bottom left photos are of inlet & outlet prior to implementation, respectively
 Top & bottom right photos are of the inlet & outlet after implementation - note new outlet at bottom of fill, rock armored
 channel & outboard fillface

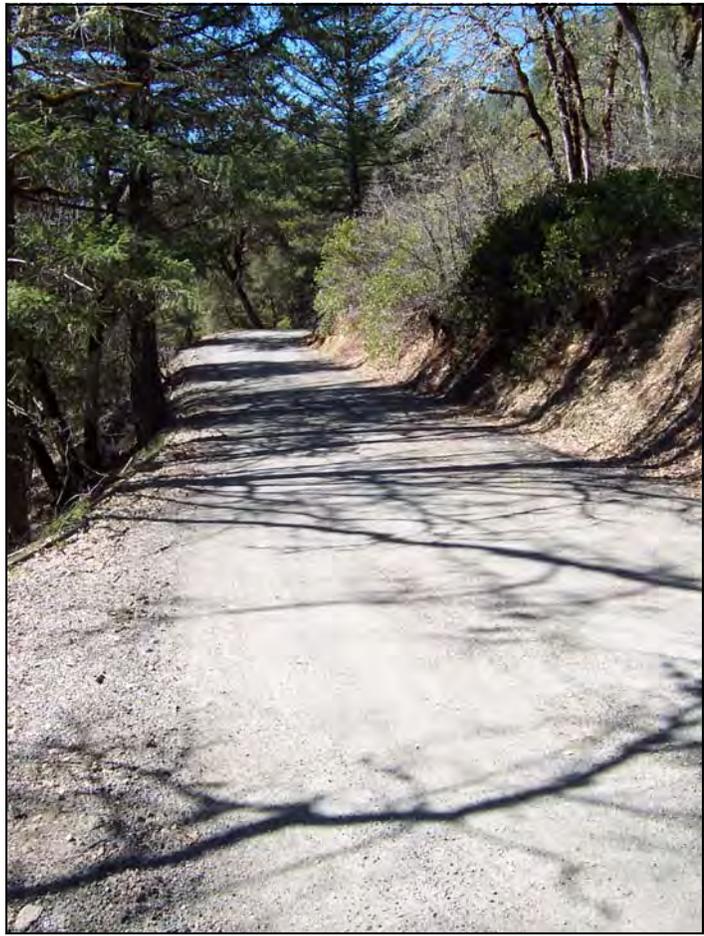
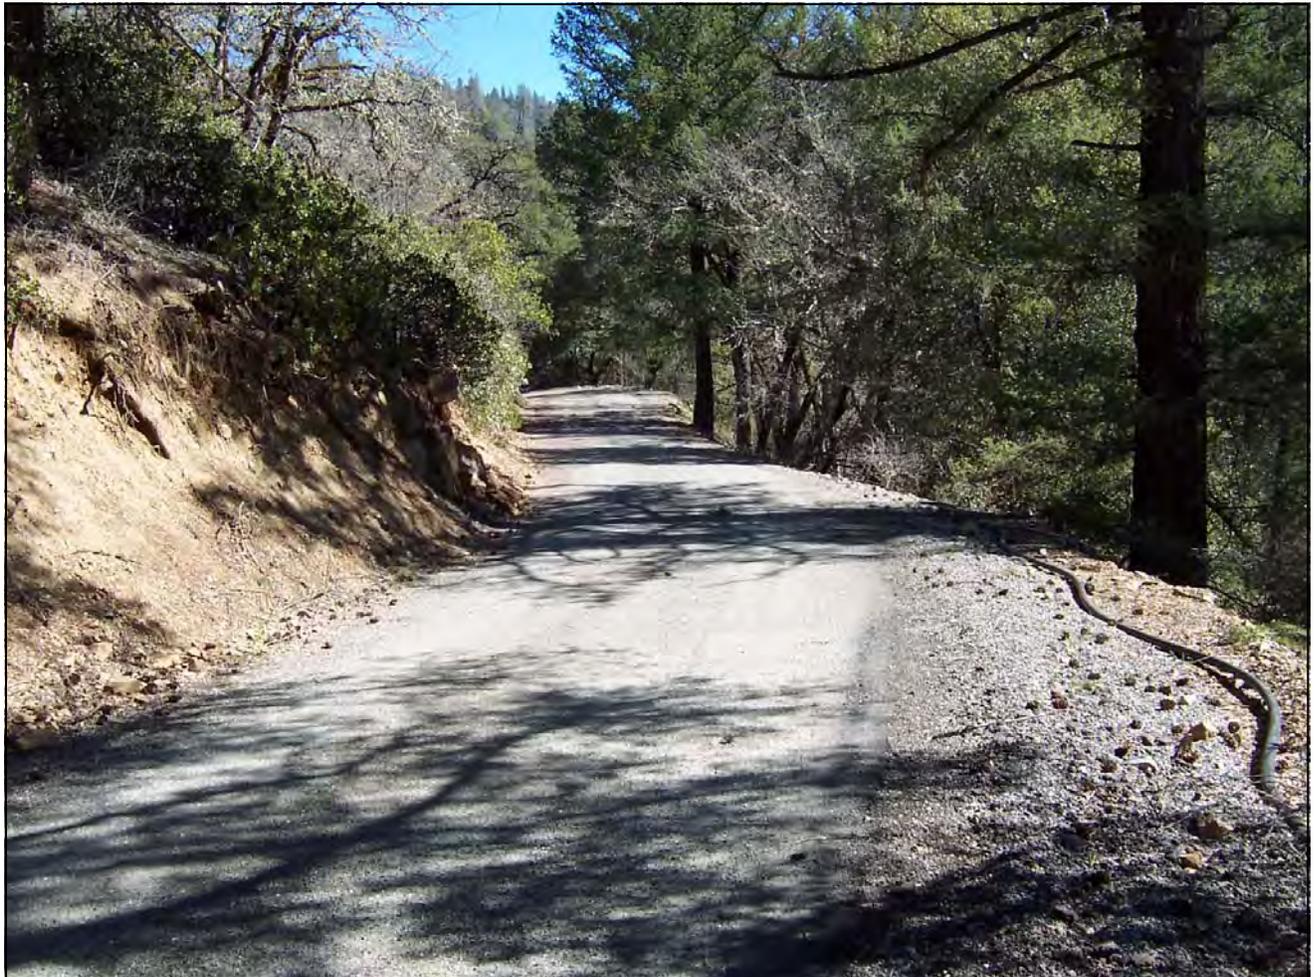
Site 461—Milepost 5.21

Treated Erosion: ~ 350 cyds
Top & Bottom photos are the section of
outsloped & surfaced roadway between Site
461 & Site 460

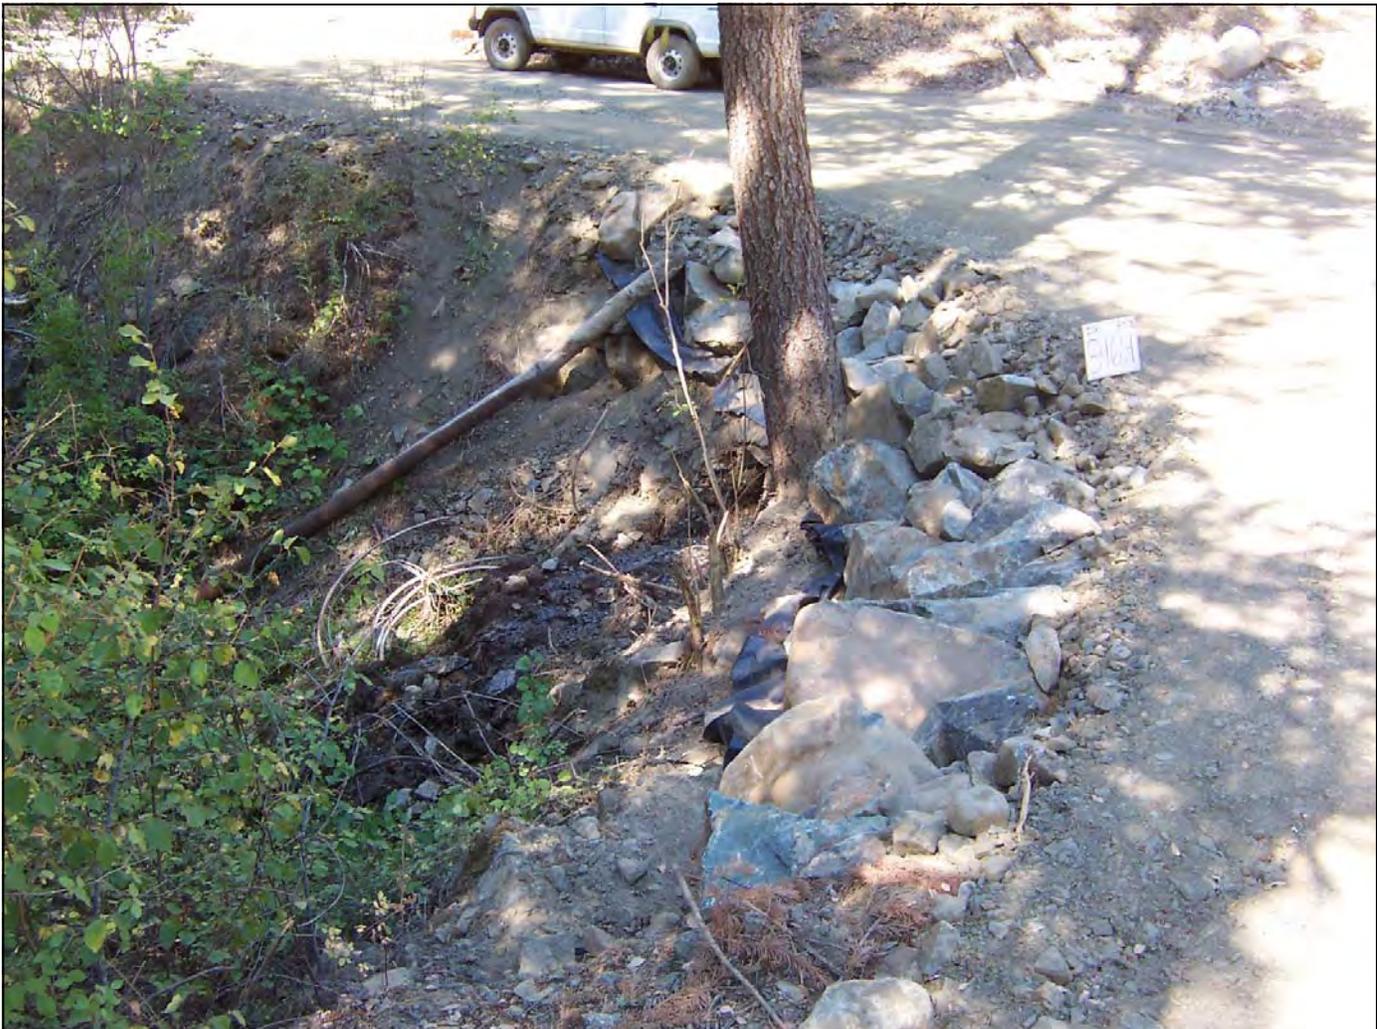
Installed critical dip with filter fabric & large rock

Both photos are of the outboard fill face with C-dip rock & fabric installed. Rock extends approximately 10 feet back into the roadfill

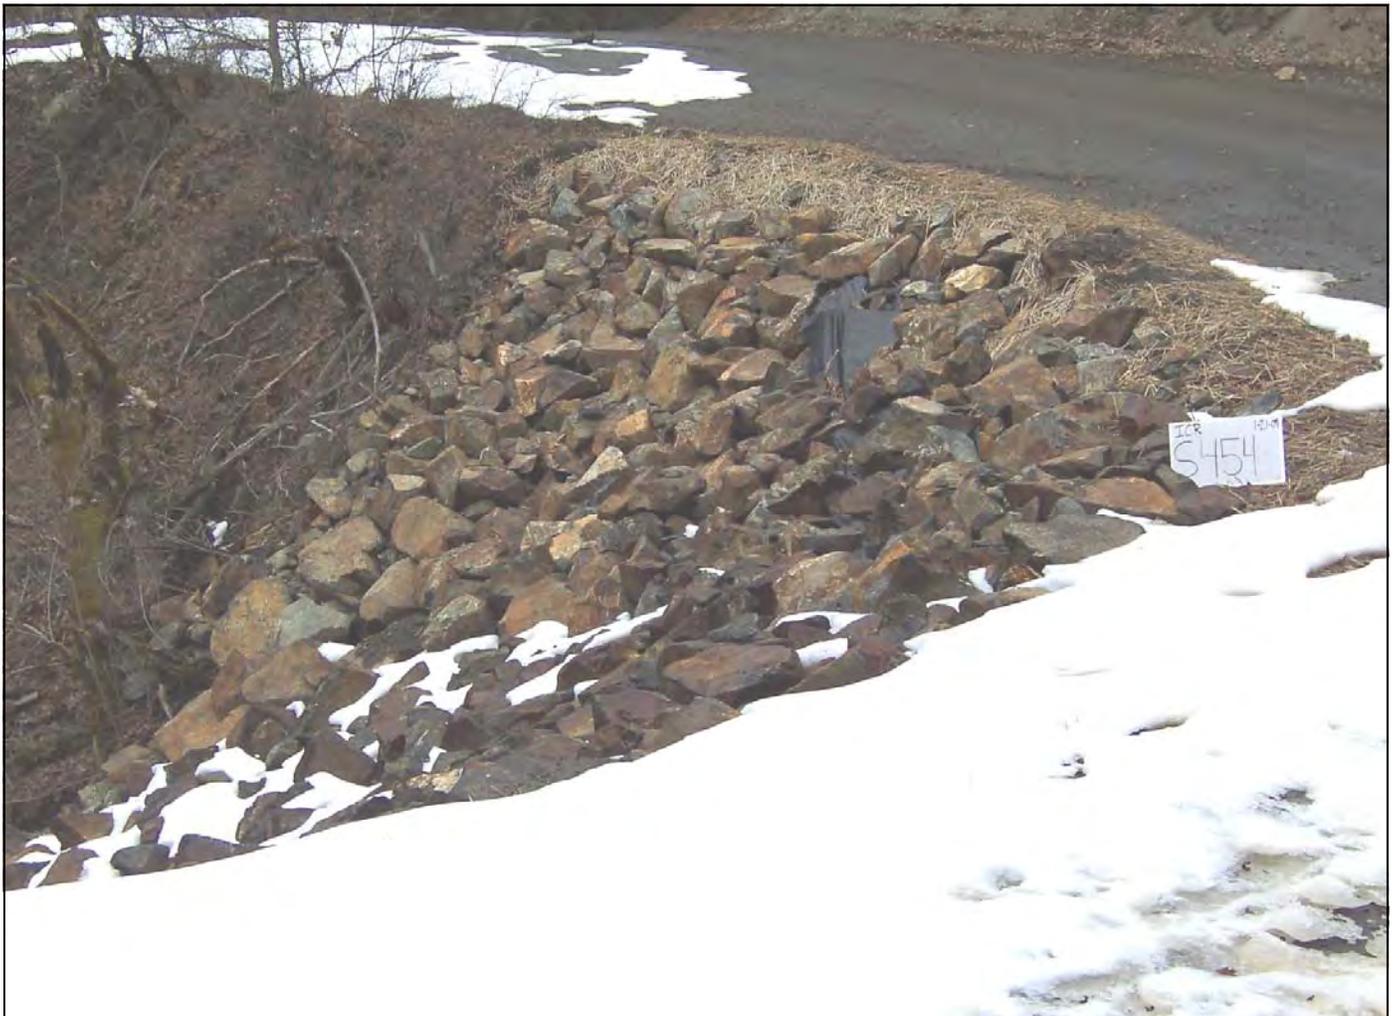
Site 454—Milepost 6.3

Top photo is of the roadway configuration at the crossing prior to implementation
Bottom photo is the critical dip filter fabric & large rock as well as rock armored outboard fillface

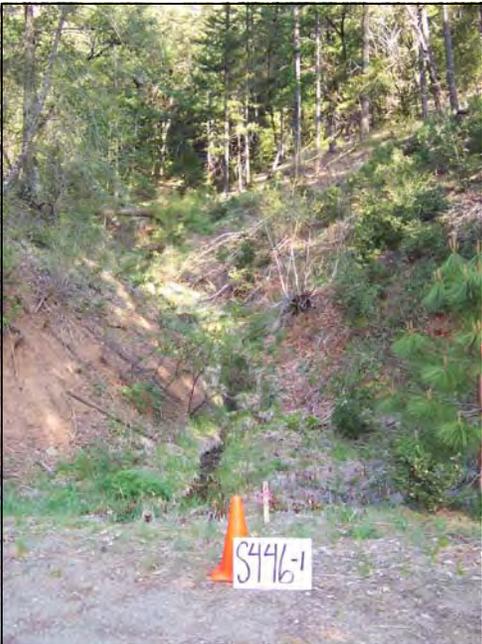
Stream crossing with 30" x 100' Smooth Bore Plastic pipe that was installed ~6 years ago with rock armor at inlet & outlet. Upstream is private timber land & past logging activity has resulted in large amounts of material discharge to this crossing. Treatment: Install a critical dip with filter fabric & large rock. Requires re-grading the road up right to conform to the dip at the crossing. Rock the road after the dip is installed.

Top photo is of the crossing from up left prior to critical dip installation. Bottom photos show the upstream channel area & the road up right fro the crossing. See next page for post-treatment photos.
