Group Design Exercise

San Juan Creek Project Description

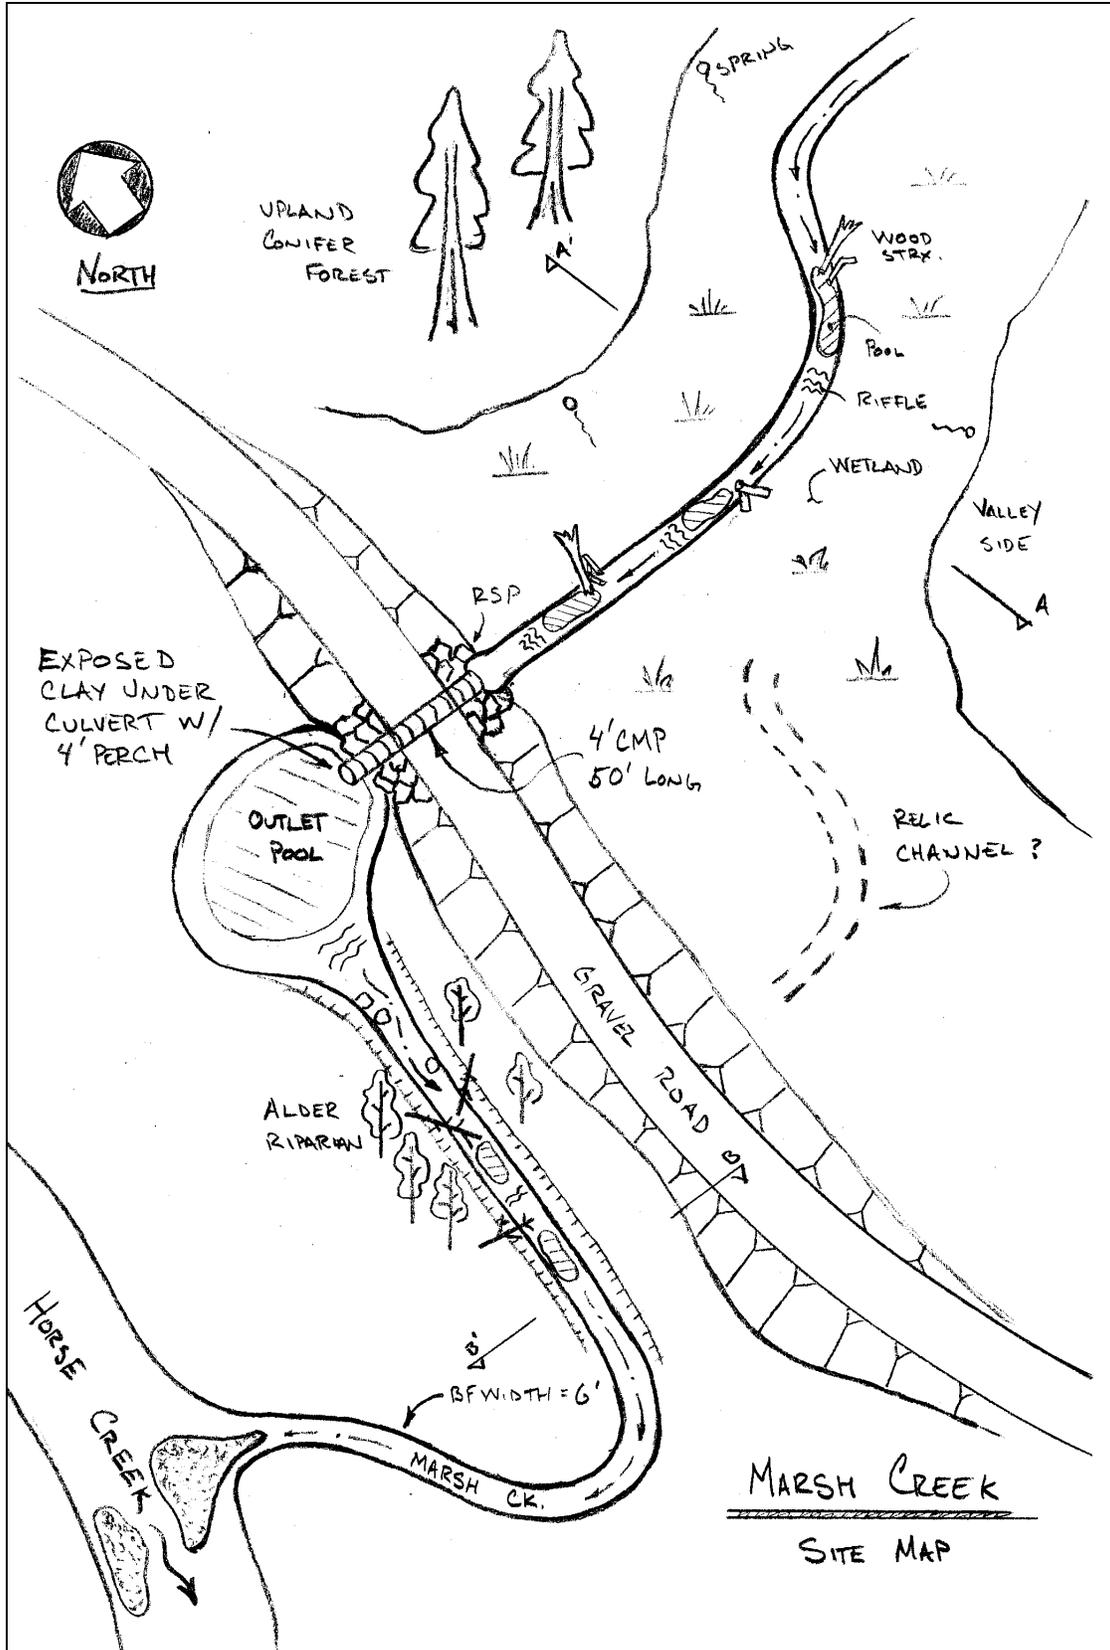
The existing crossing consists of a 48-inch diameter corrugated metal culvert that is 50-ft in length. The overall culvert slope is 1.0 %. The outlet is perched more than 4-ft above the outlet pool.
