Channel Morphology - Stream Crossing Interactions

An Overview

Michael Love
Michael Love & Associates
mlove@h2odesigns.com
(707) 476-8938

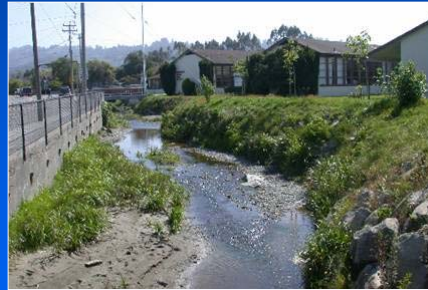
Example of Channelization

Little Browns Creek, Trinity County, CA

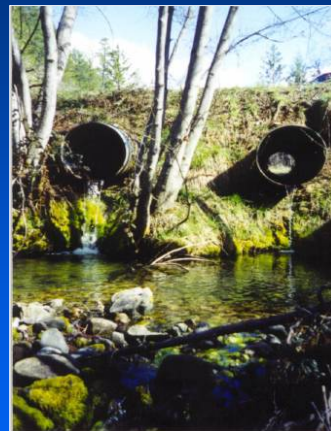
Original Disturbance:

- Channel moved during historical placer mining
- Downstream channel straightened for 5,000 feet for Highway 3

Result:

- Channel downstream of County culvert incised 9 feet.
- Unstable channel banks, numerous bank failures, continuing incising of channel bed, loss of riparian trees.

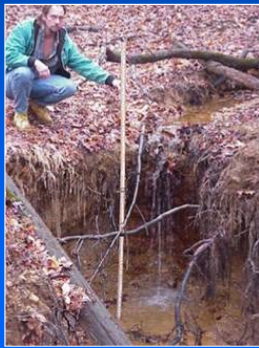
Head Cutting and Channel Incision

Headward retreat of a Nick Point, an interruption in a stream's longitudinal profile.

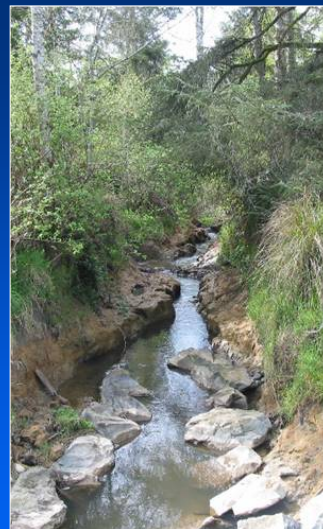
Incised channel upstream of culvert replacement

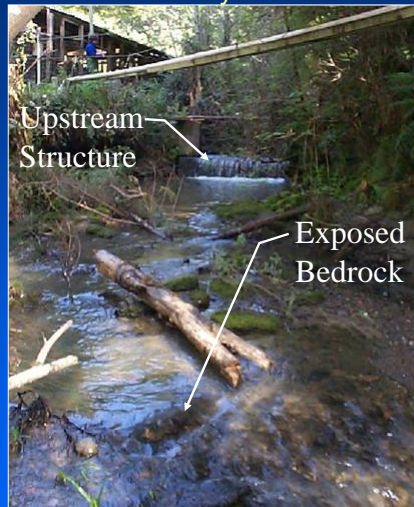
McCready Gulch

Upstream of perched culvert, prior to removal

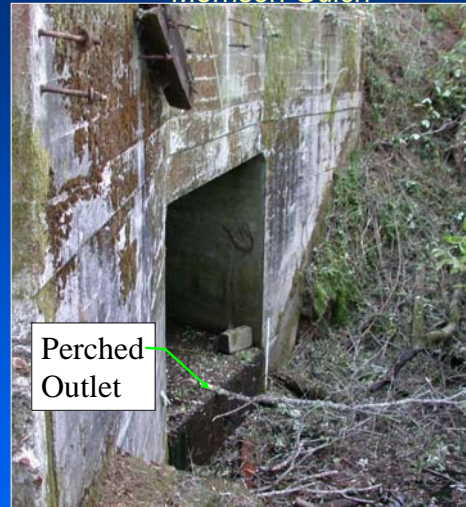
Morrison Gulch

Perched Outlet
Channel upstream of culvert replaced with natural regrade

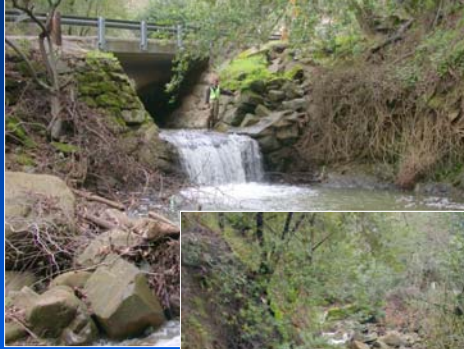
Rate of Natural Regrade

More mobile the bed material, more rapid the channel regrades

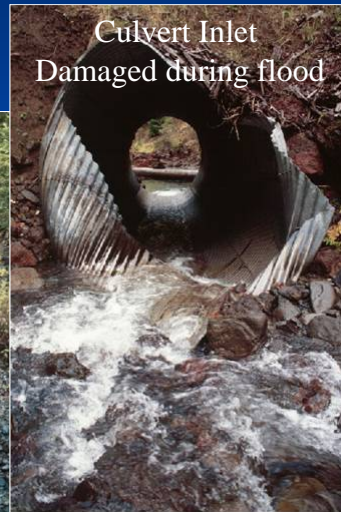
Aggradation from the 1997 Flood Event

Case Example Upstream Aggradation

Groundhog Creek
Middle Fork RD, Willamette NF

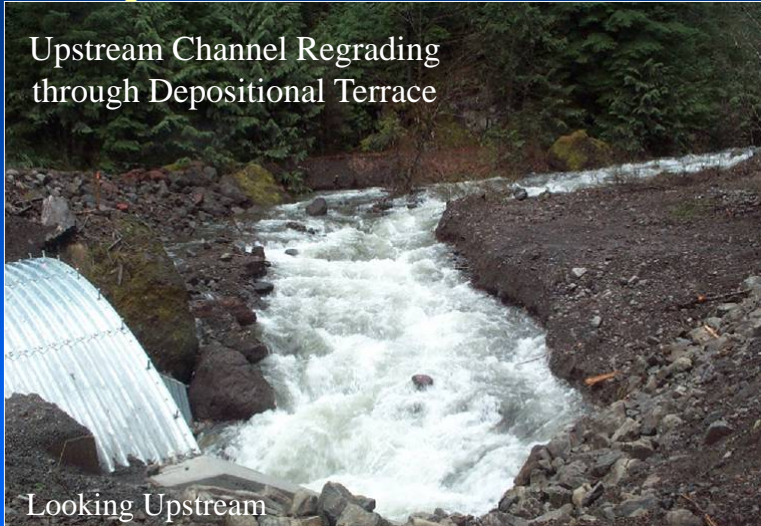
Upstream Channel Regrading
through Depositional Terrace

Looking Upstream
